The drainage
of
Wilbraham
Fulbourn
and
Teversham
Fens

**THE DRAINAGE OF WILBRAHAM
FULBOURN AND TEVERSHAM FENS**

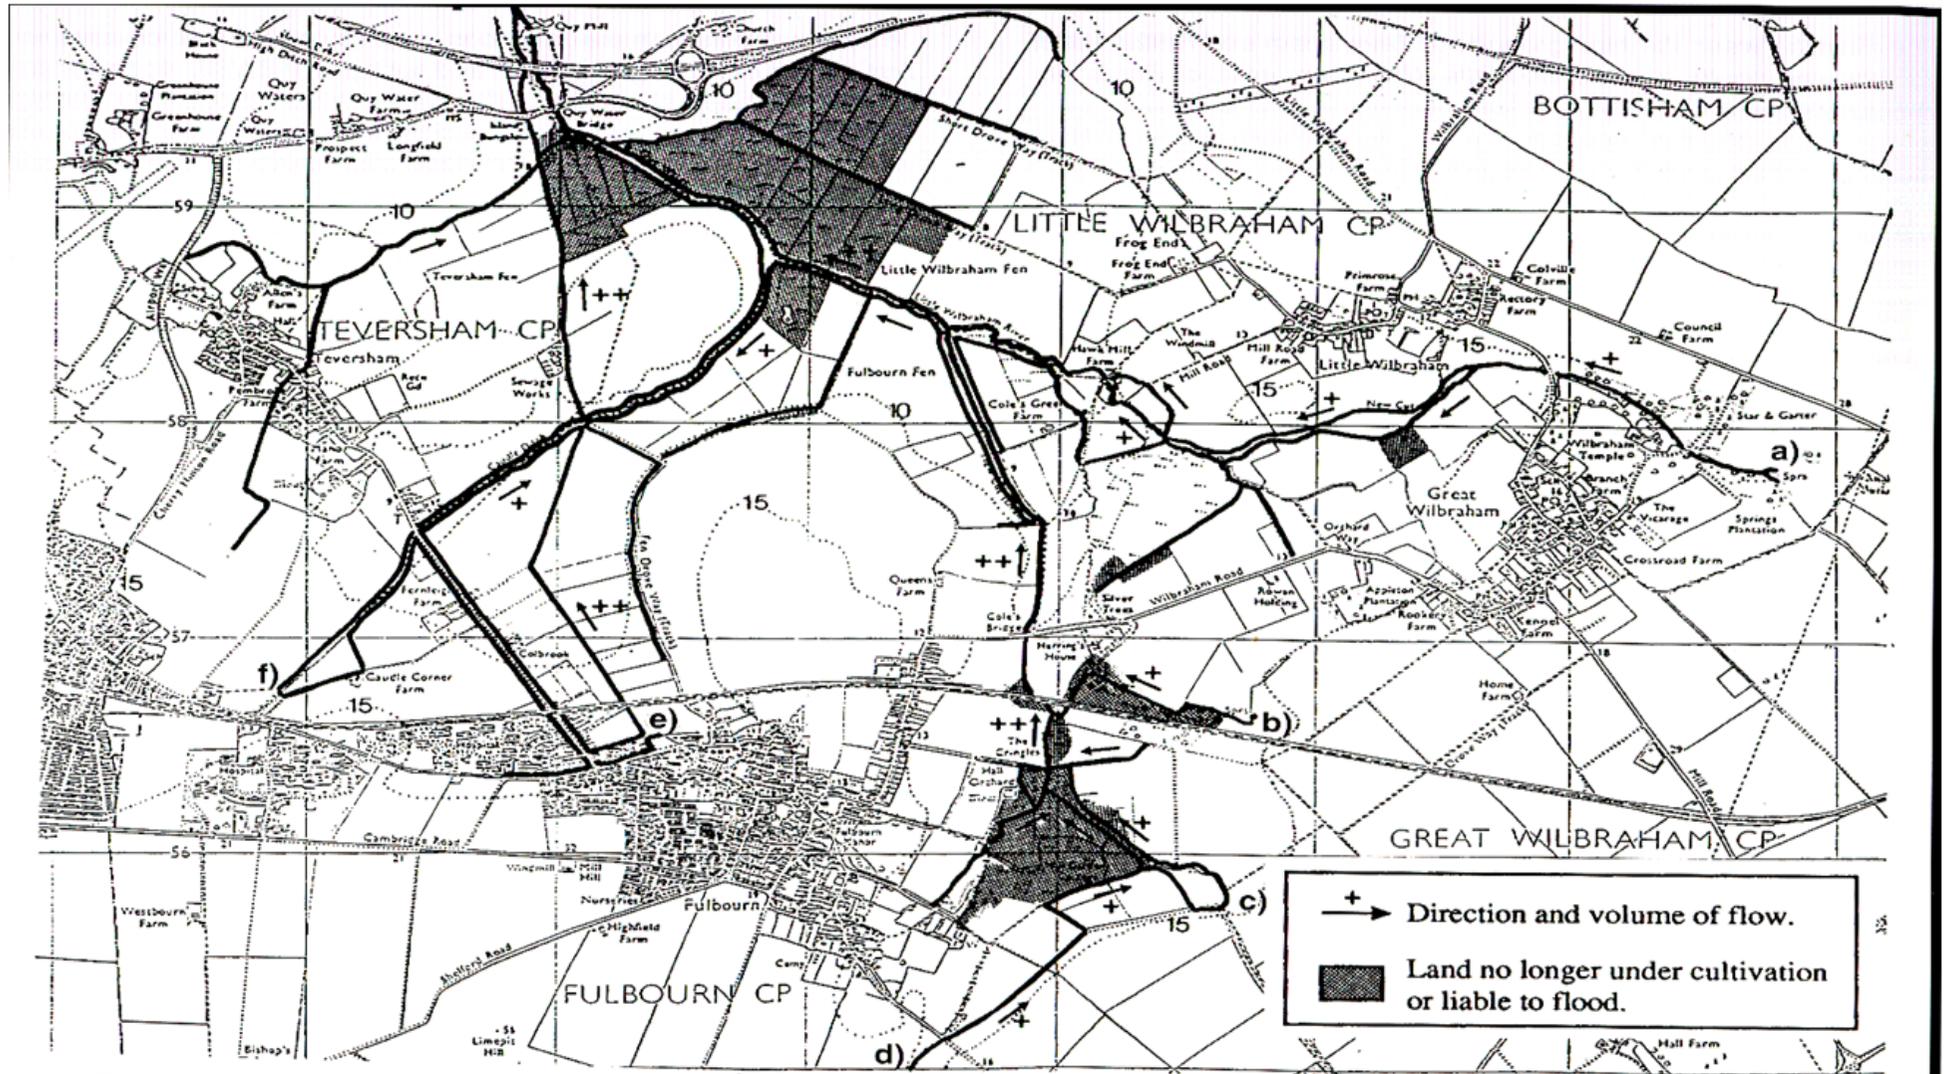
Figure 1. Map showing area of Wilbraham, Fulbourn and Teversham Fens. Superimposed are the main watercourses and public drains, the flow within them and the land no longer under cultivation or liable to flood.

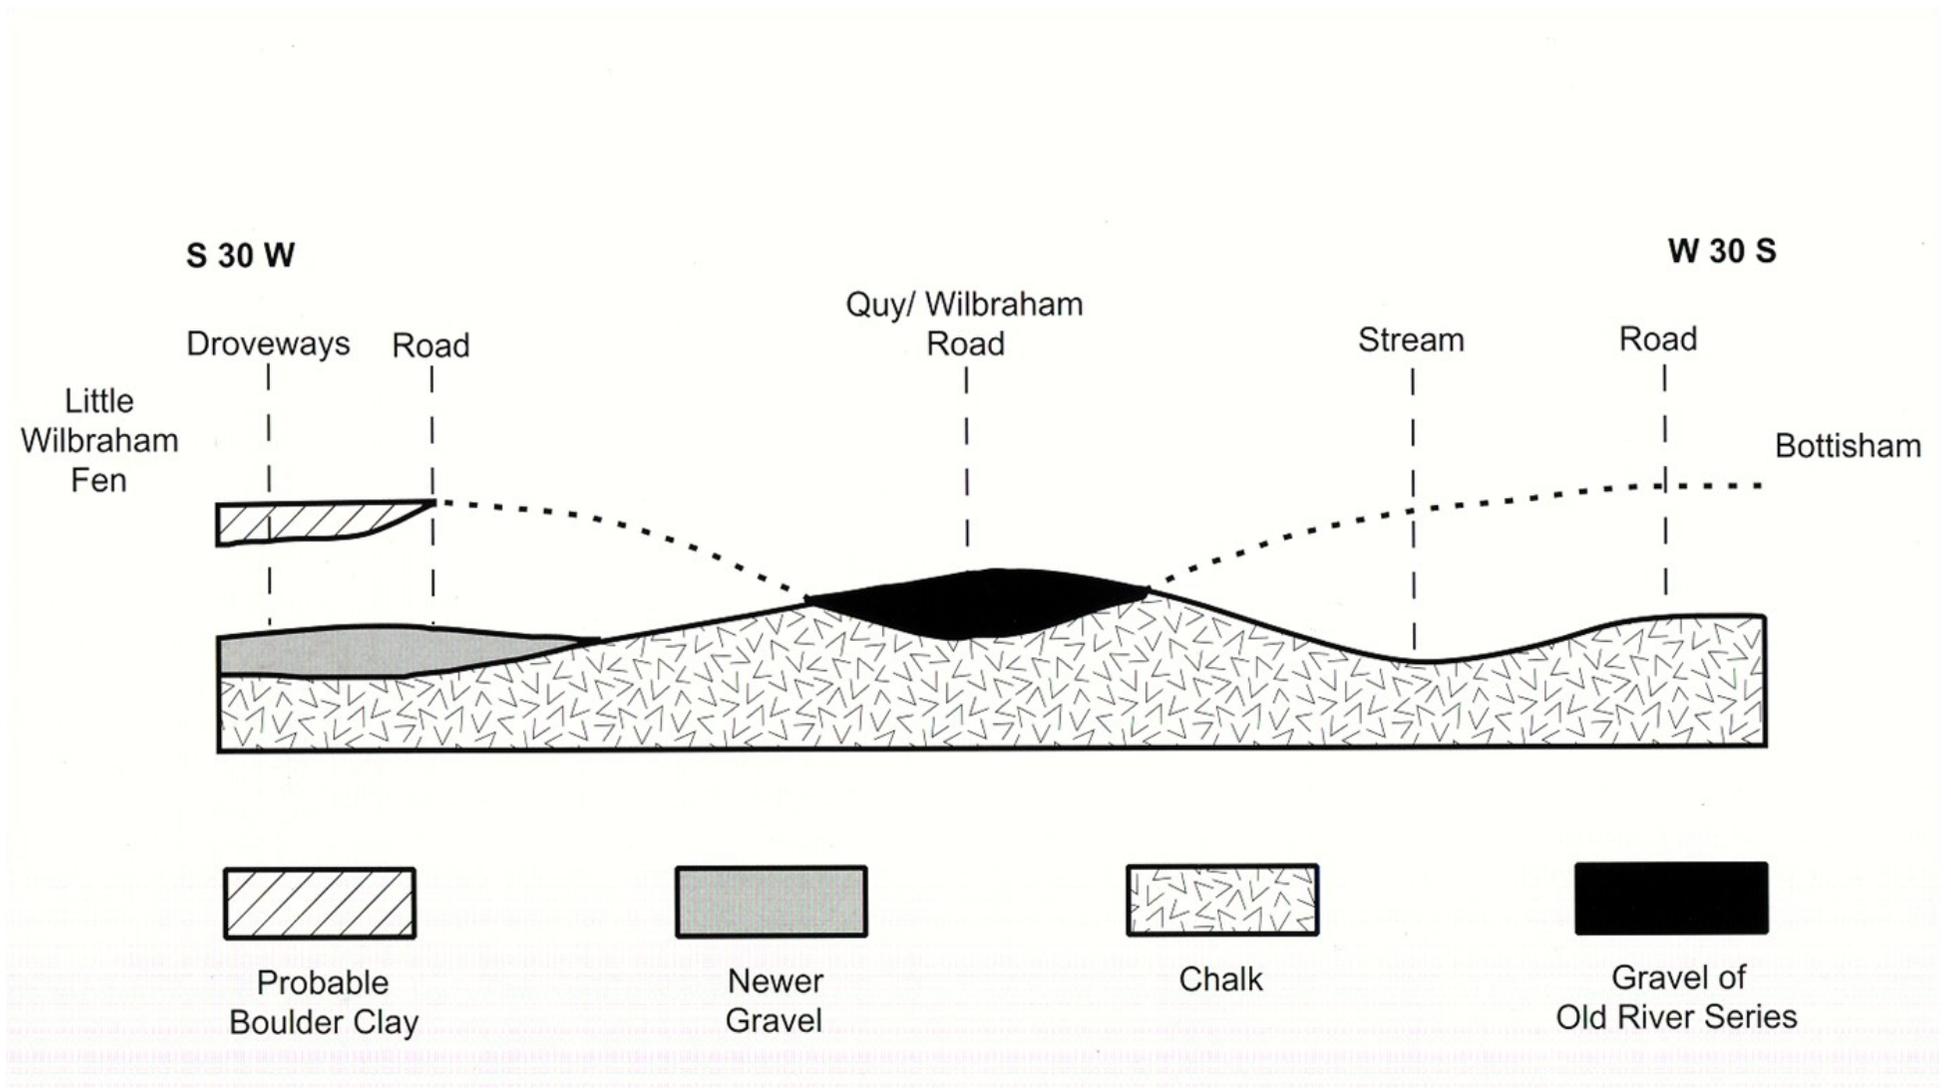
Figure 2. Geological section, Wilbraham Fen to Bottisham. The gravel laid down in the bed of an ancient river system now caps the low ridge that forms the northern and north-eastern boundaries of the fen.

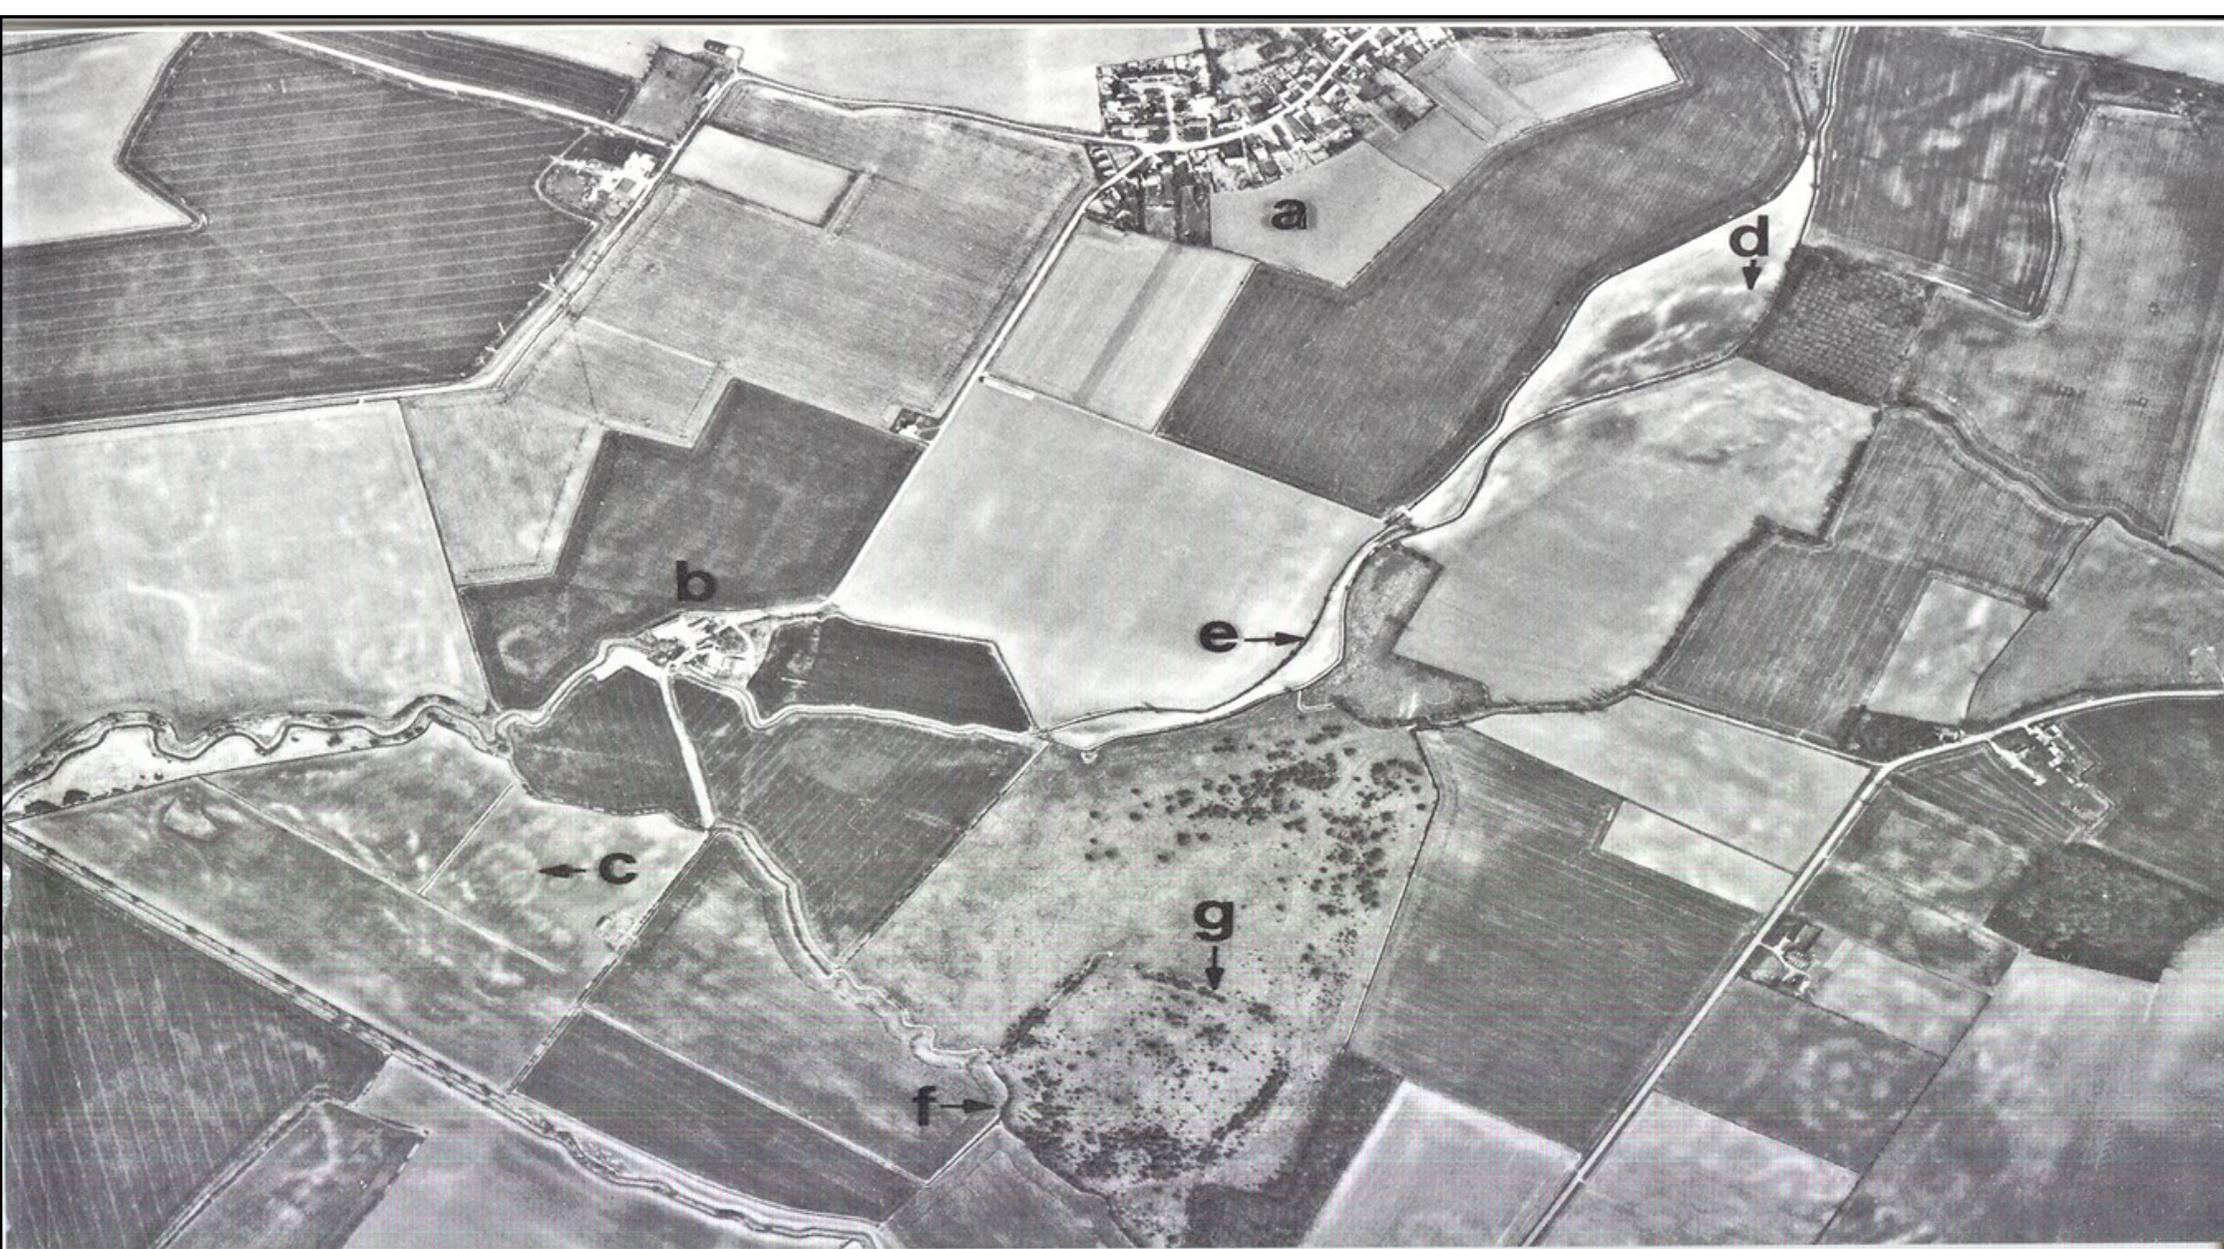
Figure 3. Hawk Mill Farm, Little Wilbraham, Spring 1992 showing soil and crop marks. Most of these are due to cryoturbation during the last Ice Age. Key: a) Little Wilbraham, b) Hawk Mill farm, c) collapsed frost mound, d) probable former course of Little Wilbraham River, e) Wilbraham New Cut, f) former course of Great Wilbraham River with later

The larger ones represent collapsed frost mounds which, starting as circles, may coalesce to form composite shapes. These changes, due to cryoturbation of the soil in the last Ice Age, develop when ground water is frozen into lenses of ice beneath the surface and may be particularly numerous near spring lines. The finer reticulated or polygonal pattern results from the seasonal freezing and thawing of the superficial layers of the soil overlying permafrost. Some of the more serpentine soil marks may represent the lines of old creeks or streams. There is such an example between the two watercourses south of the village of Little Wilbraham. But despite its great interest in other respects, aerial photography does not provide unequivocal evidence of the line of the natural drainage of this area.

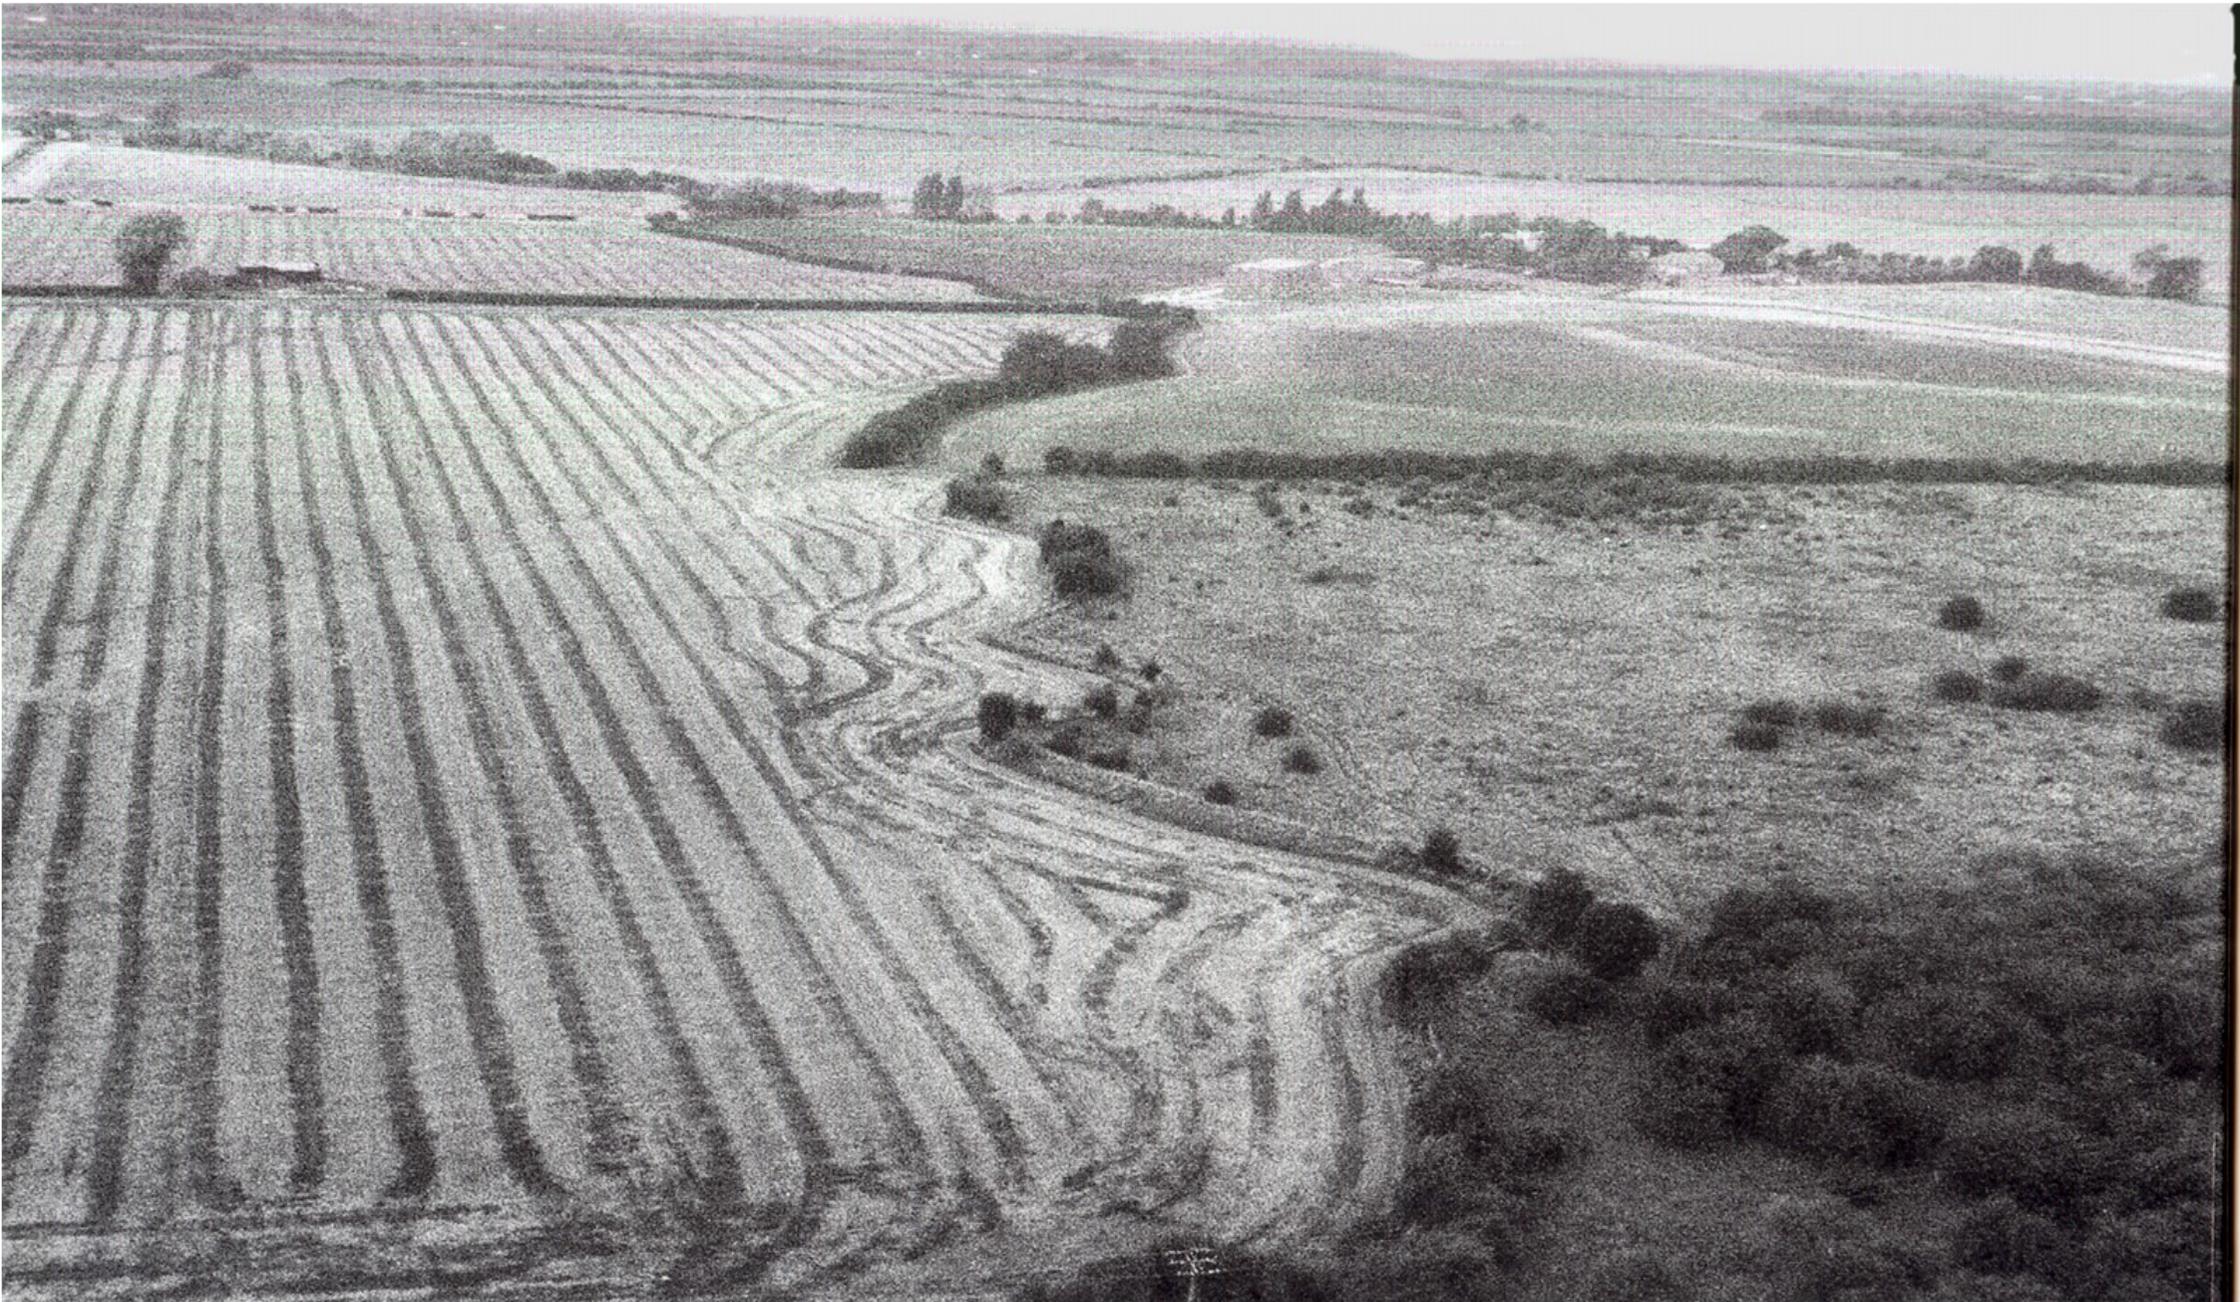
Figure 4. The sinuous parish boundary between Fulbourn and Great Wilbraham looking towards Hawk Mill Farm (to the right of the straw stack). Running between the harvested fields to the west and Great Wilbraham Common and ploughland to the east it follows the former course of Great Wilbraham River before its diversion to increase flow at Hawk Mill.

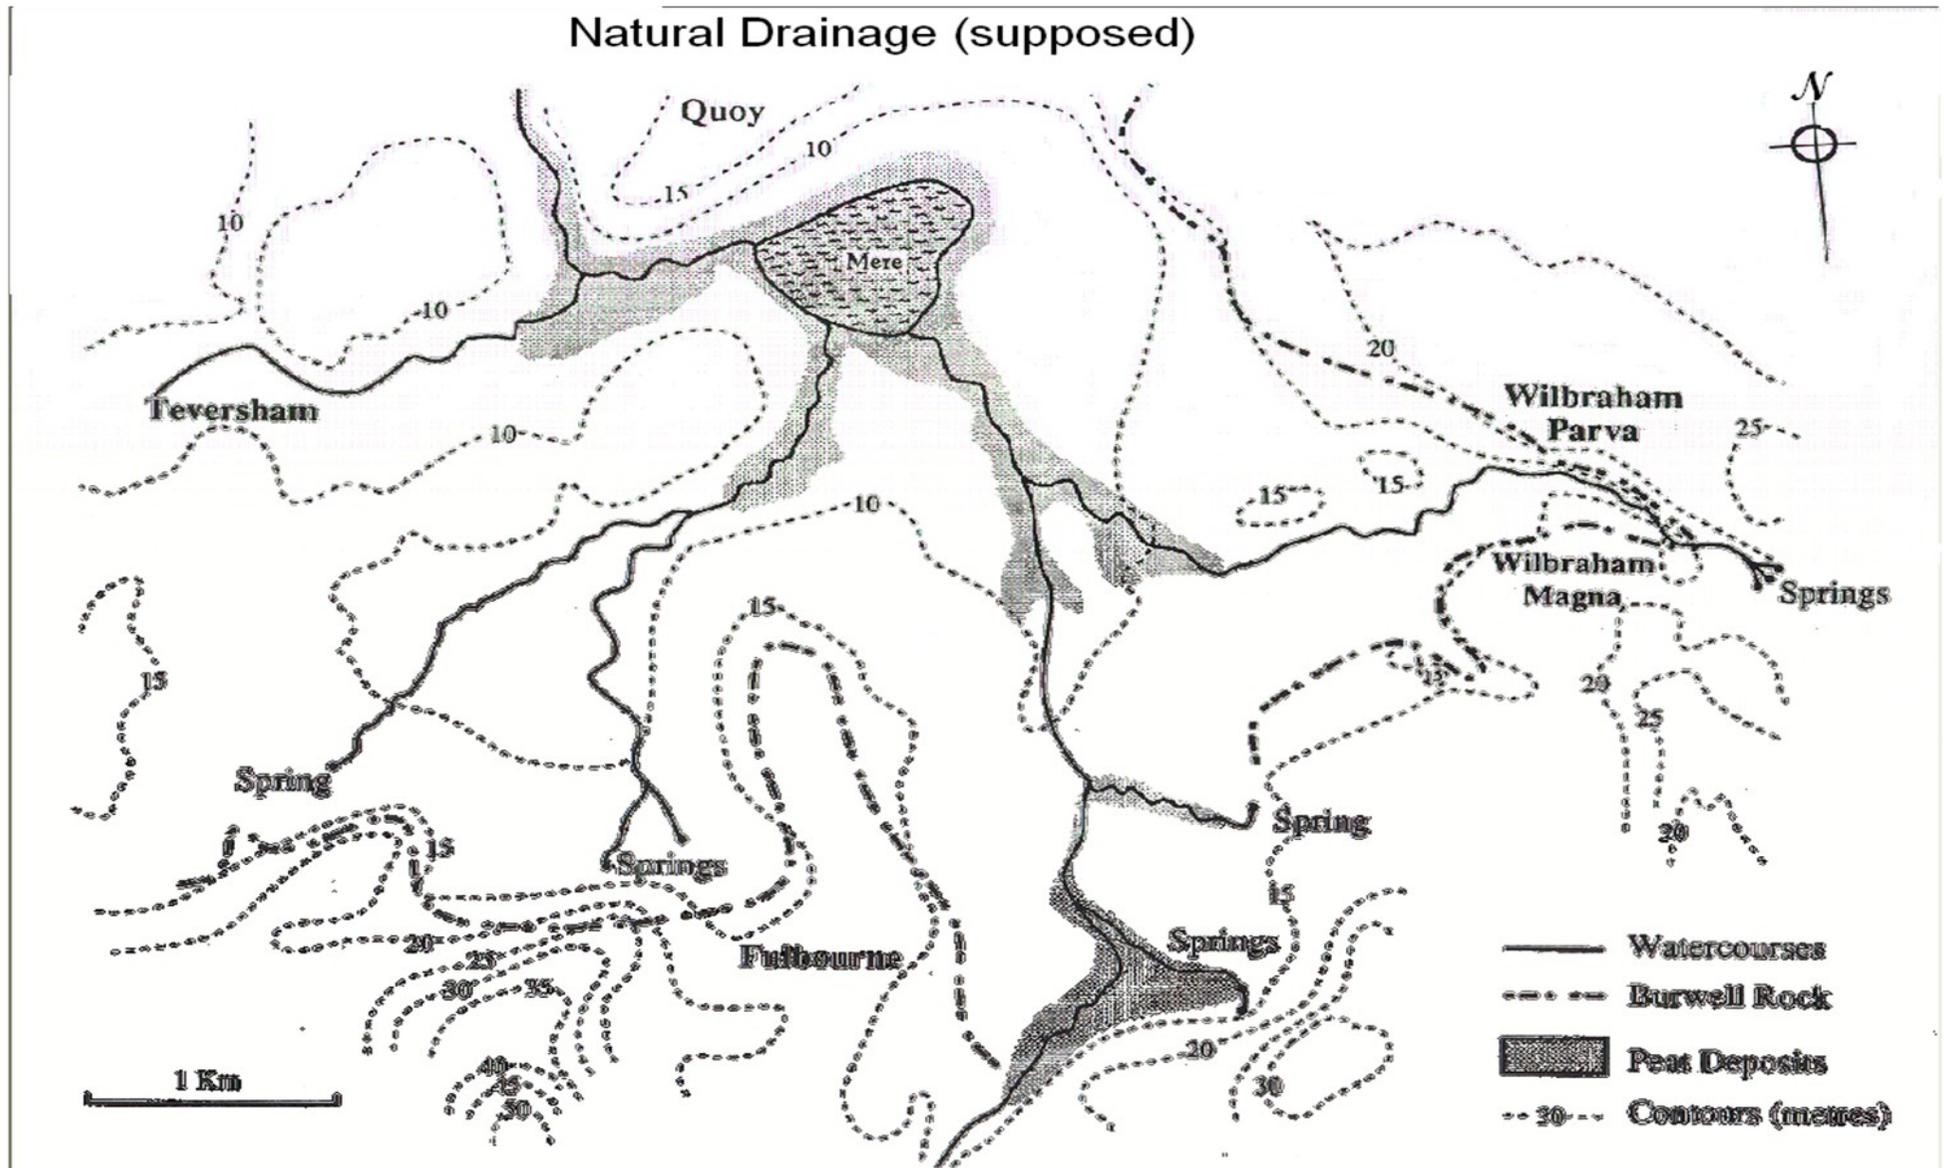
Figure 5. Probable natural drainage before the watercourses had been modified to provide power for watermills. Most of the

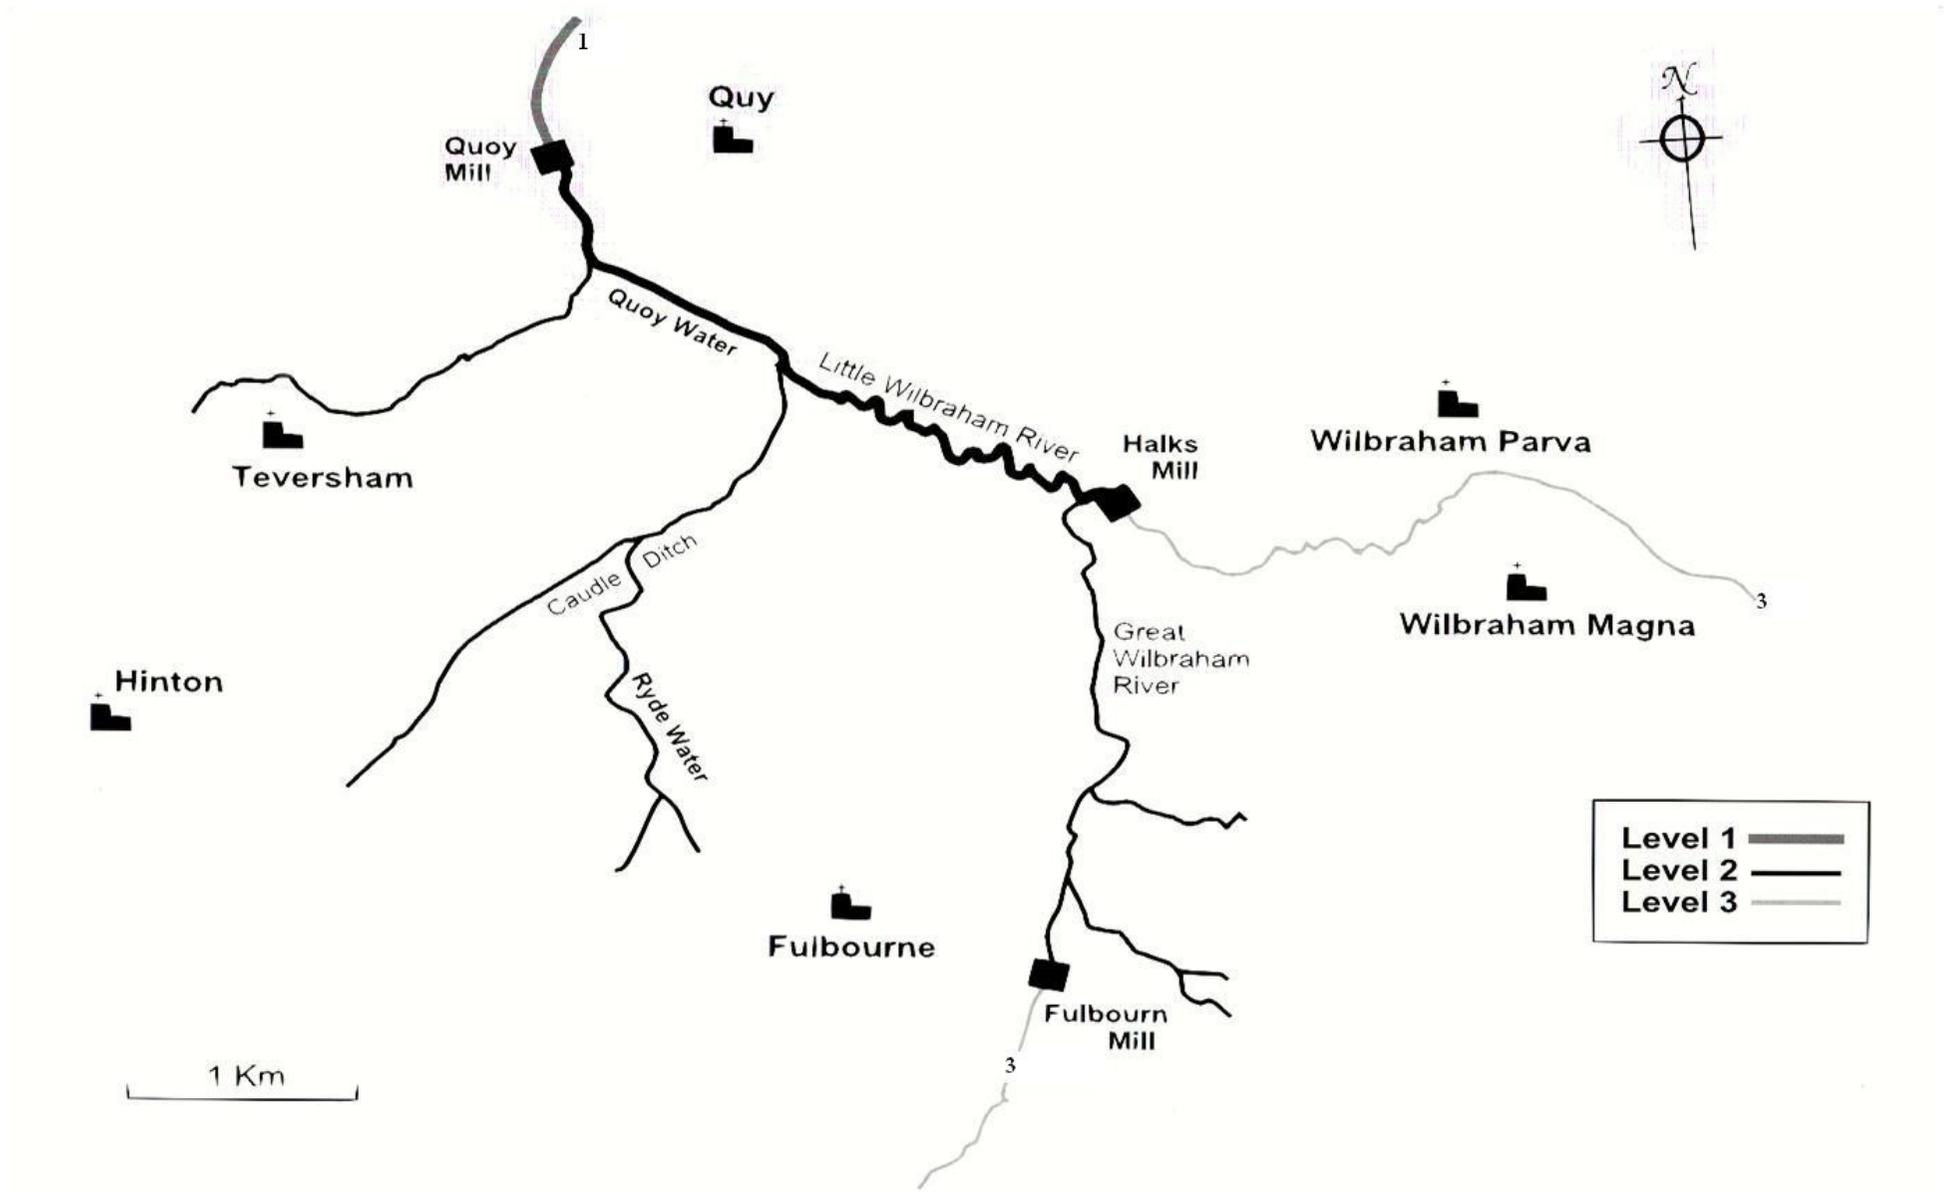
Figure 6. The effect of watermills on water levels. See text

The site of these mills was determined not only by the streams which appear to have been diverted to serve them but where gravel or chalk subsoils adjacent to the existing fen provided firm foundations for the buildings and access for heavy loads. Their construction and continuing presence significantly altered the natural drainage by creating three different water levels (Fig.6). These were:

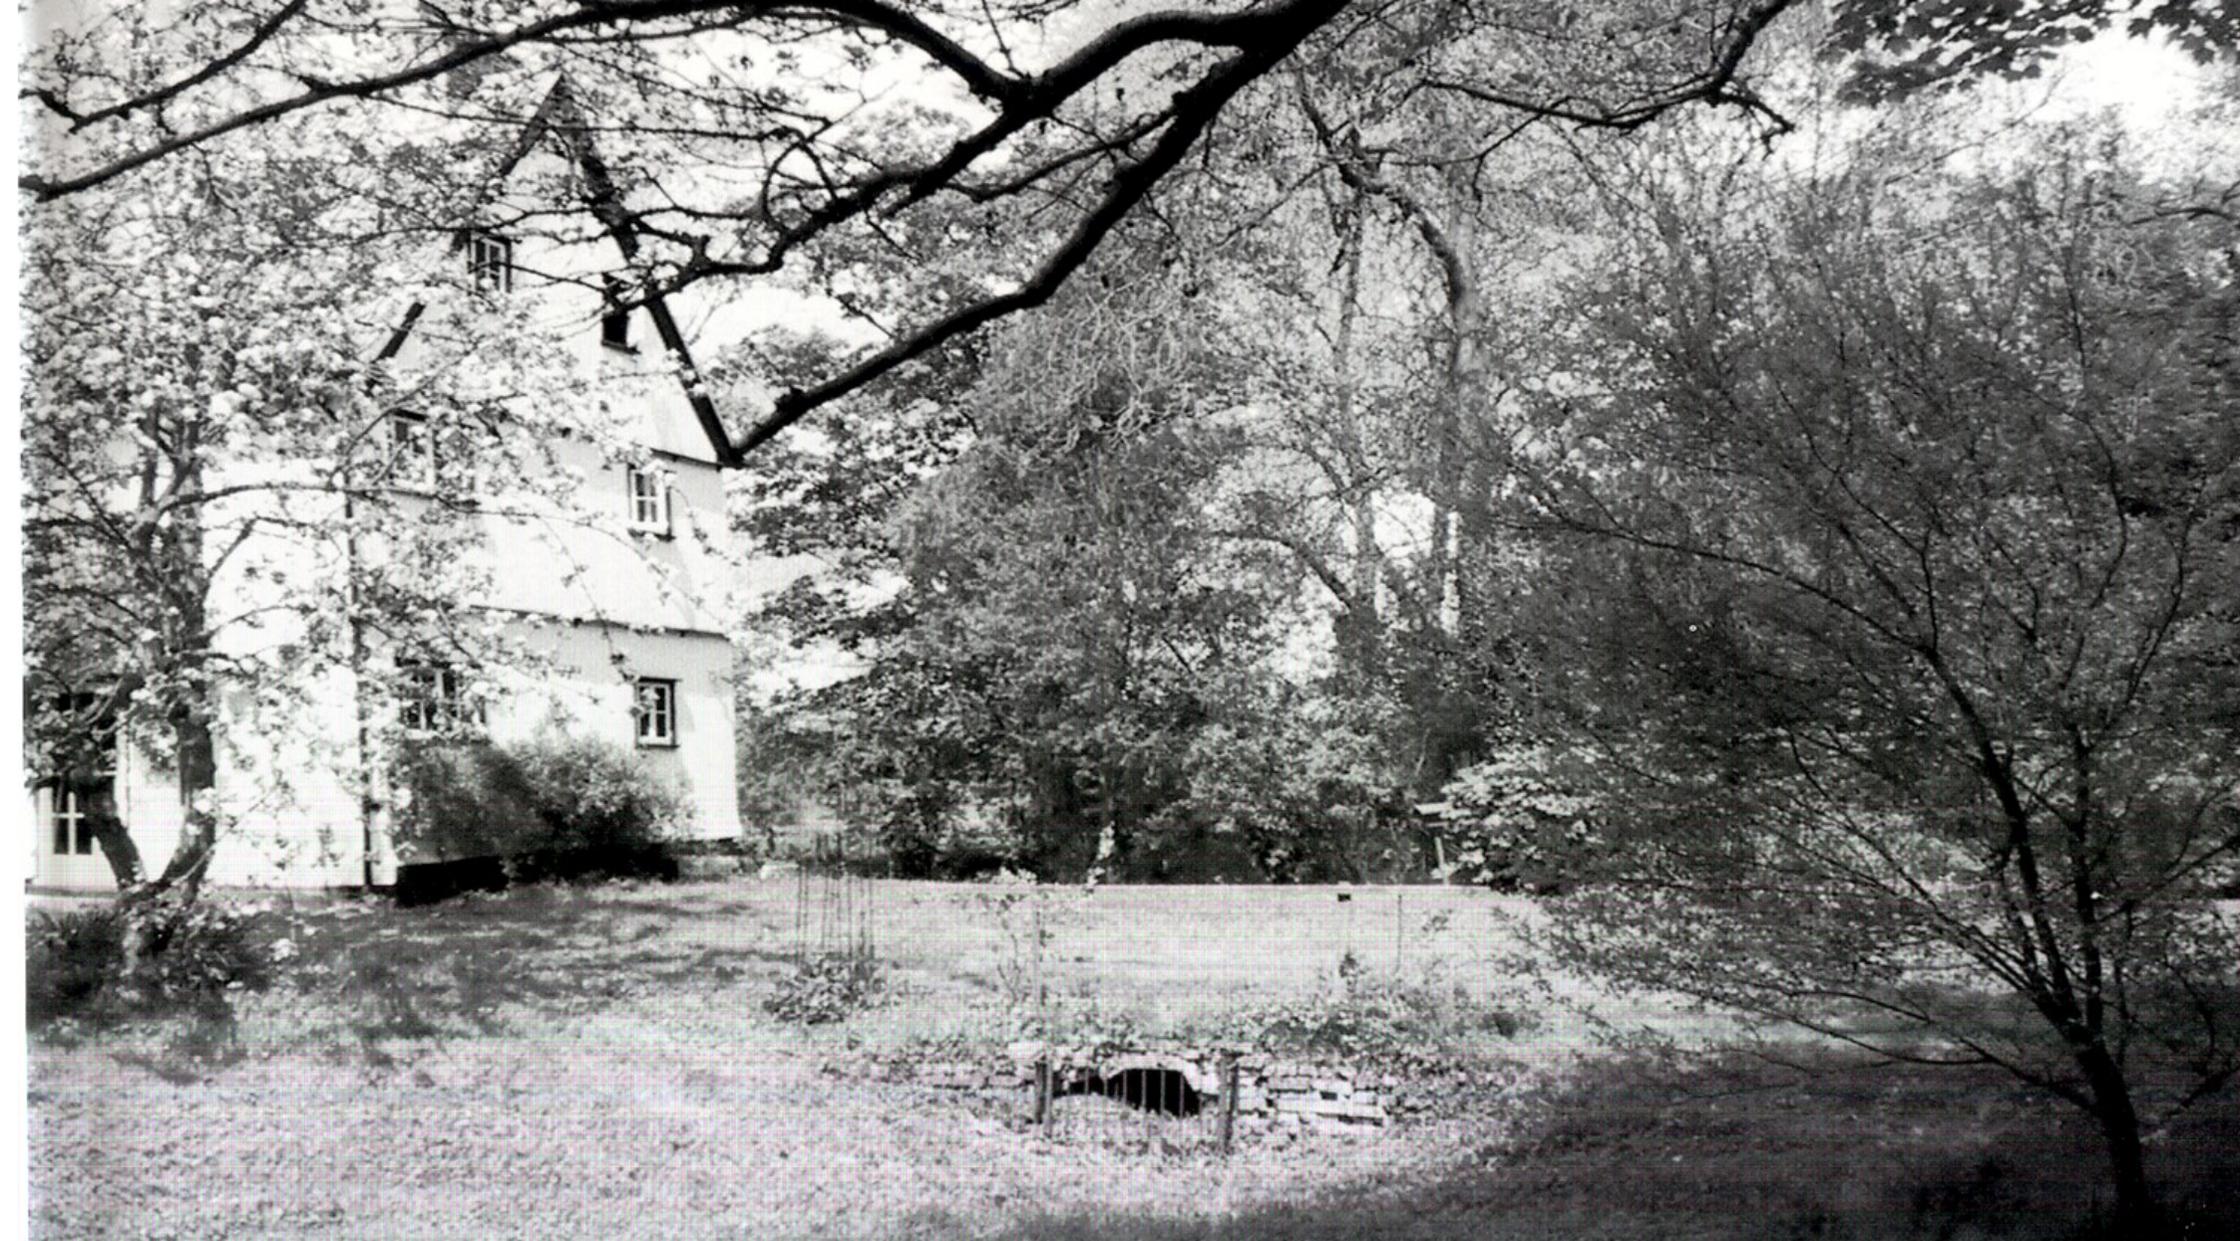
Figure 7. Mill Gardens Cottage, Fulbourn. The watermill, demolished in 1808, stood above the culvert seen to the right of the former miller's house.

Parliamentary Commissioners to facilitate drainage, with the consent of the owner and the payment of £200 in compensation, when the parish was enclosed in 1808.¹⁰ The watermill was replaced by a windmill elsewhere in the parish and its machinery and millstones were sold by auction in 1809.¹¹ Both the building and memory of it have largely been erased but its former presence lives on in the name Mill Gardens Cottage (Fig. 7)

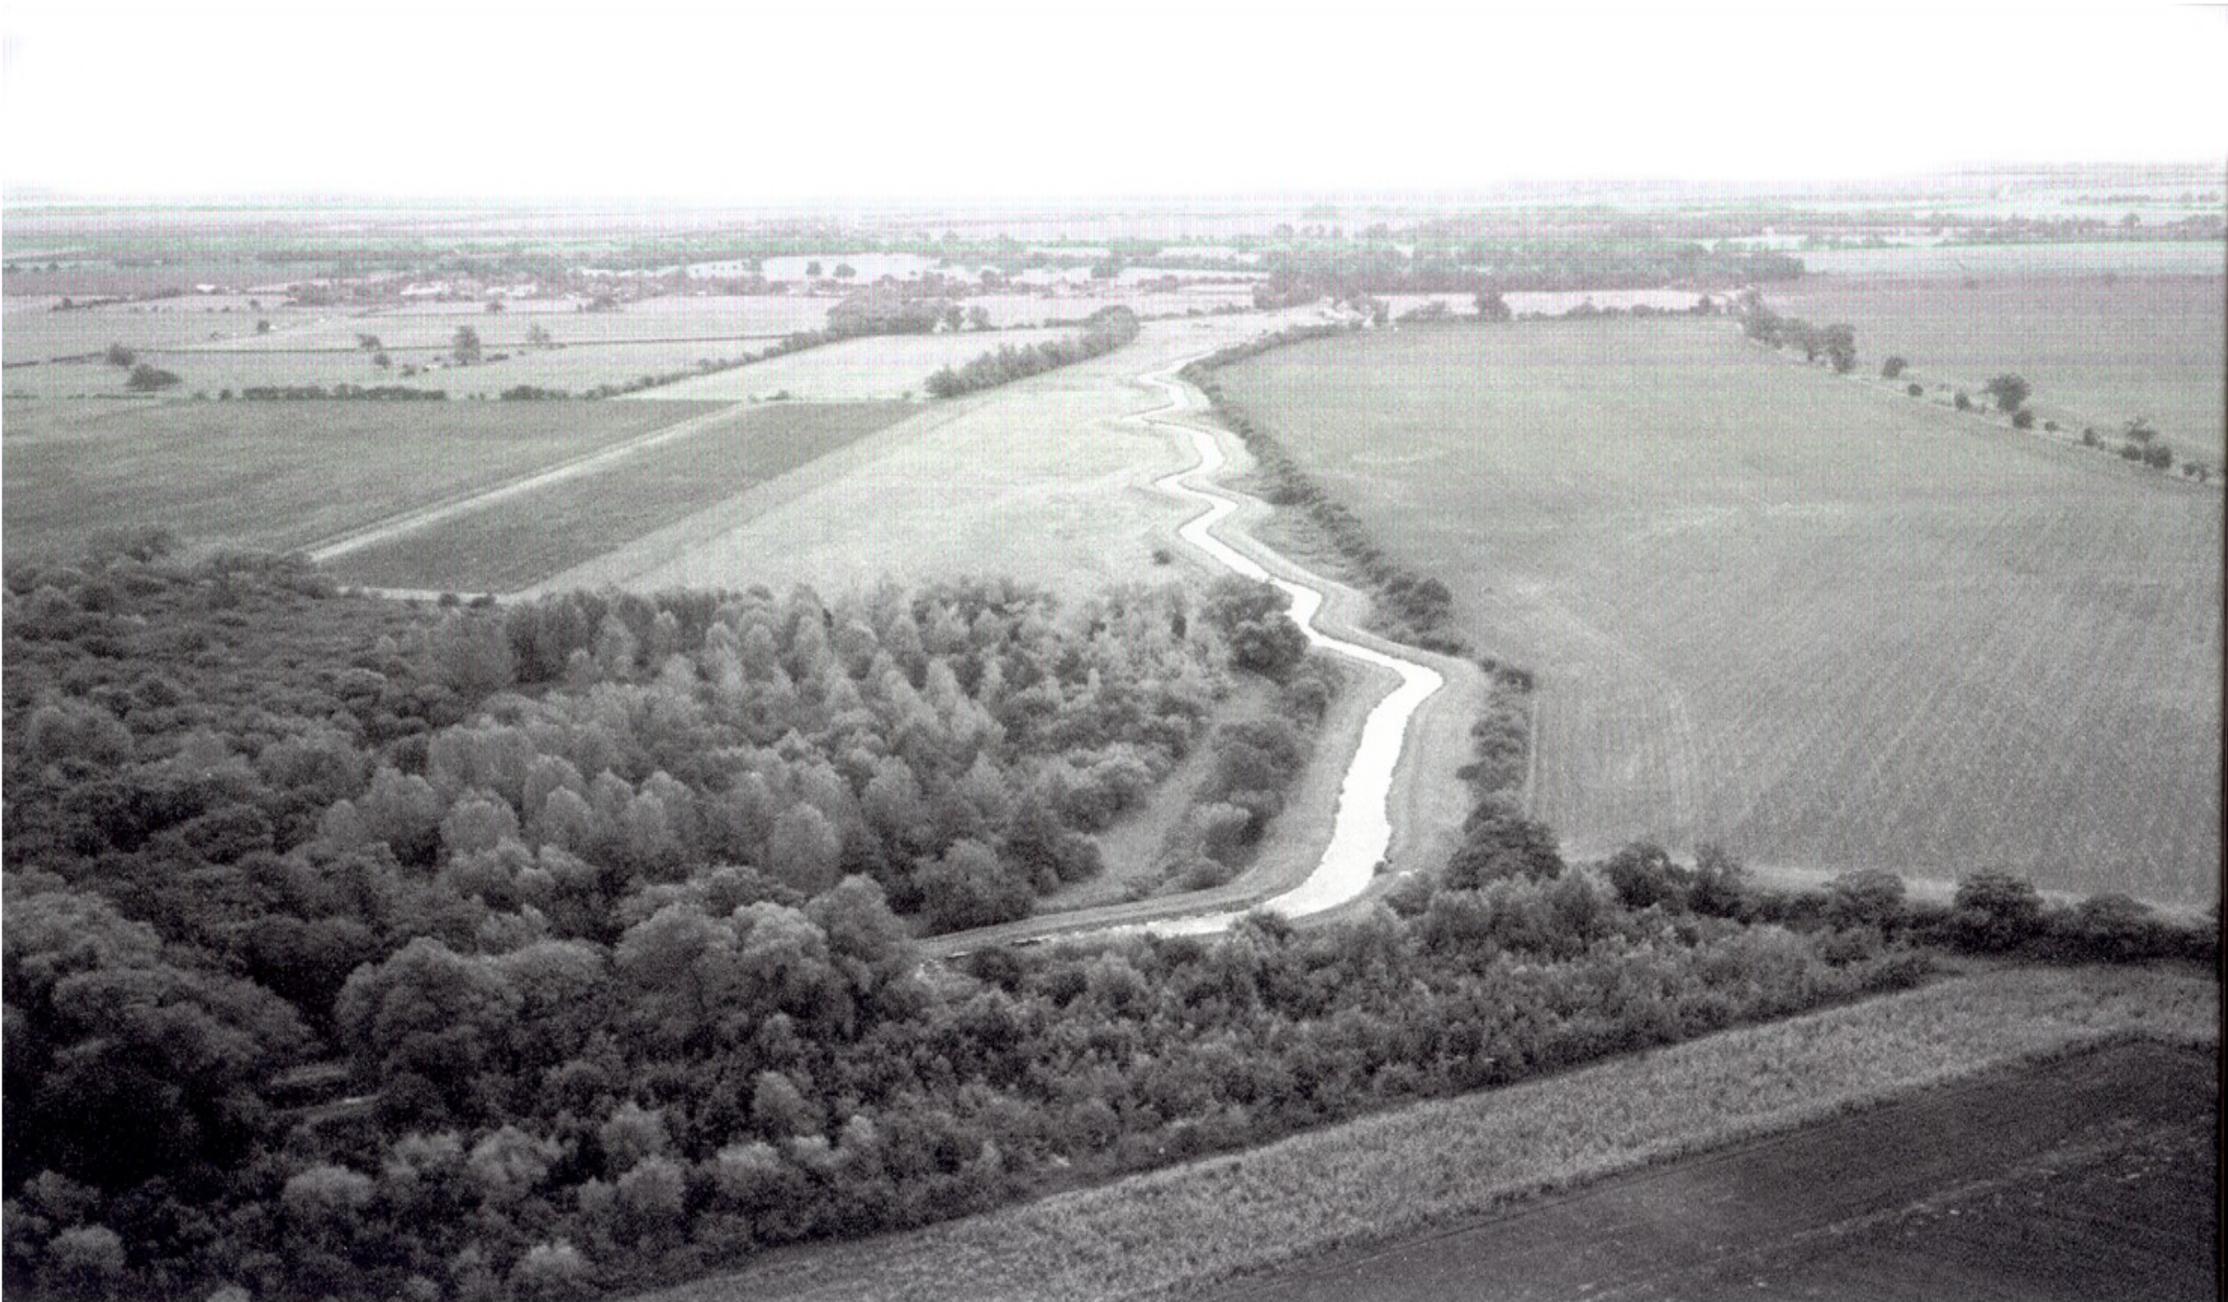
Figure 8. Quay Water between Lode and Stow cum Quy , looking south-west. This embanked artificial watercourse runs well above the natural drainage level to provide a head of water for Lode Mill.
