The drainage
of
Wilbraham
Fulbourn
and
Teversham
Fens

**THE DRAINAGE OF WILBRAHAM
FULBOURN AND TEVERSHAM FENS**

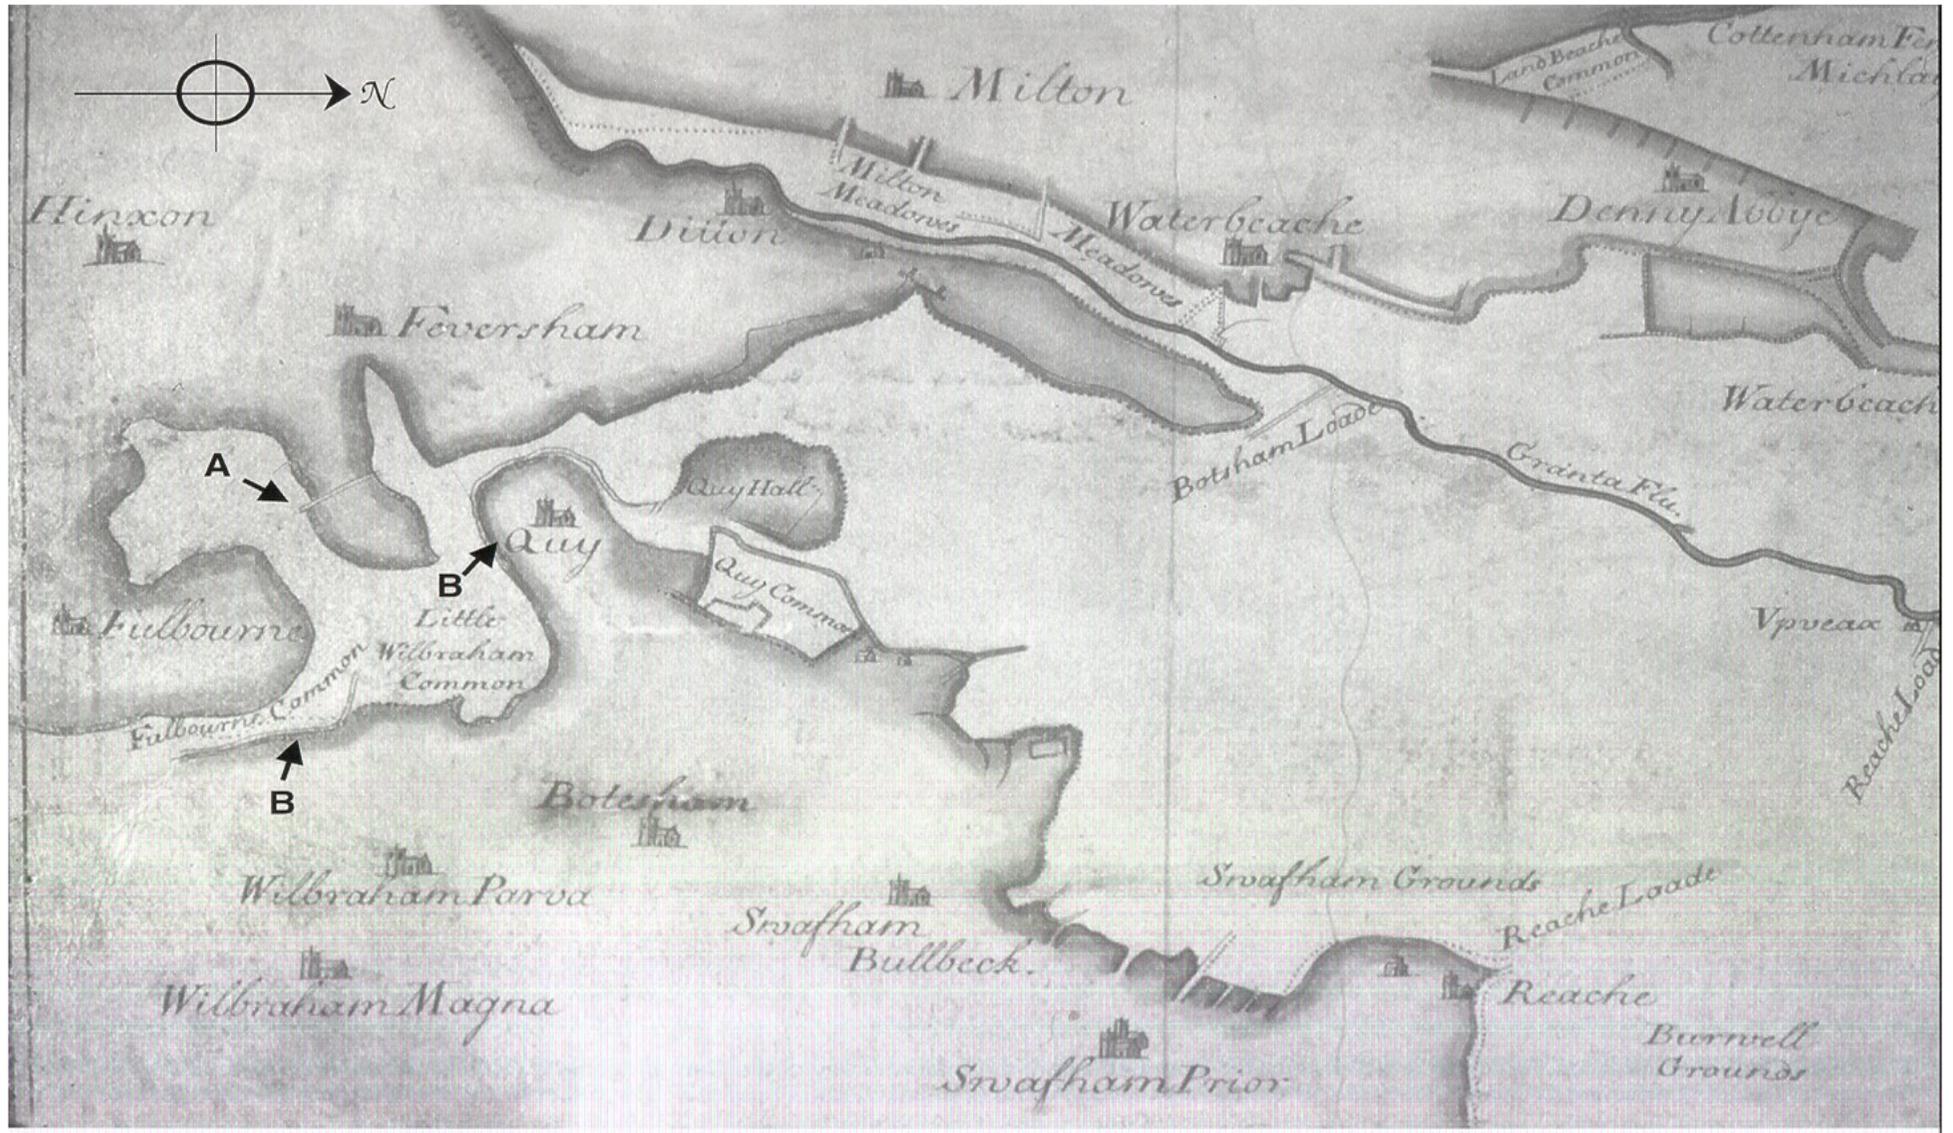
Figure 9. From a PLAN OF THE FENNS by William Hayward dated 1604. An artificial cut is shown (A) crossing the promontory of high ground between Fulbourn and Teversham Fens and the original course of Little Wilbraham River (B)

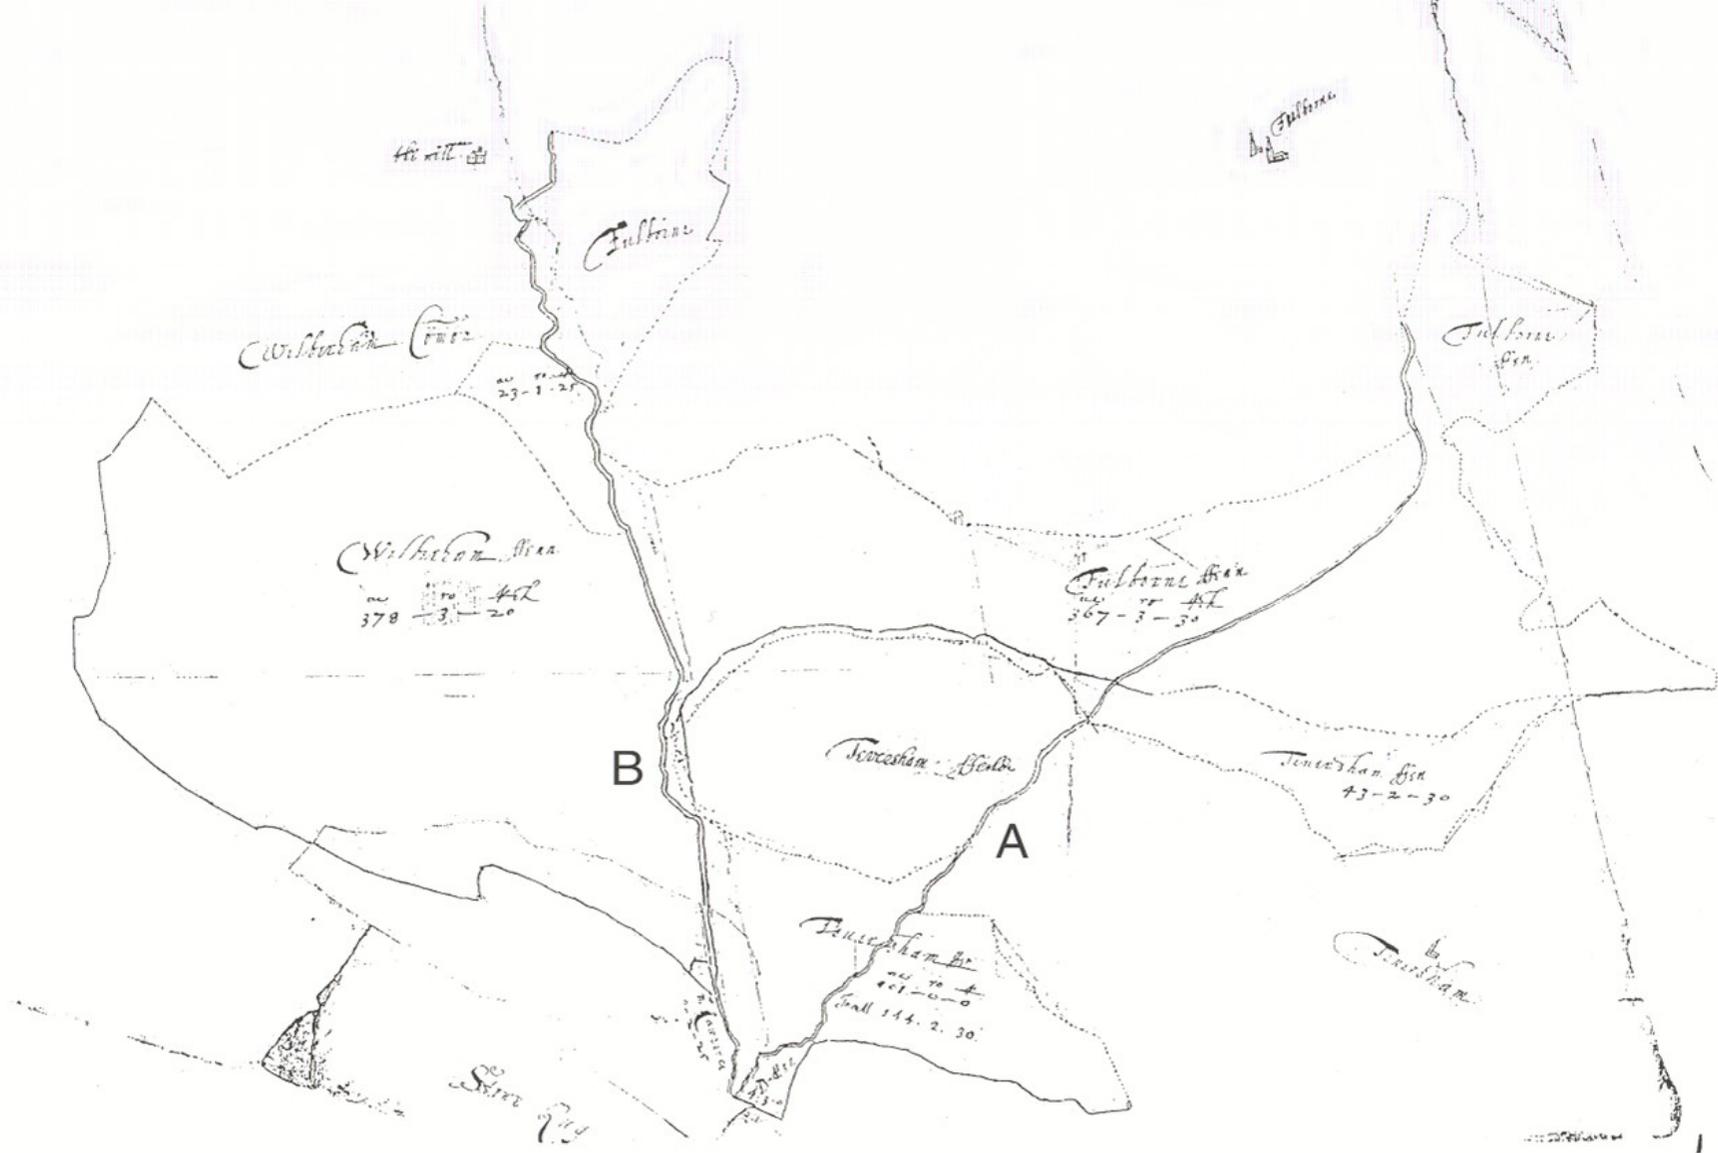
Figure 10. Map of Wilbraham, Fulbourn and Teversham Fens made during a major survey of Cambridgeshire Fens between 1680 and 1700. The watercourses converging towards Quy Bridge are the Mill Ditch (A) the artificial channel traversing the promontory of higher ground between Fulbourn and Teversham Fens and the Little Wilbraham River (B). (to compare with other figures the map should be inverted)

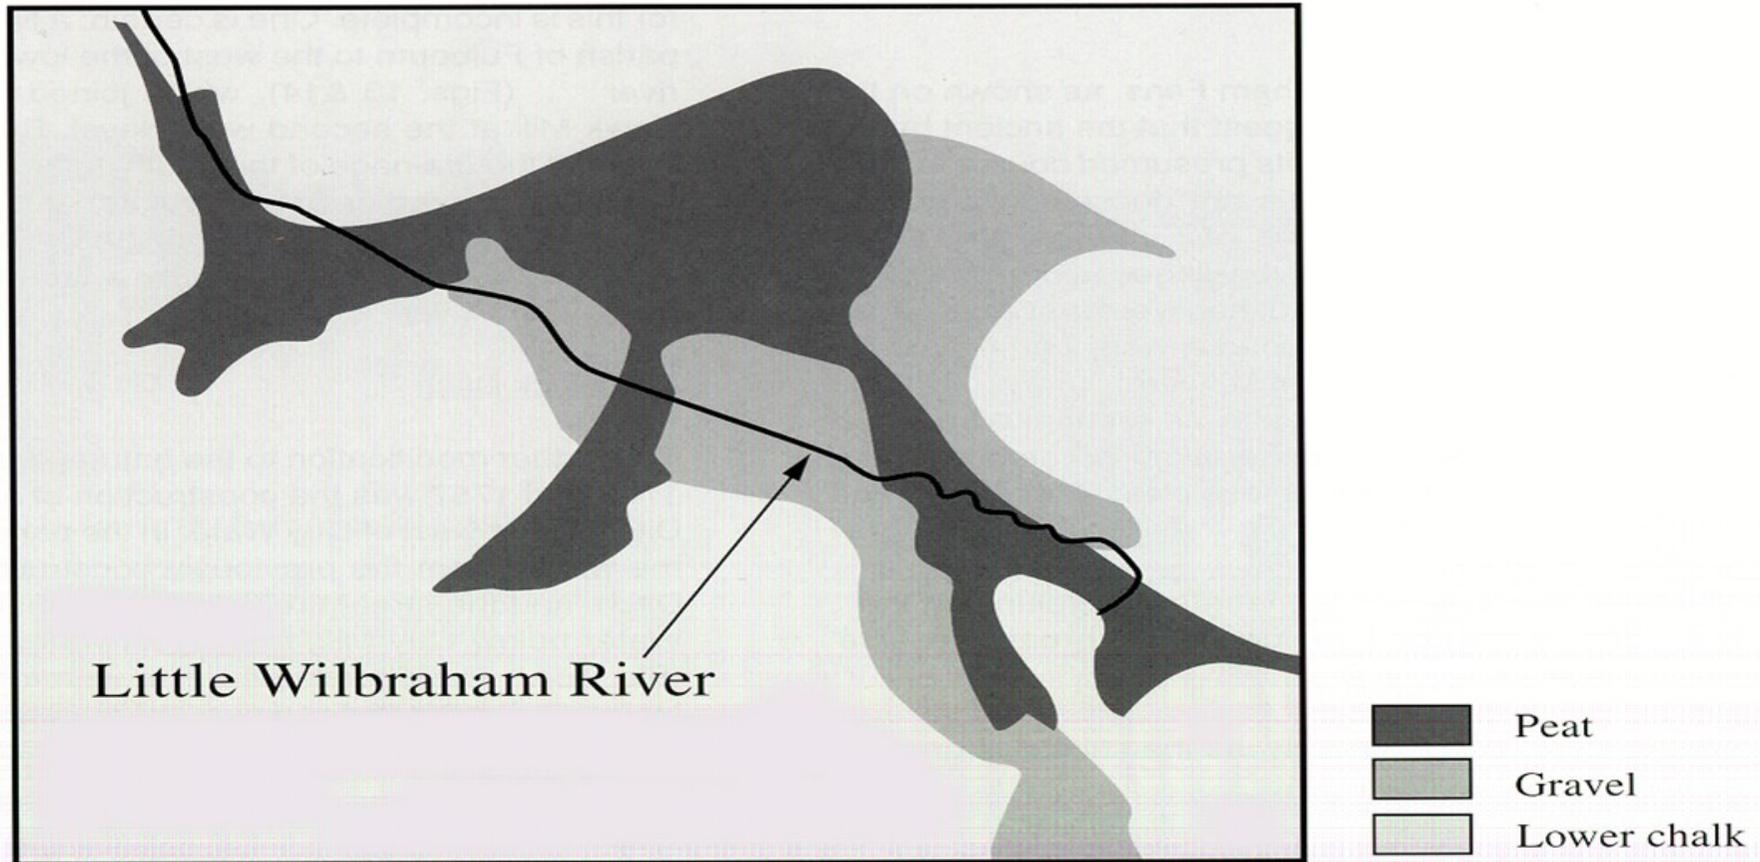
Figure 11. Course of Little Wilbraham River between Hawk Mill and Quy Mill. The present course of the river is clearly artificial as it bears no relation to the underlying drift geology

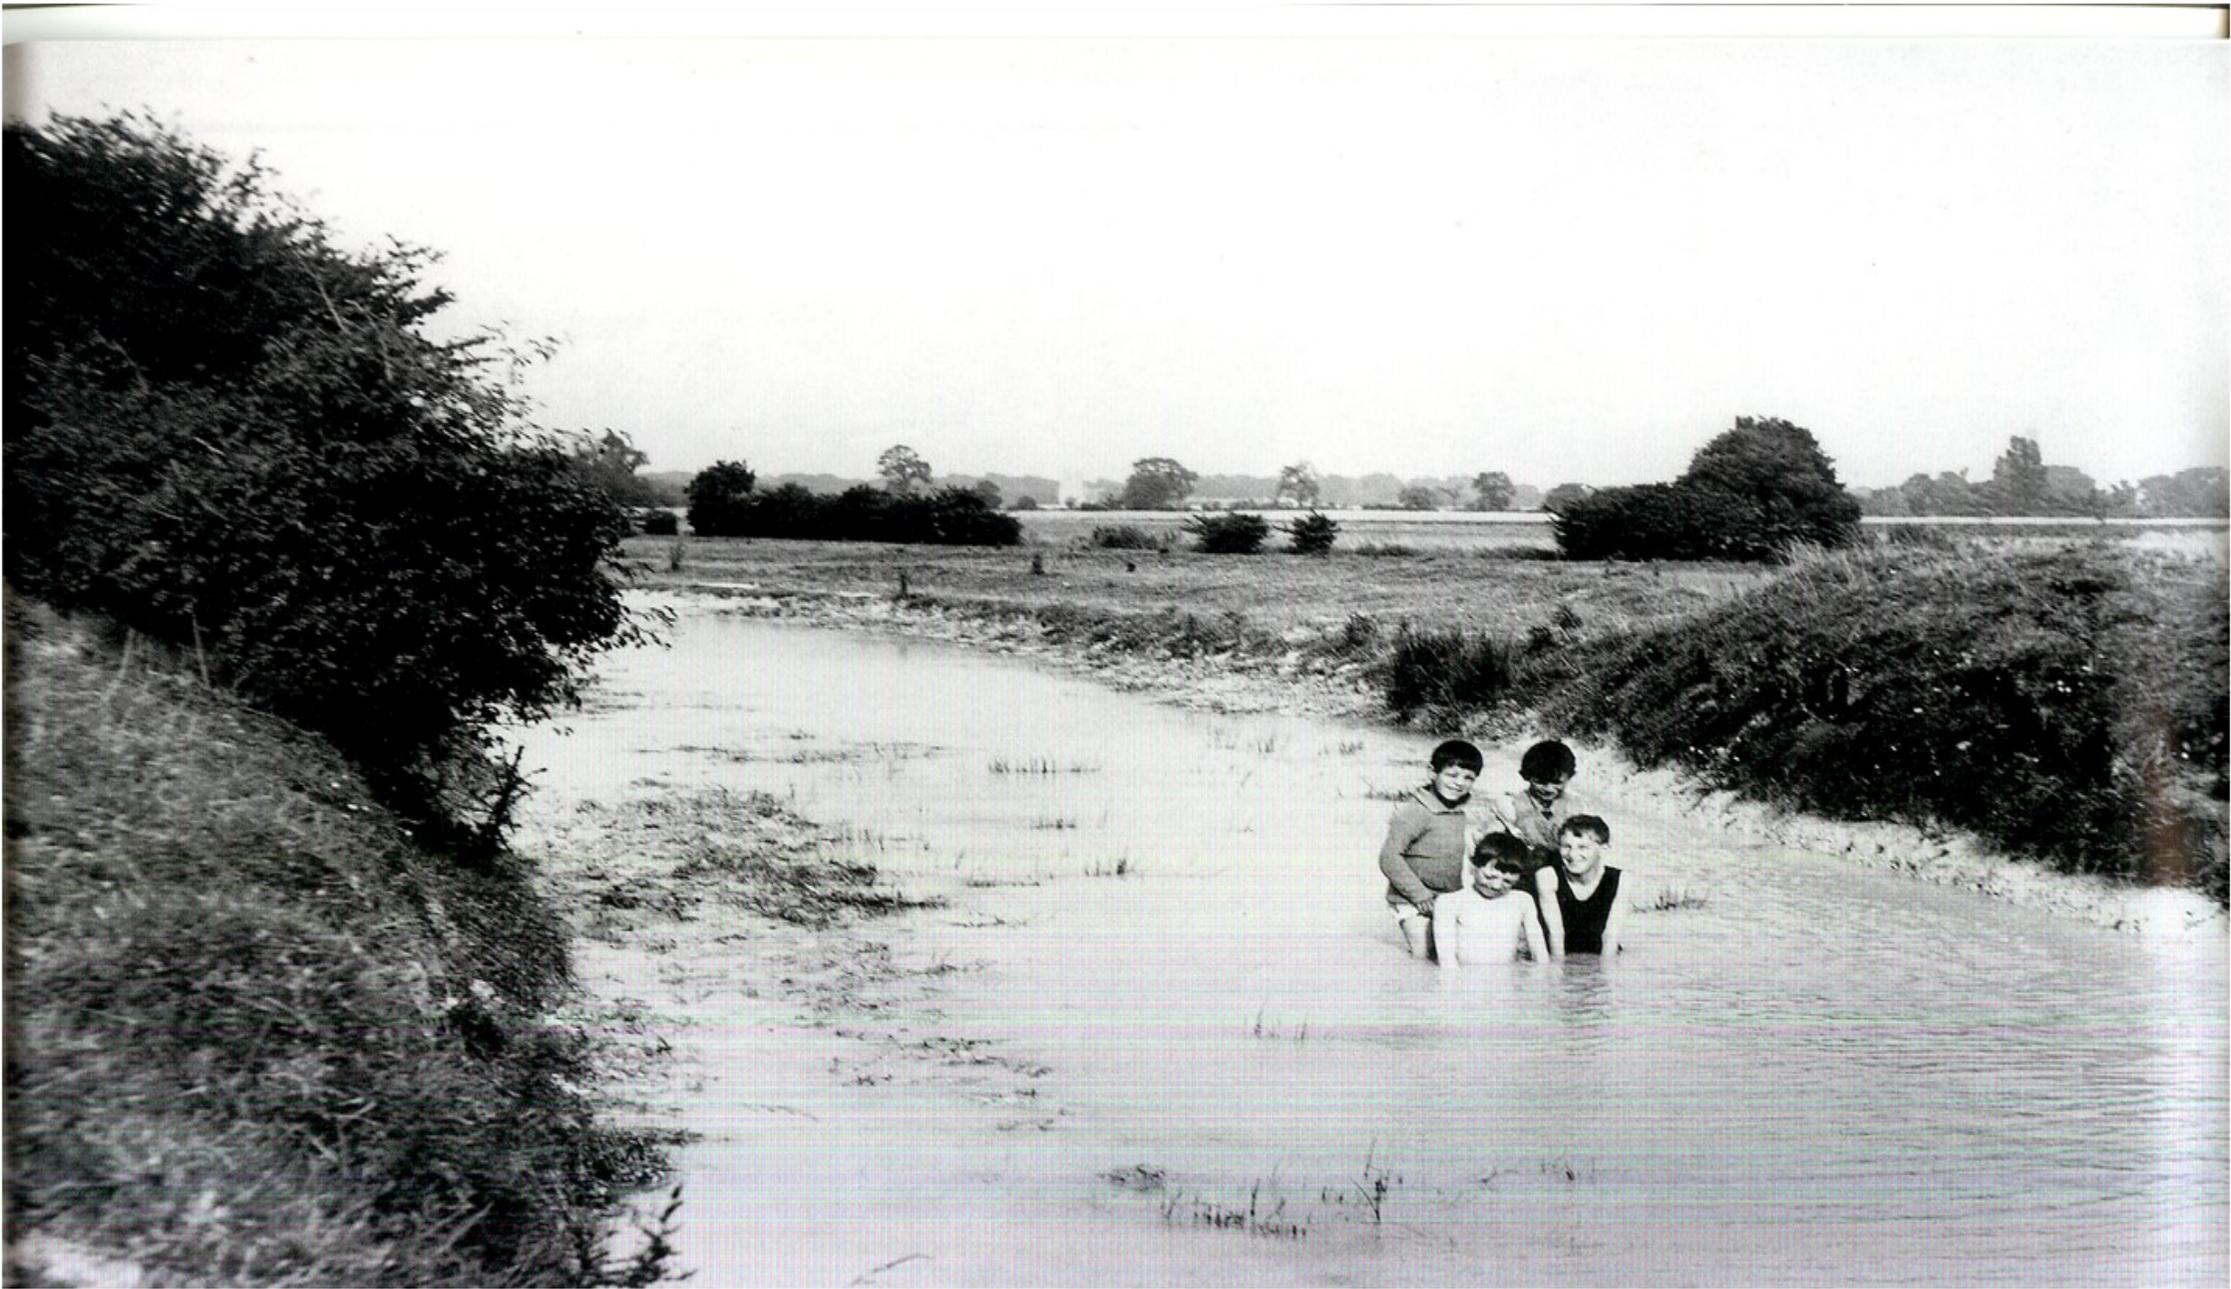
Figure 12. The former Great Wilbraham River in its course on the common, circa 1930. Flow was by then much reduced due to neglect of the watercourses and groundwater abstraction.

- 1).The diversion of a section of the river into an embanked artificial channel on Great Wilbraham Common, undertaken sometime before 1797 (Figs.12 & 14). The reason for this is less clear. There are three possible explanations:
 - a) The artificial channel, by increasing the length and volume of the river, served as a distant mill and provided greater reserves of power.
 - b) It captured more springs. This is unlikely as the subsoil is gravel and the spring line some distance away.
 - c) Improved drainage had caused the bed of the river to subside. Again an unlikely explanation as the peat deposits are a little to the north of this.

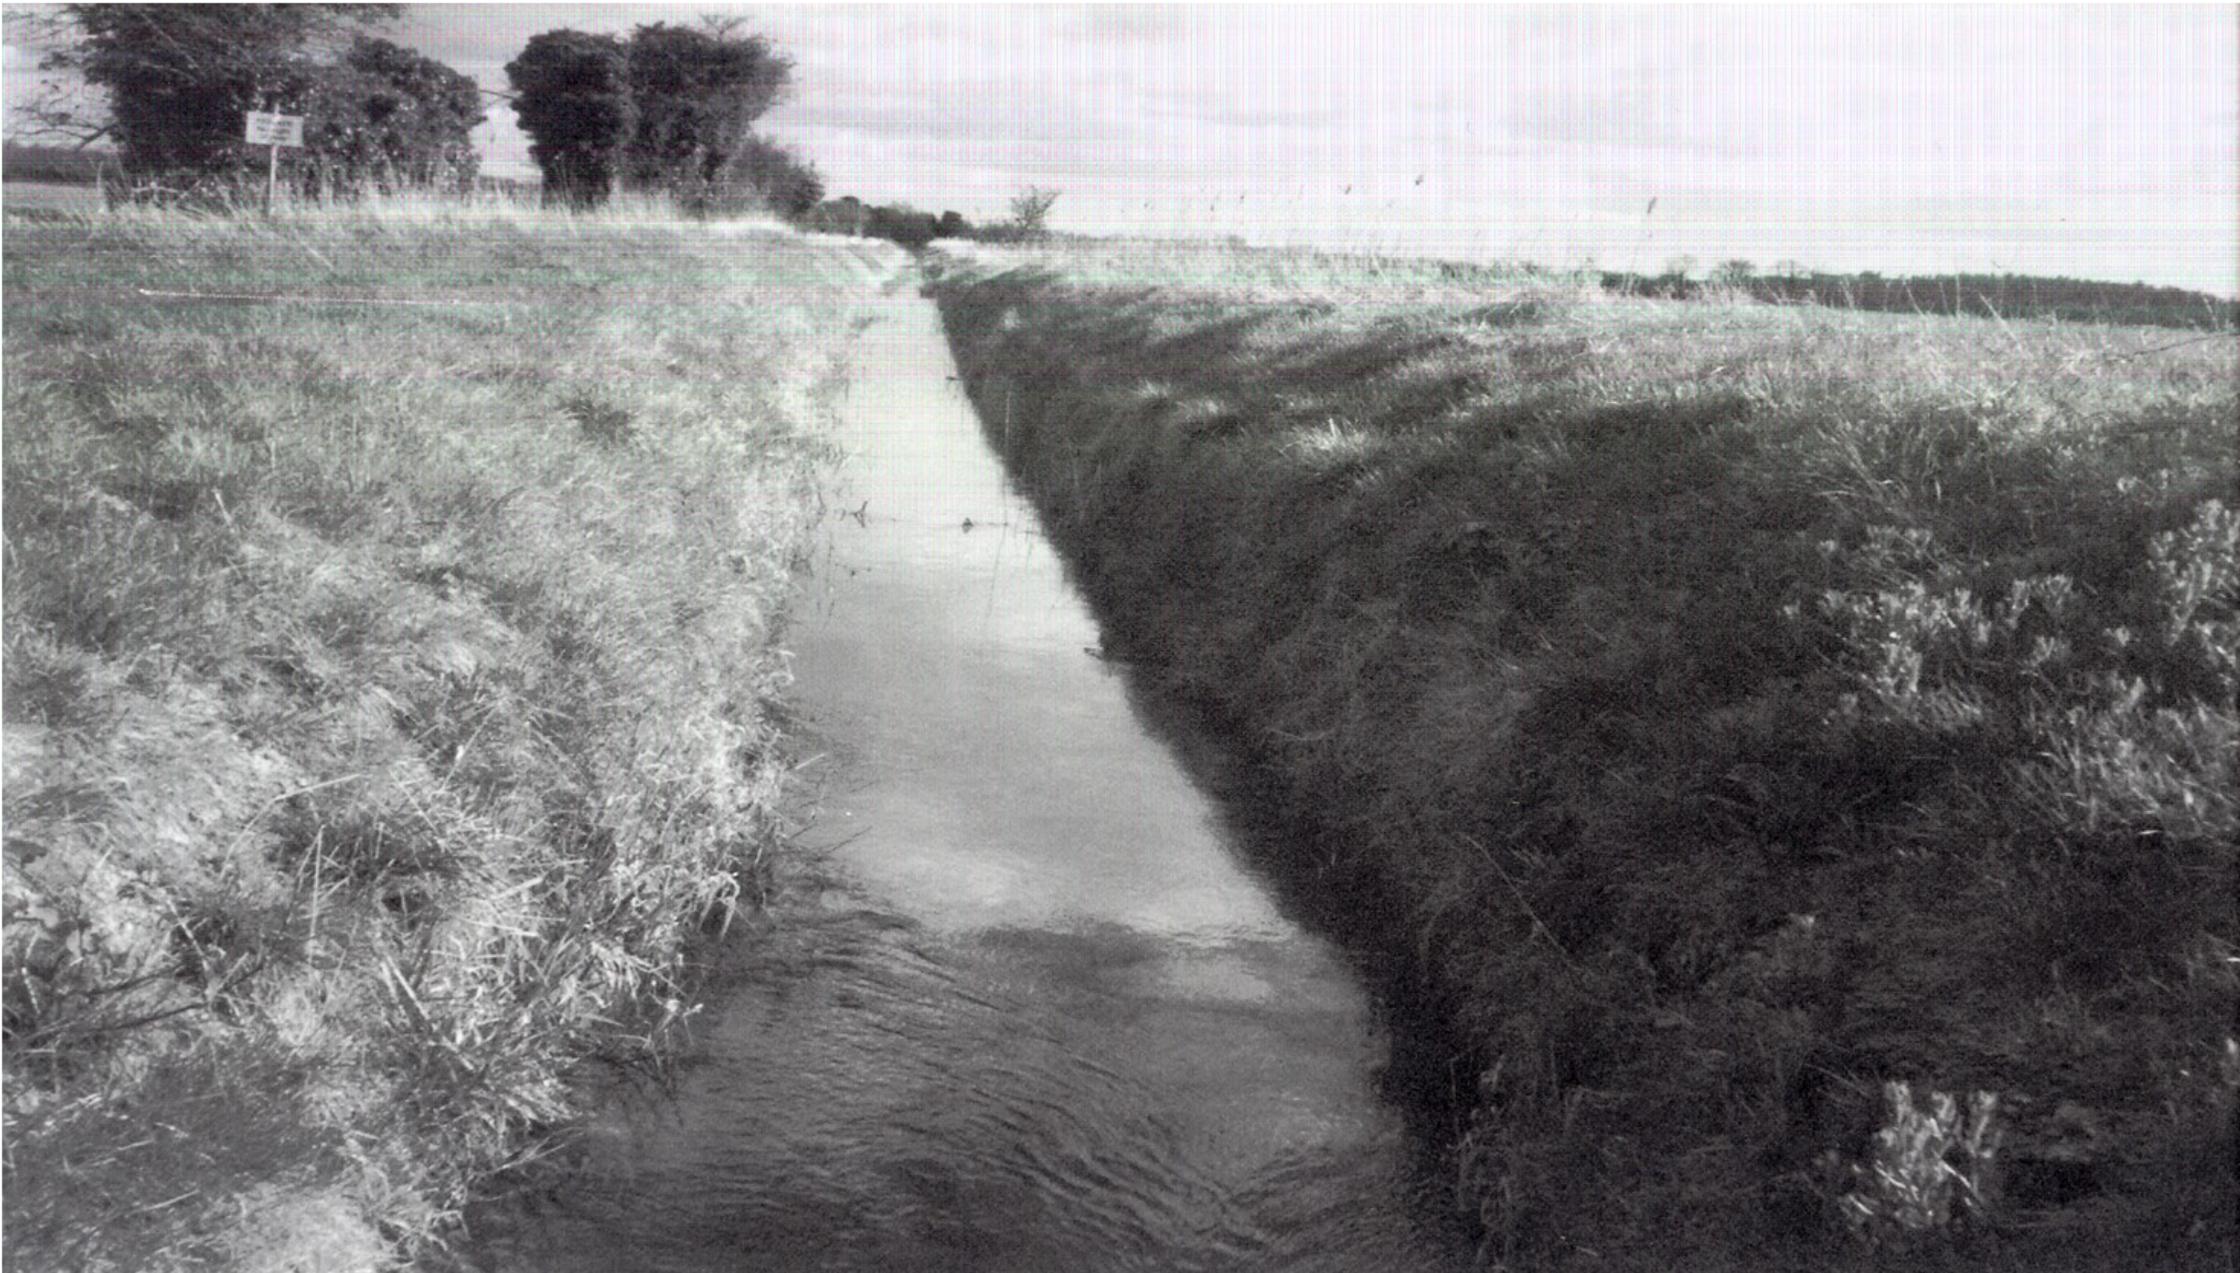
Figure 13. Fulbourn New Cut looking south from its junction with Little Wilbraham River,, Spring 2000.

connected to the watercourse running northwards to join the pre-existing Fulbourn New Cut which discharged its waters into Little Wilbraham River below Hawk Mill (Figs 13 and 14B).

3) The 4th public drain which was the southern extension of the pre-existing Fulbourn New Cut in the north-east part of the parish (Figs. 13 & 14B). This received water from the new 7th public drain and from the springs in the parish of Great Wilbraham, by the tunnel under the bed of Great Wilbraham River.

At or about this time the headwaters of the Great Wilbraham river were purposely and permanently diverted into the Fulbourn 4th public drain at the Cringles, and thence into the Fulbourn New Cut, to discharge into Little Wilbraham River below Hawk Mill (Figs. 13 & 25). The drainage system was not overloaded by this intervention as the flow from the springs at Shardelows Well was now much reduced by water abstraction at the Fleam Dyke pumping station. This act of expediency was responsible for the demise of Great Wilbraham River between the railway and Hawk Mill.

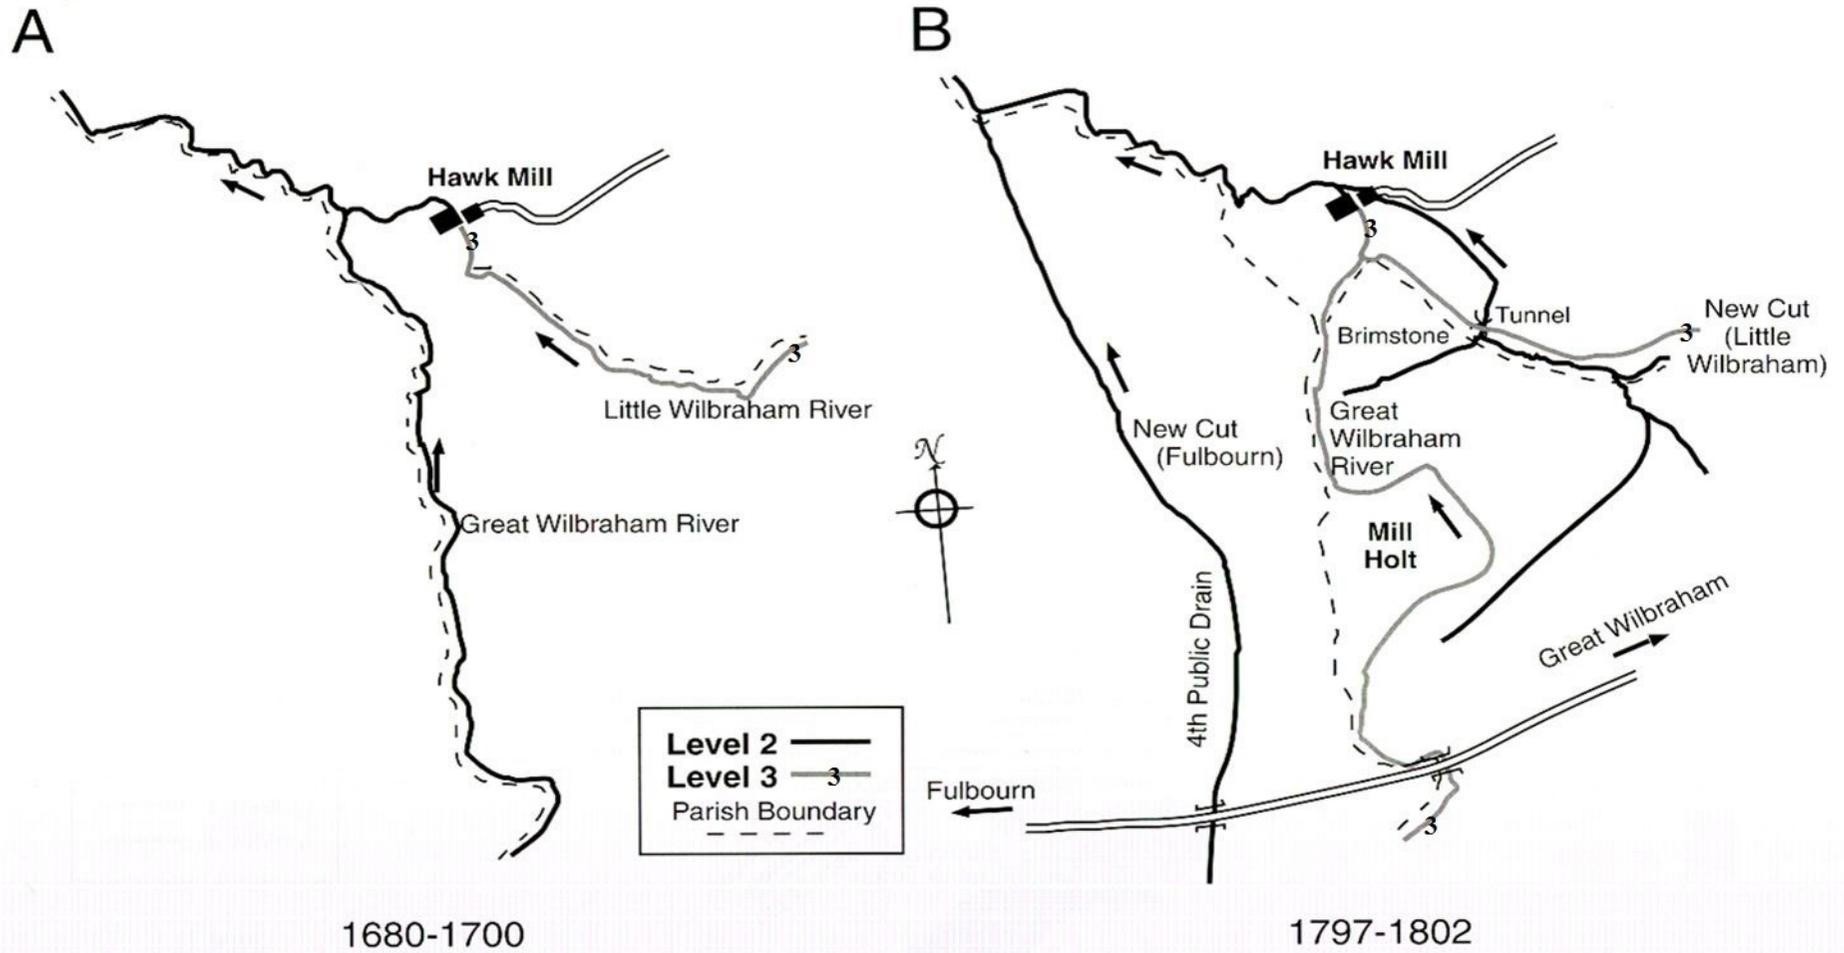
Hawk Mill Confluence of Waterways

Figure 14. The waterways in the region of Hawk Mill—See text.

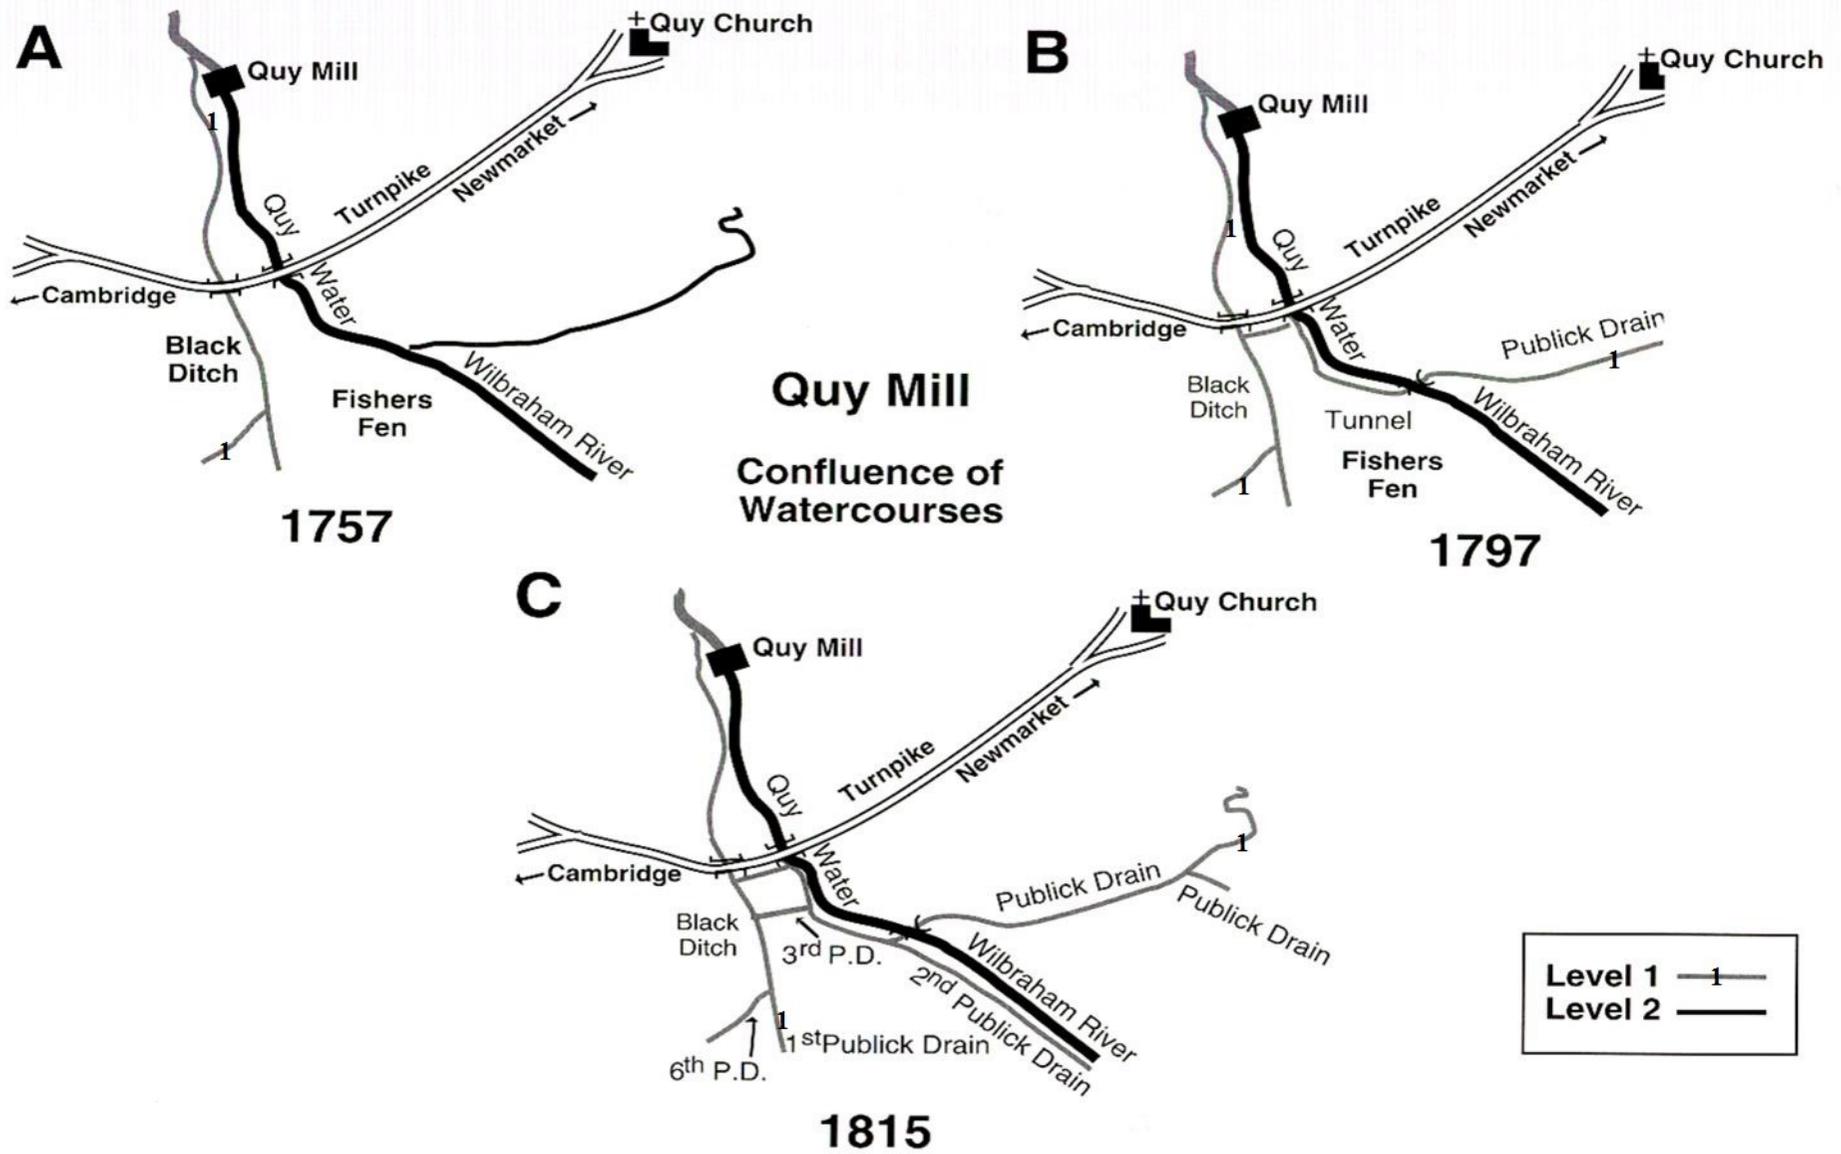
Figure 15. The watercourses in the region of Quoy Mill. See text

Newmarket turnpike. The new drain was joined to the Black Ditch which ran into Quy Water below Quy Mill: the lowest of the water levels (Fig. 15).

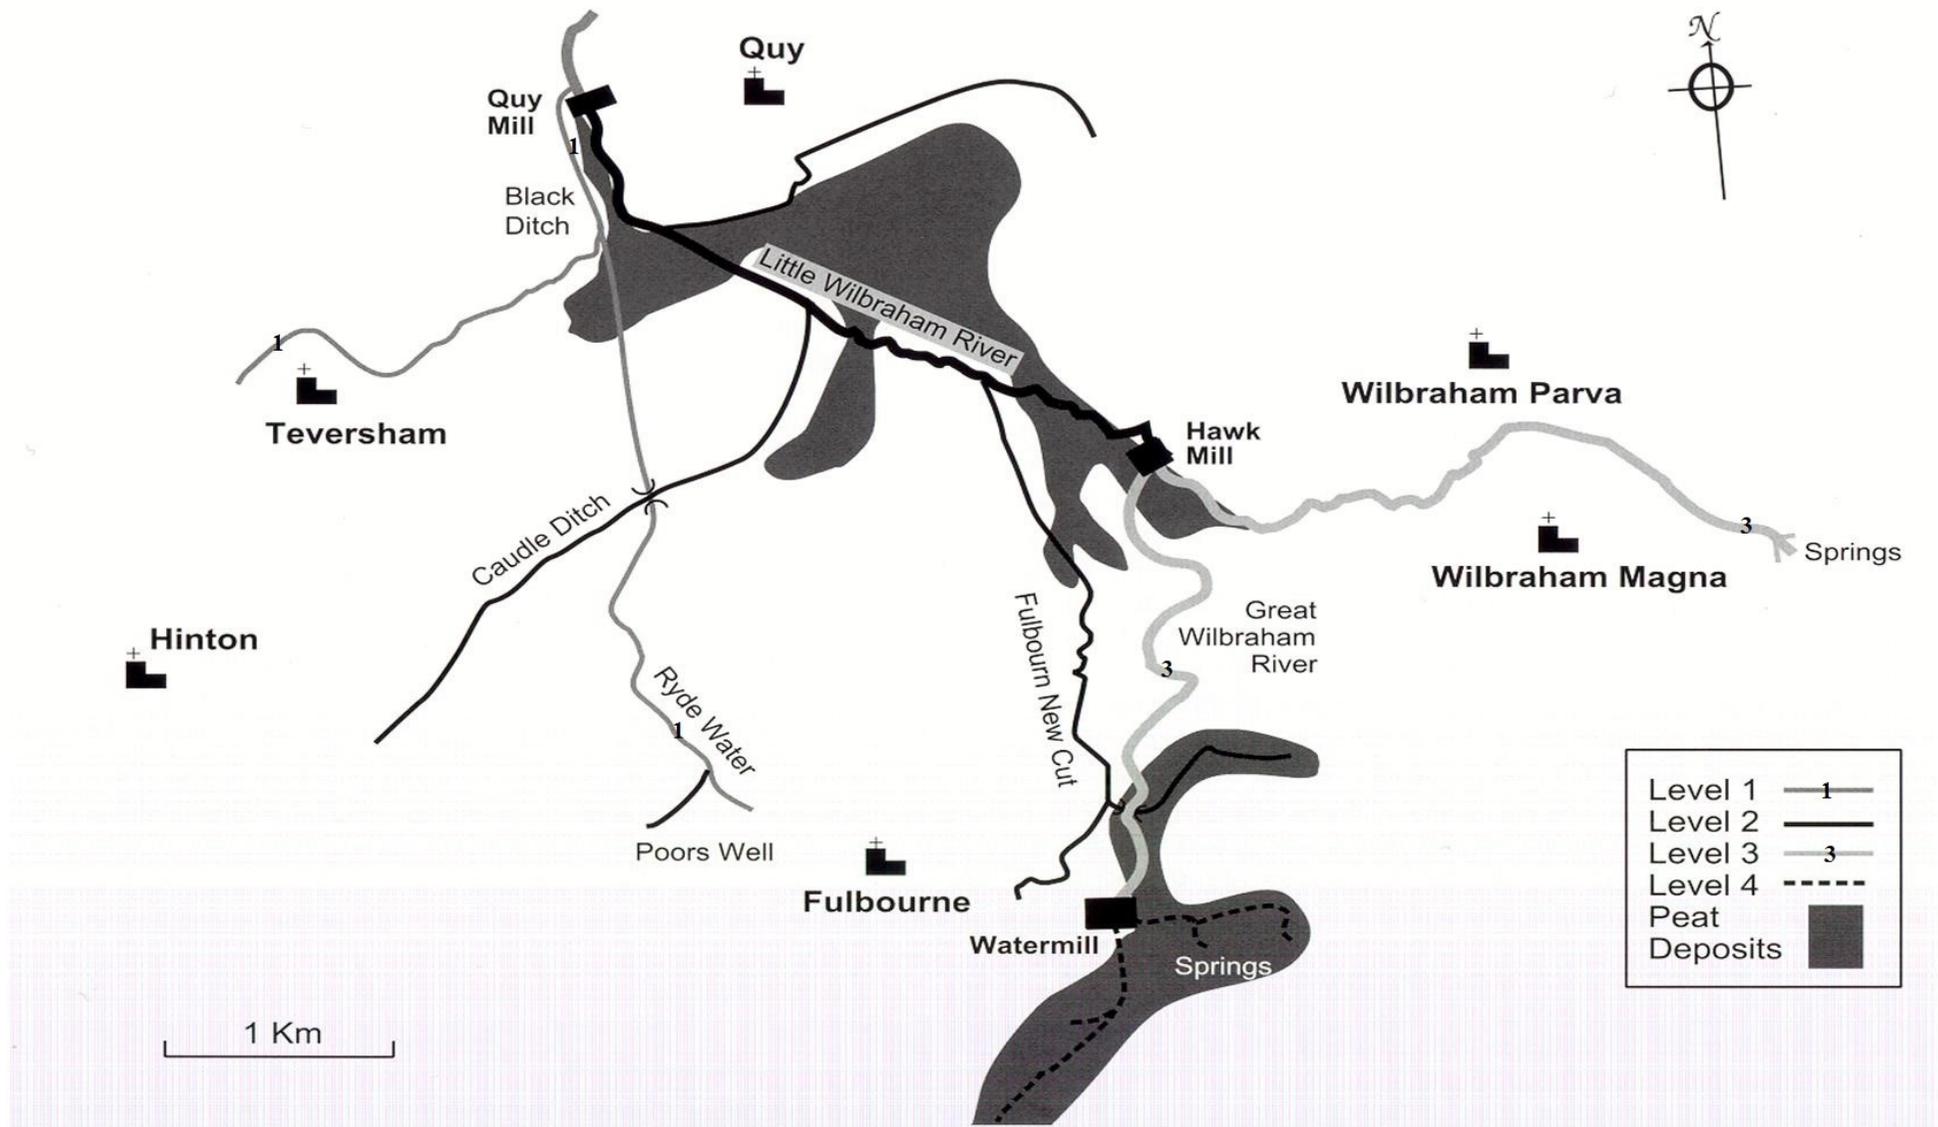
Figure 16. Changes to the watercourses and drains carried out before 1797 to increase water power and to improve

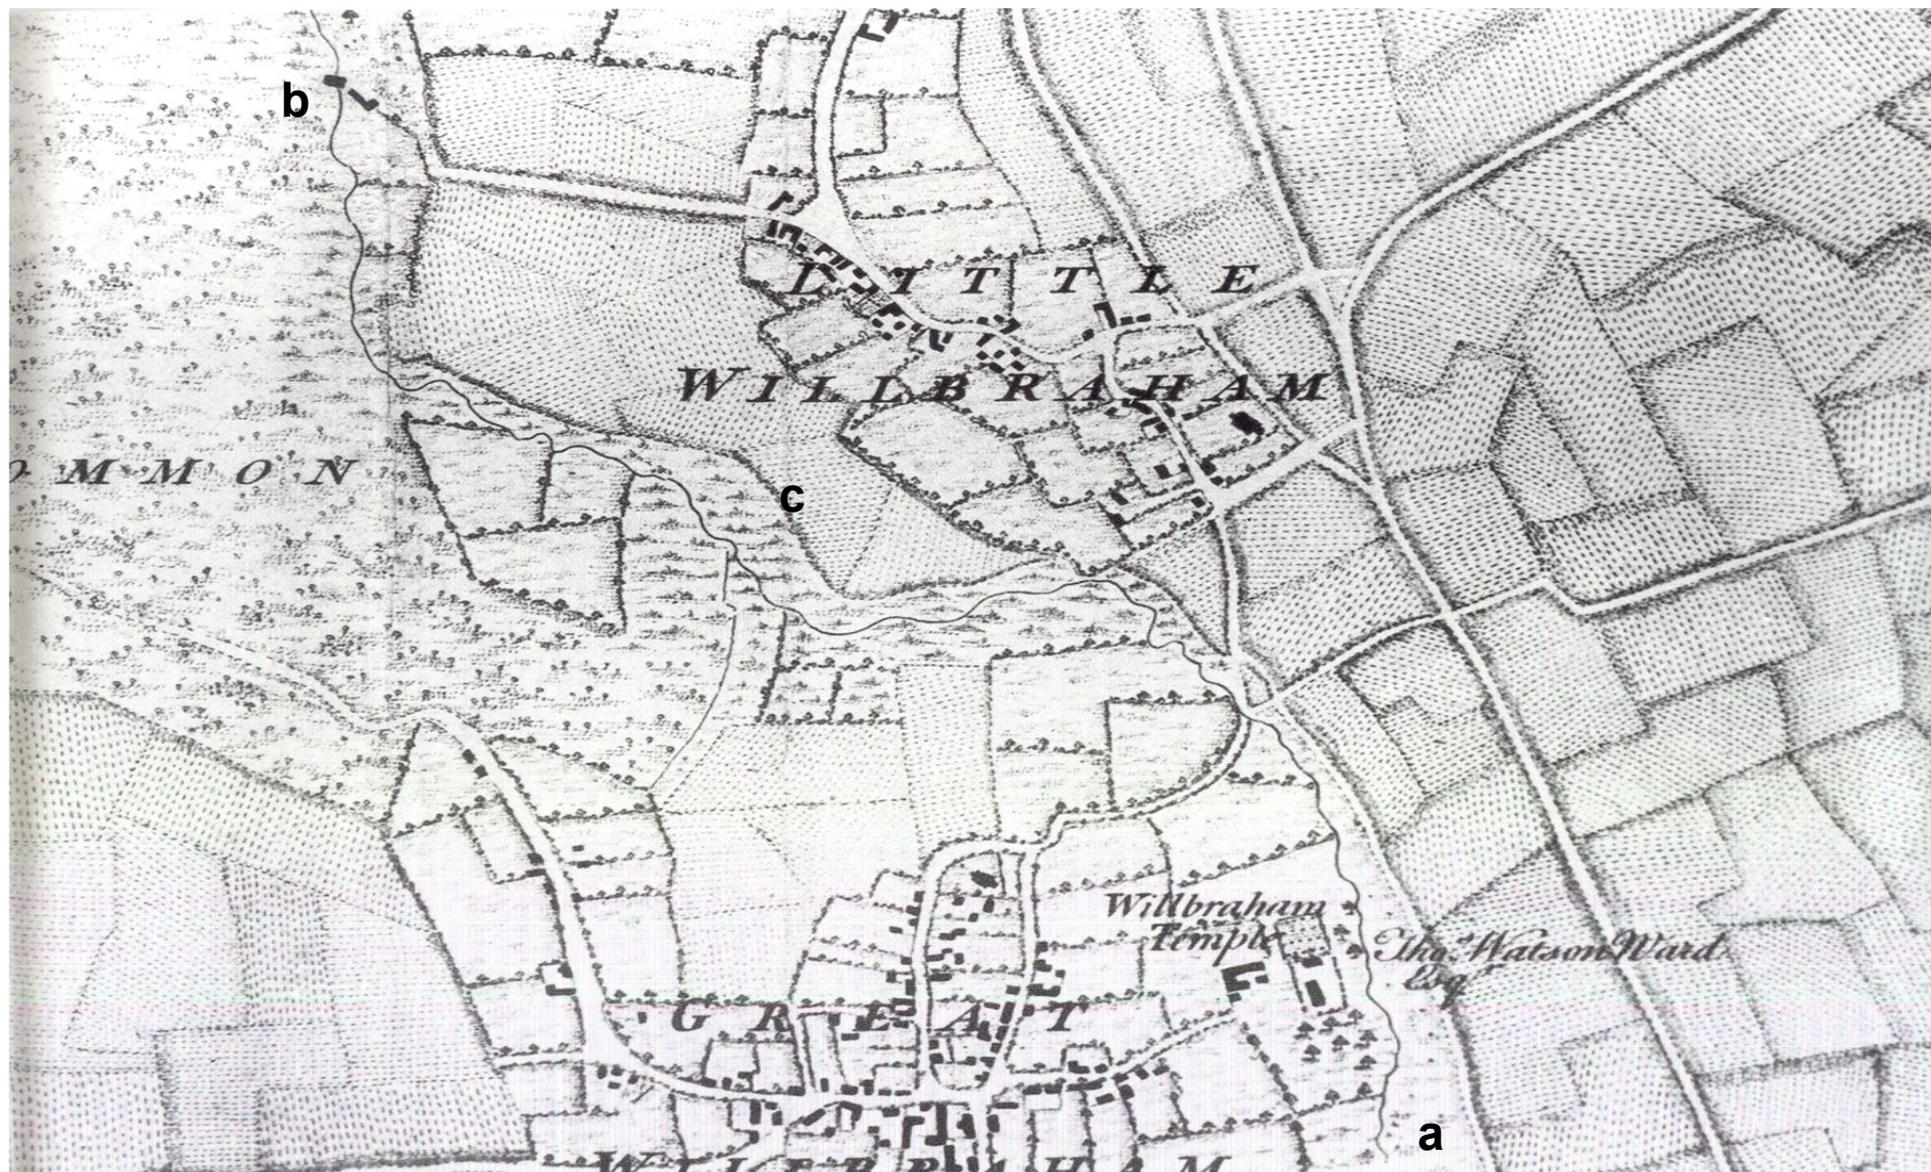
Figure 17. Part of Chapman's pre-enclosure map, Newmarket and Adjacent Villages, dated 1768, showing the original course of Little Wilbraham River from Temple Springs (a) to Hawk Mill (b). The river was later diverted into a New Cut running along the southern boundary (c) of the unenclosed West Field.
