The drainage
of
Wilbraham
Fulbourn
and
Teversham
Fens

**THE DRAINAGE OF WILBRAHAM
FULBOURN AND TEVERSHAM FENS**

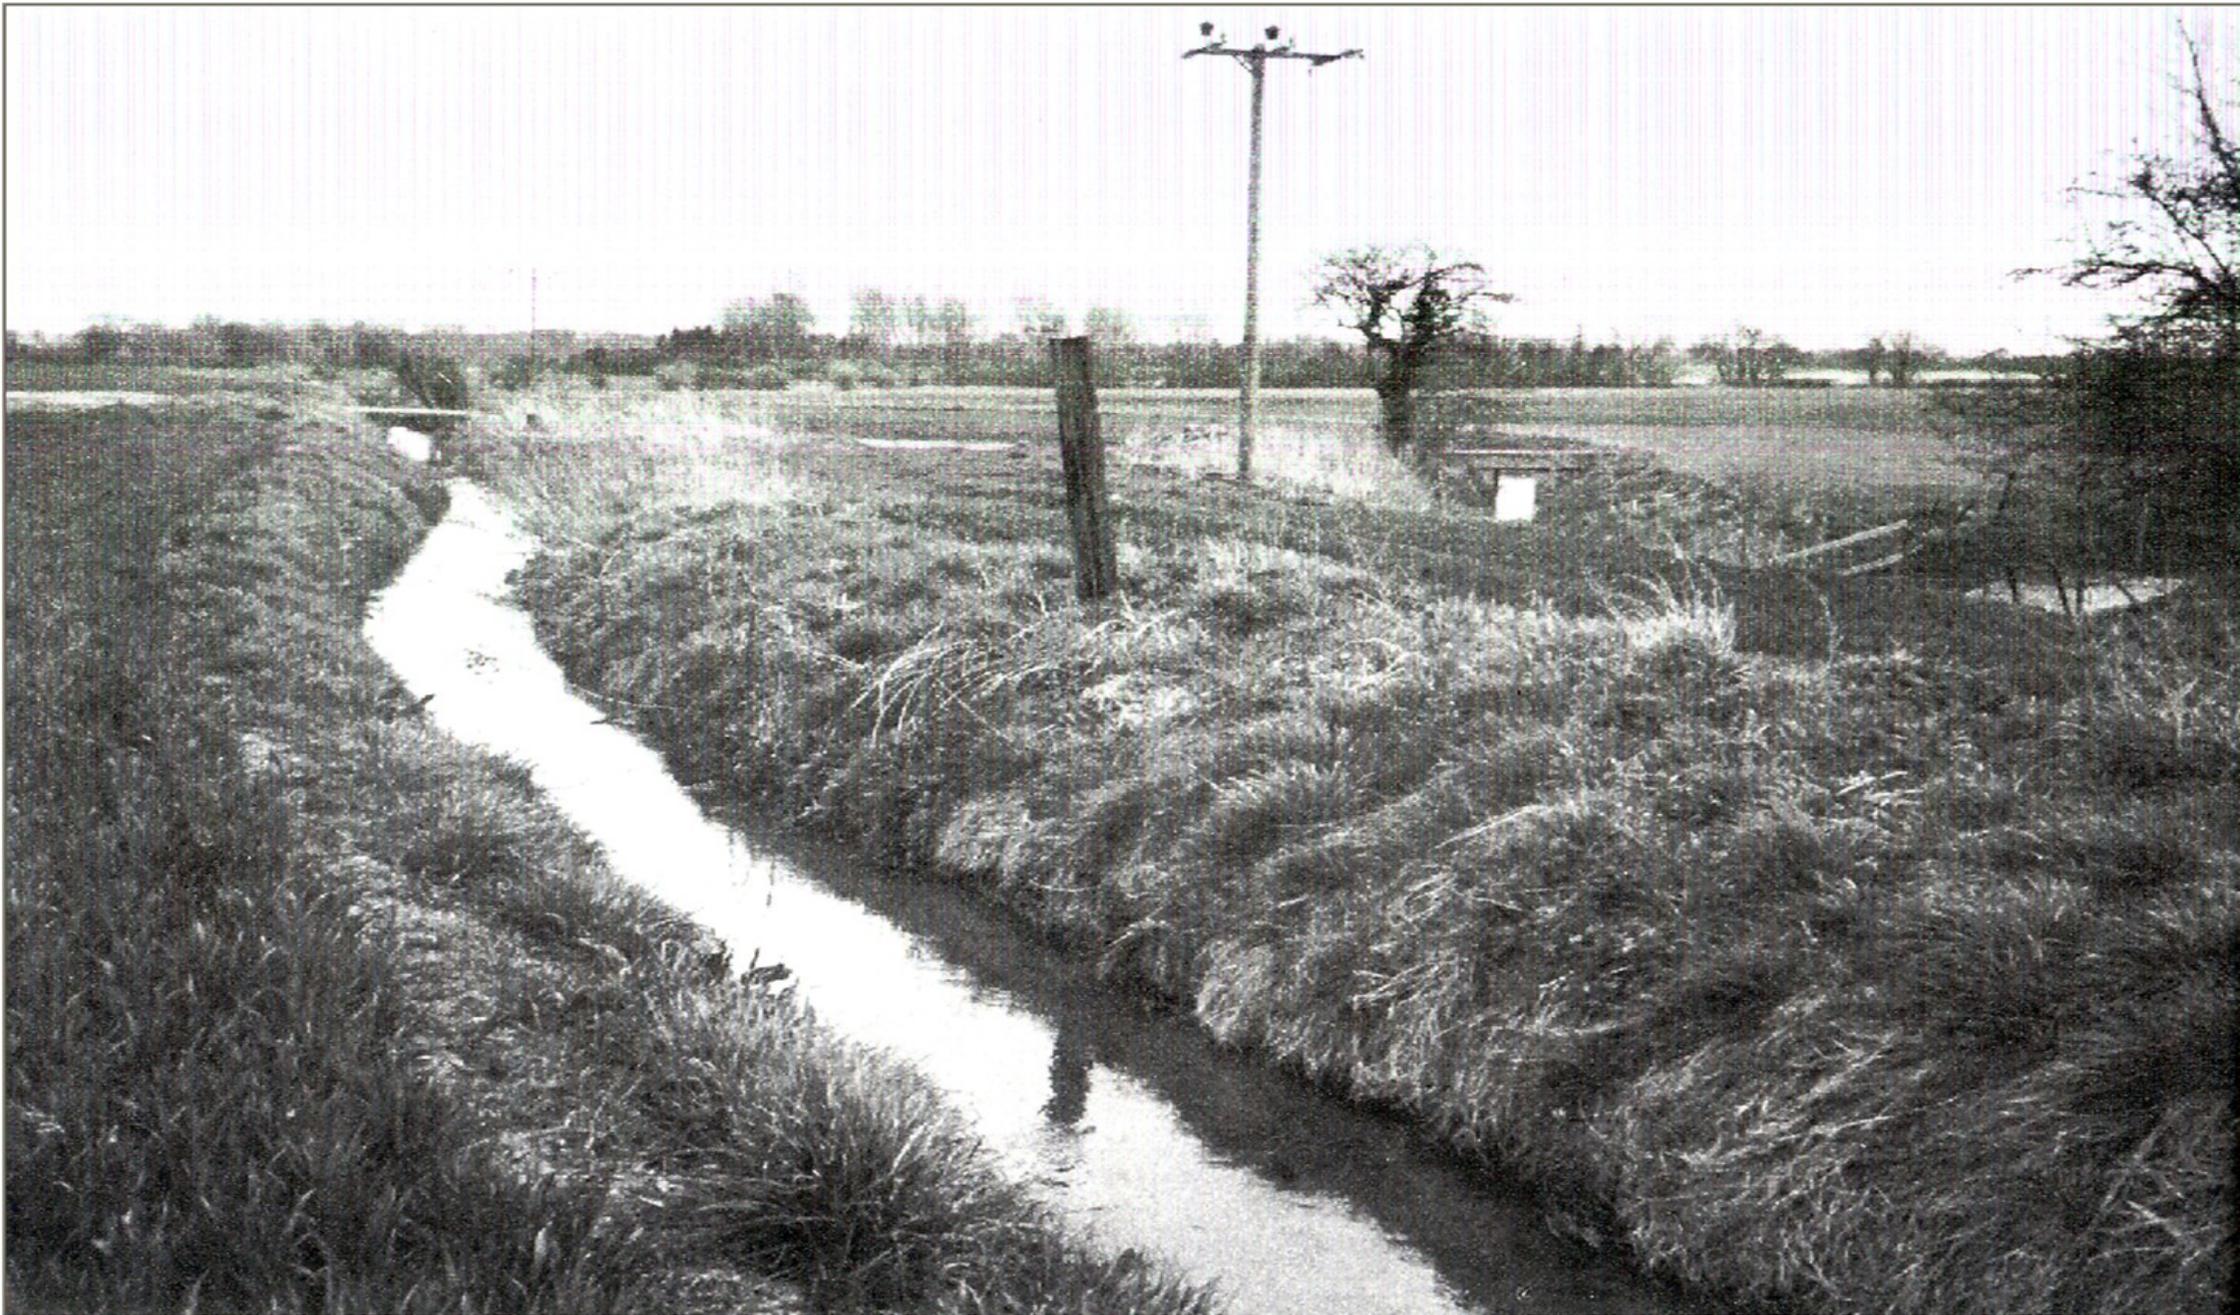
Figure 18. Wilbraham New Cut looking east, Spring 1988. The bed of the New Cut is some two metres above the old course of the river on the right which marks the parish boundary

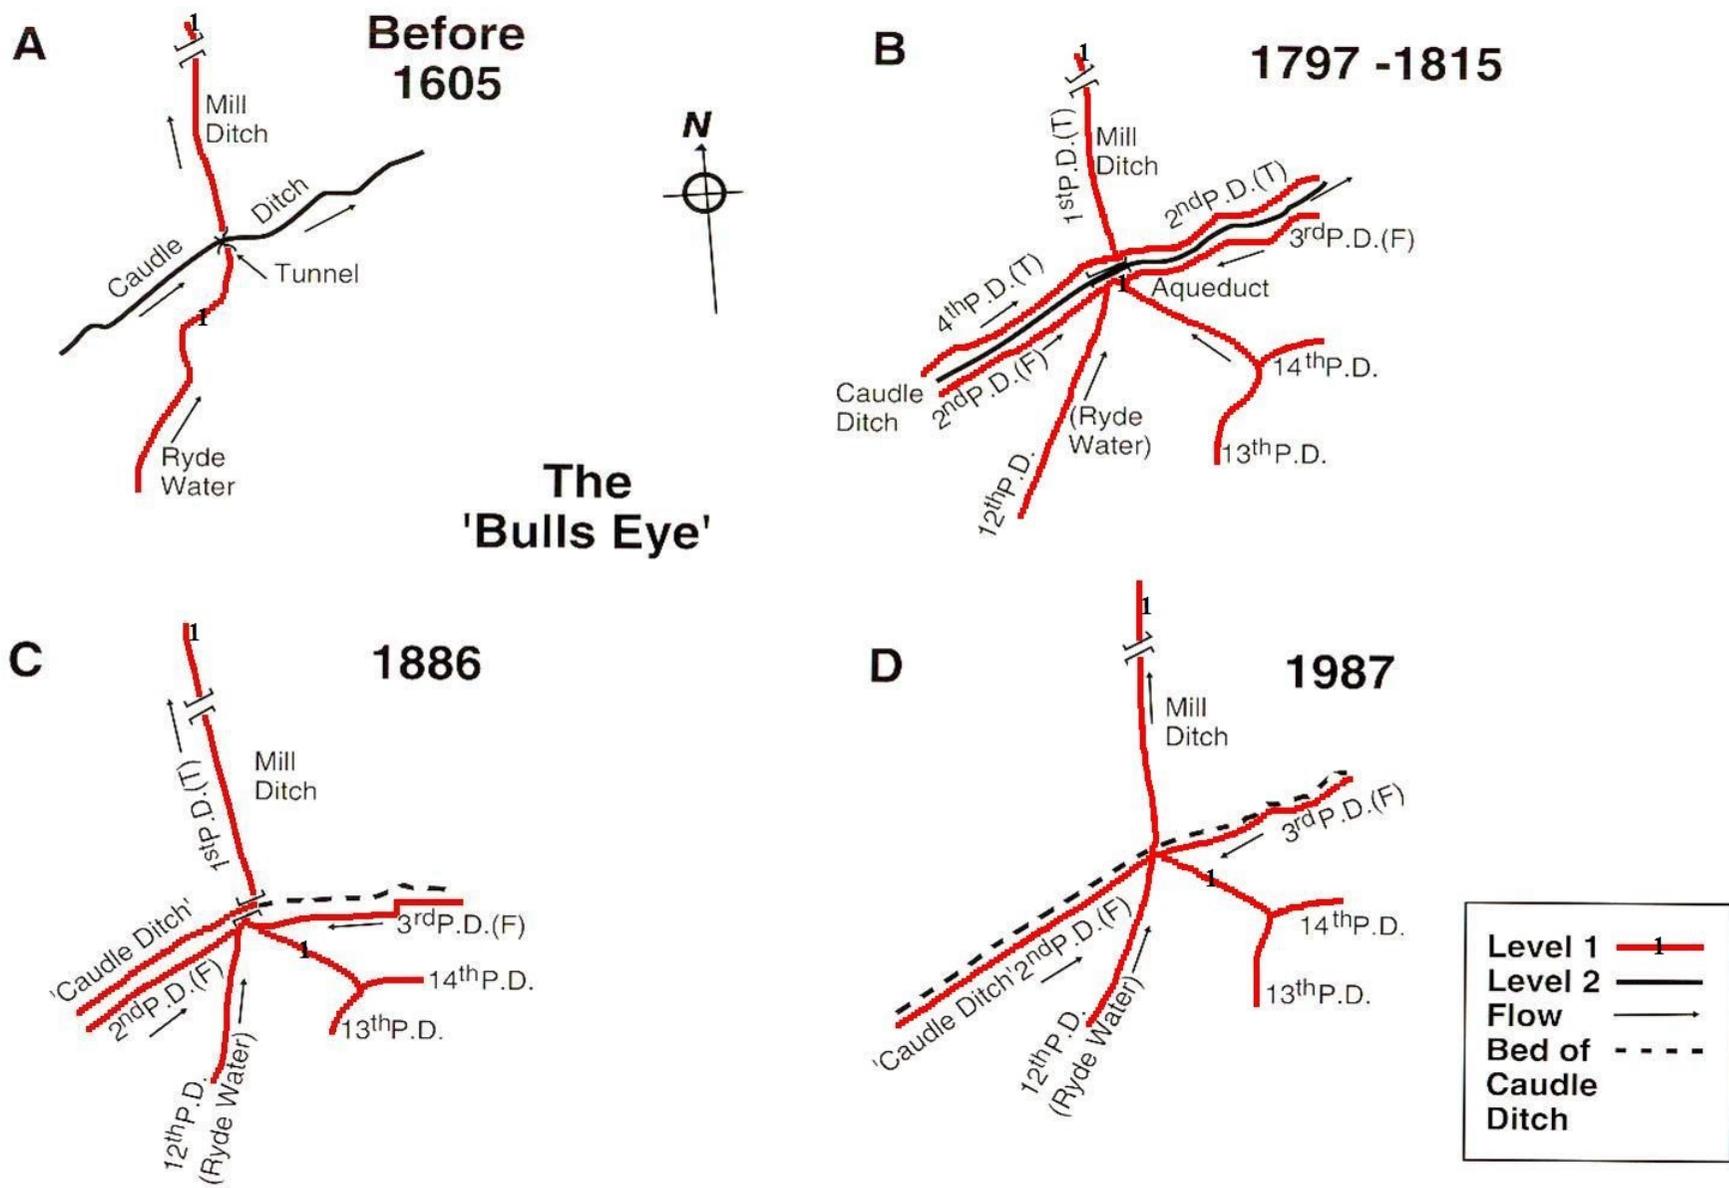
Figure 19. The changing configuration of the public drains at the “Bulls Eye” on the Fulborn/Teversham parish boundary.

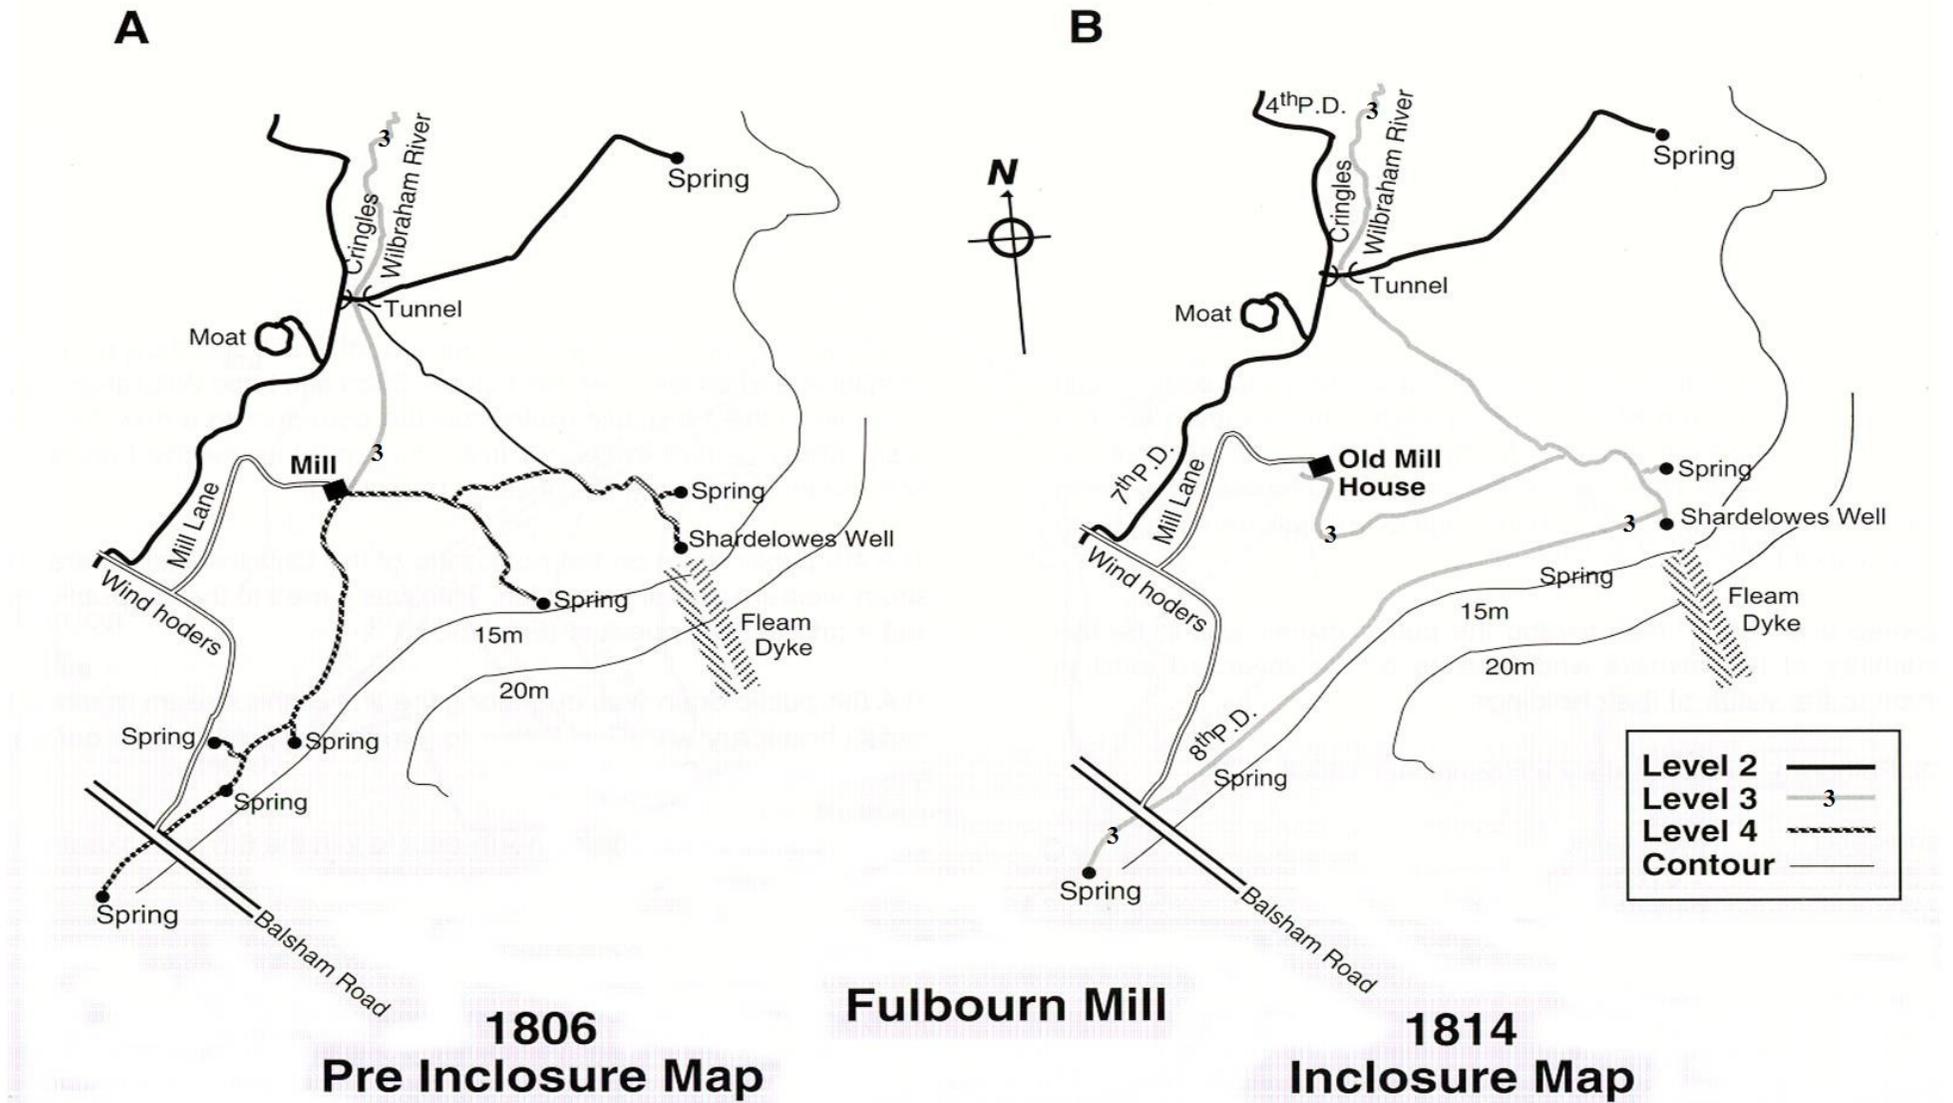
Figure 20. The watercourses before and after the demolition of Fulbourn watermill. See text.

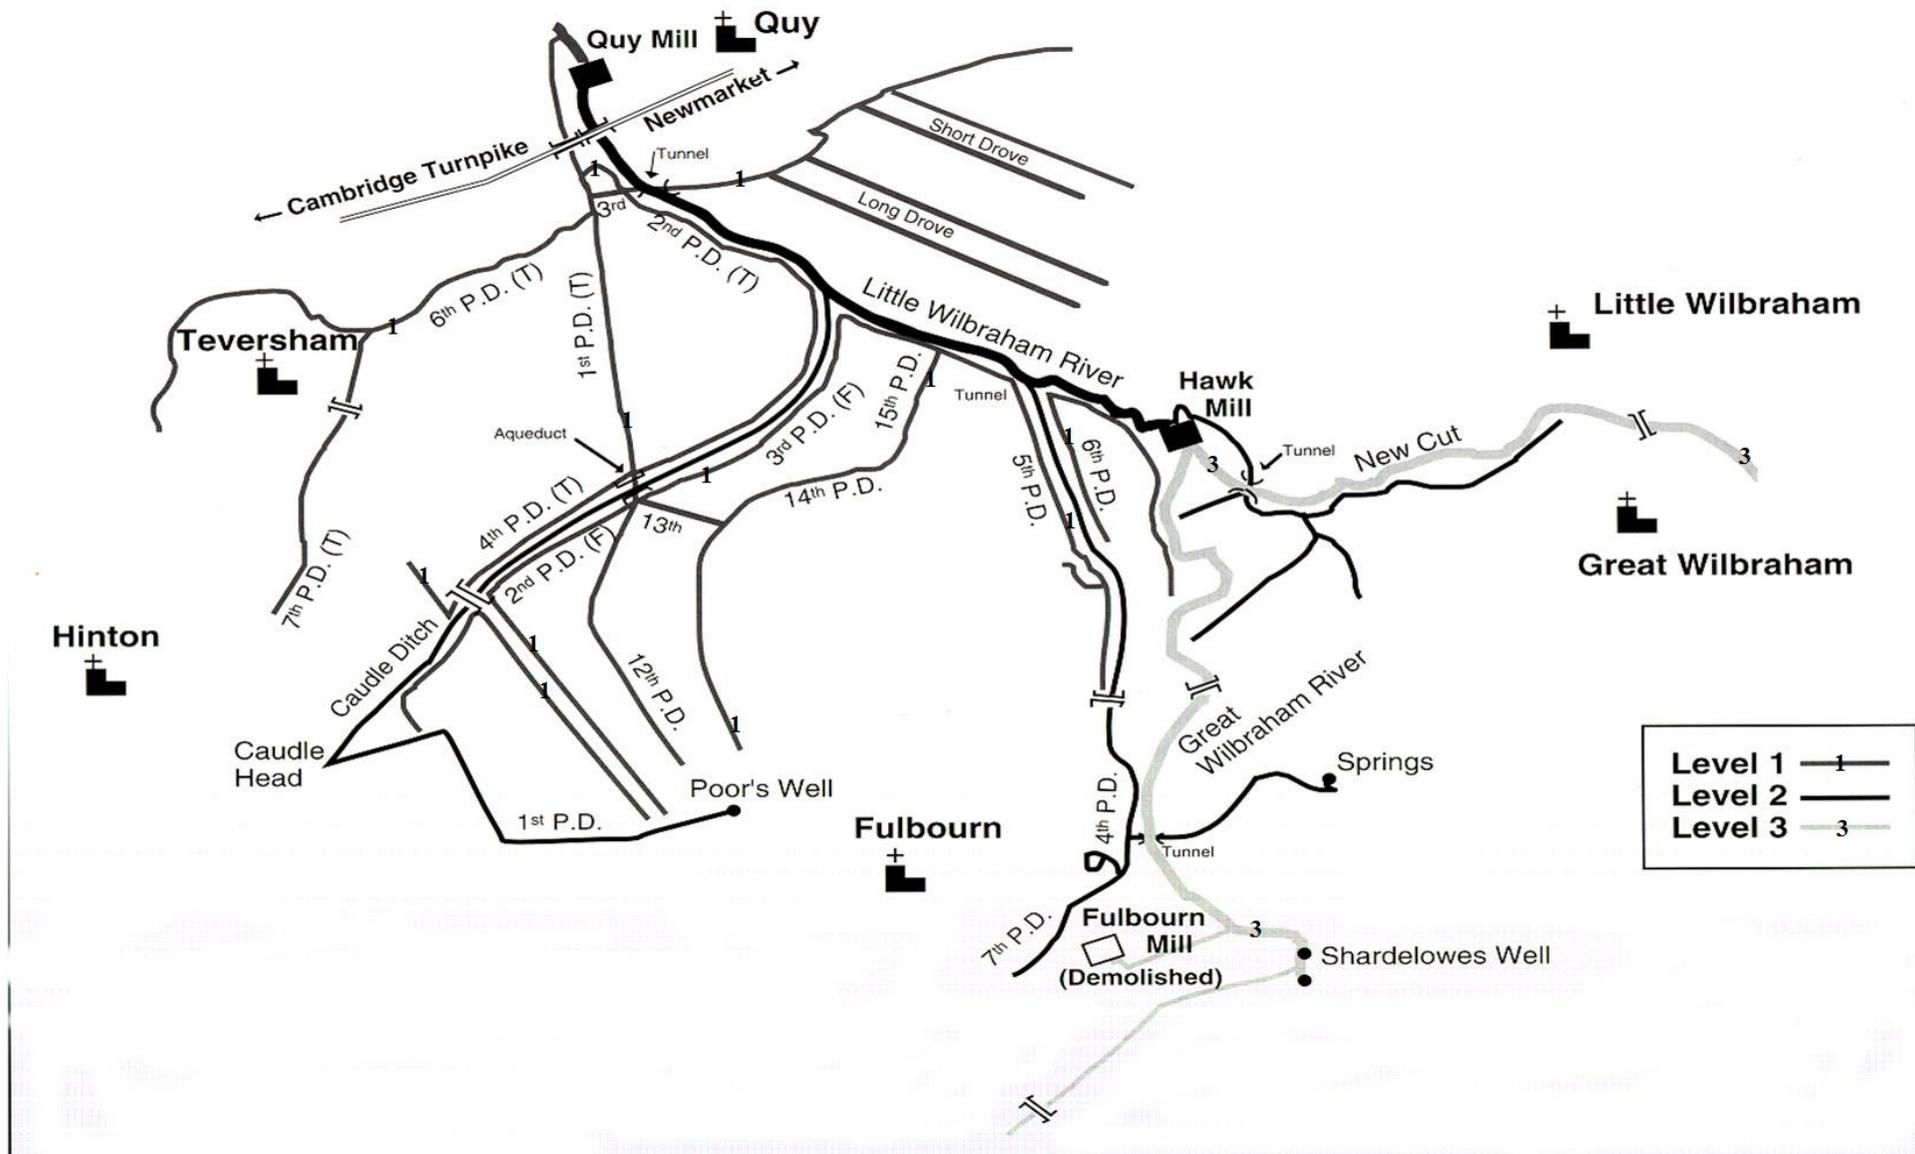
Figure 21. The watermills, rivers and public drains in the four parishes after the Parliamentary Inclosure Acts 1797-1810. The system is at three levels.

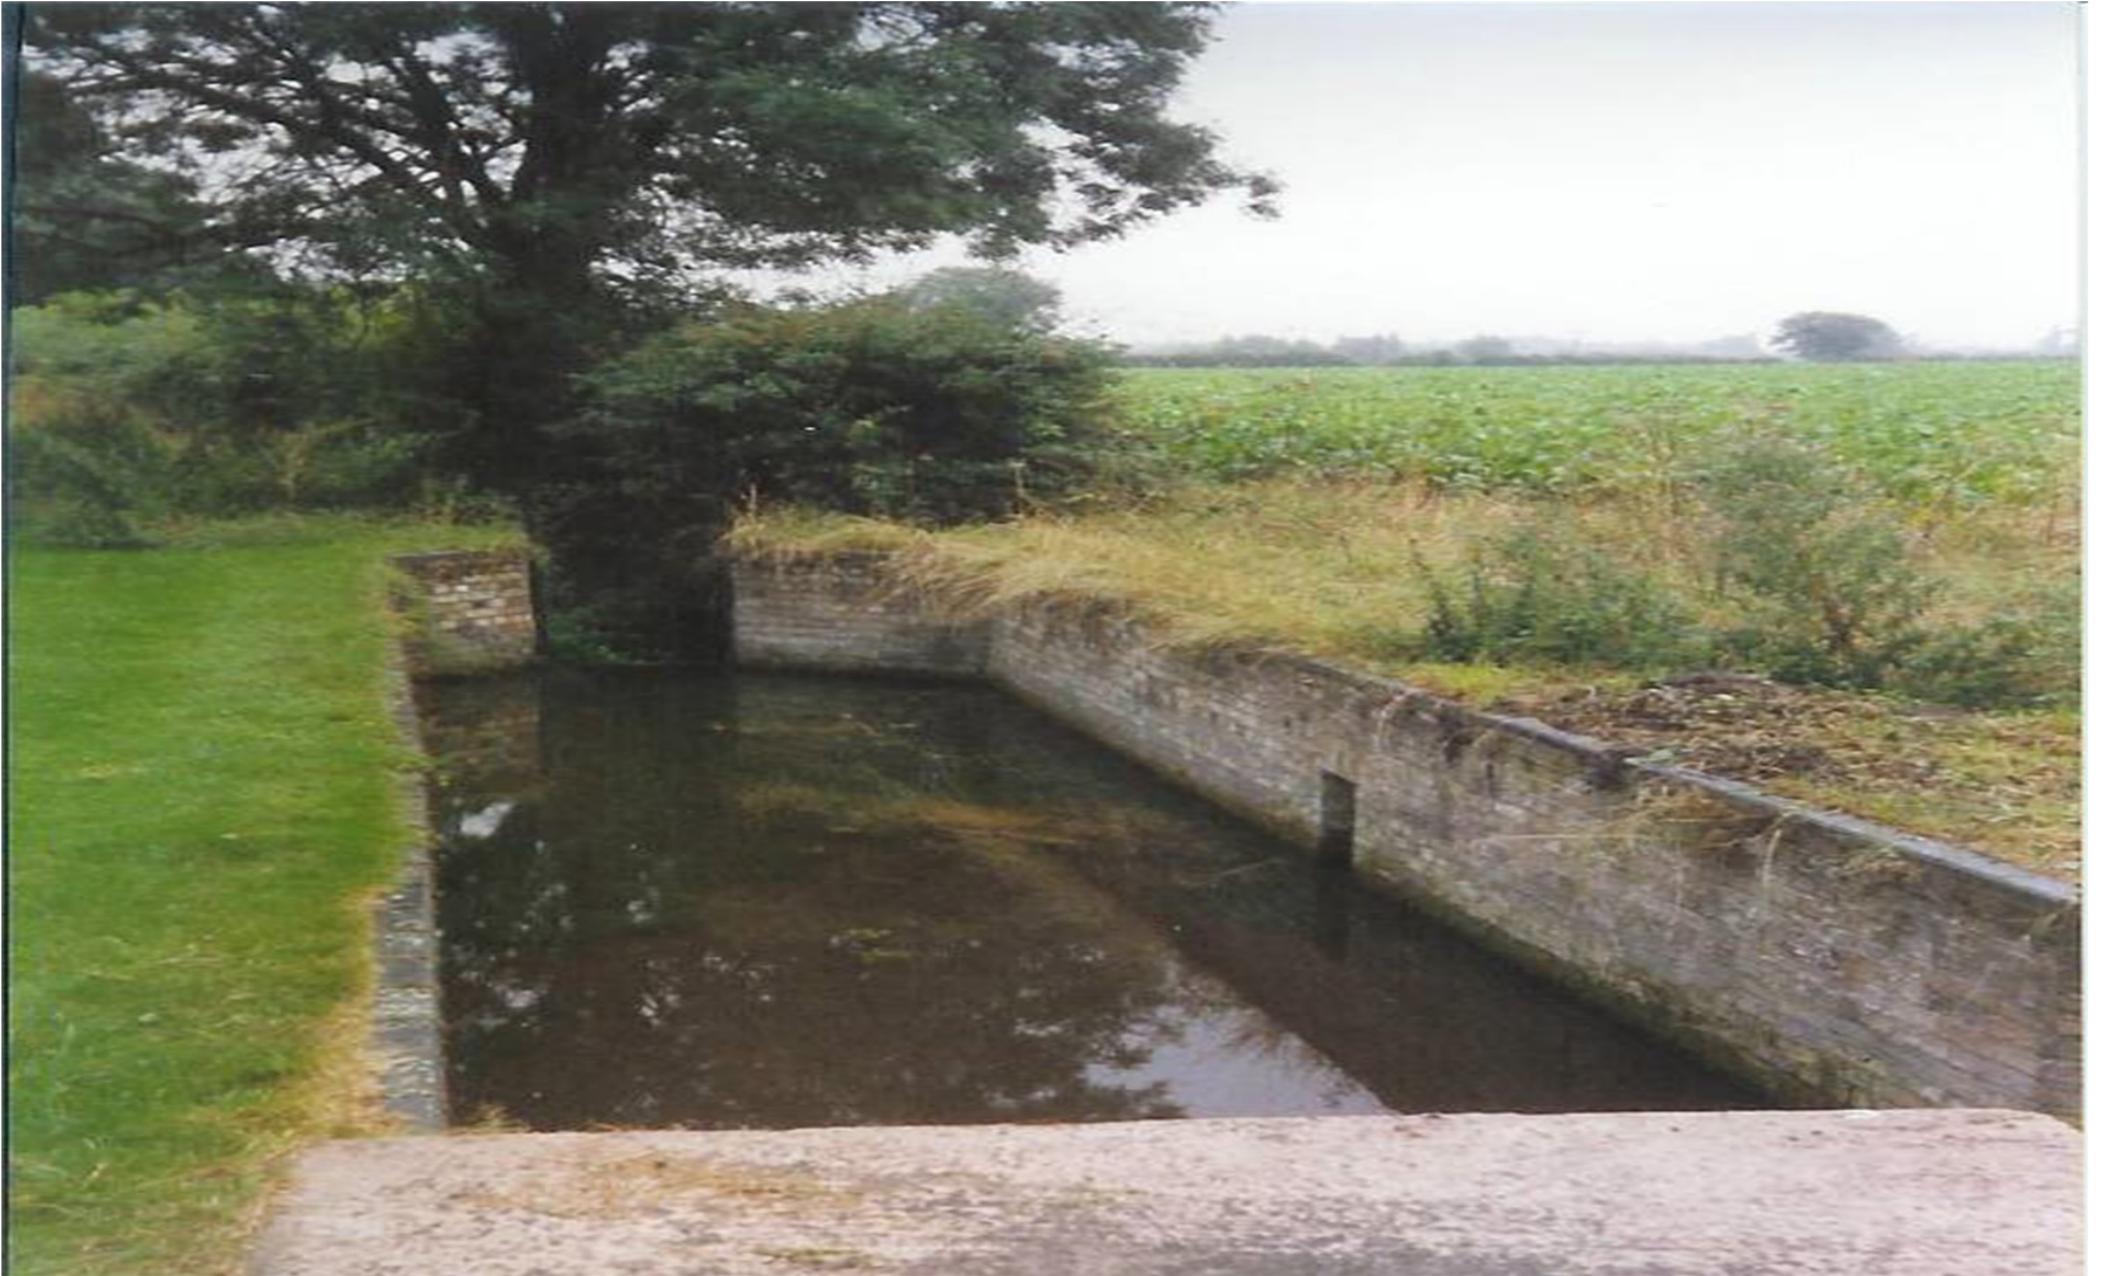
Figure 22. The sluice, looking downstream. Baffle boards were lowered at the far end to divert water through the square aperture seen on the right into a conduit leading to an open channel beside the High Street.

The sluice is situated on the upper part of the Wilbraham New Cut (Fig.22). Its purpose was no longer recalled on local inquiry but tradition had that it was a sheep-dip. Although it may have been so used this clearly was not its main purpose which was to divert water from the watercourse. The bricks of which it is built together with the time the New Cut was constructed and the fen drained point to it having been put in place sometime in the nineteenth century; there appears to be no documentary evidence to verify this. The method of operation was that baffle

boards were lowered, either partly or completely, at the downstream end of the sluice to reduce or stop the flow of water running along the New Cut. As the level of the water rose it flowed through a square aperture in the wall of the sluice, seen on the right in Figure 22, into a leat or conduit running some 300 metres north west to the High Street where it ran in a channel between the road and the properties on the south side and thence along Fen Road to a drainage ditch alongside the Long Drove (Fig. 23). Its purpose was to provide water for livestock grazing the fields in the former Wilbraham Fen, probably those nearer the village, and it served also to augment the water-supply for properties in that part of the village. The utility of the system and how it was operated were made clear when thought to be under threat by a Bill before Parliament in 1910 to permit the Cambridge University and Town Water Works Company to build a pumping station at Fleam Dyke. The Parish Council instructed the Clerk to write to the Company as follows: *"In the event of the Bill being passed it will seriously affect the water supply running through the Parish of Little Wilbraham from 6pm Saturday to 6am Monday weekly, which we claim one fifth of the water running from the Springs, called the New Ditch. If the water is taken away it will be a very serious matter for the Parish as it runs down the Fen to supply water for the Cattle and for the Poor Common. It also supplies water for Domestic use to the inhabitants of the Parish ..."*²¹ There is no evidence that the intermittent diversion of water from the river into the land drains adversely affected drainage of the fen. There is however contemporary evidence that when the sluice was incorrectly operated. the miller at Hawk Mill complained.²² The configuration of the sluice together with other evidence point to its subsidiary use as a sheep dip.²³

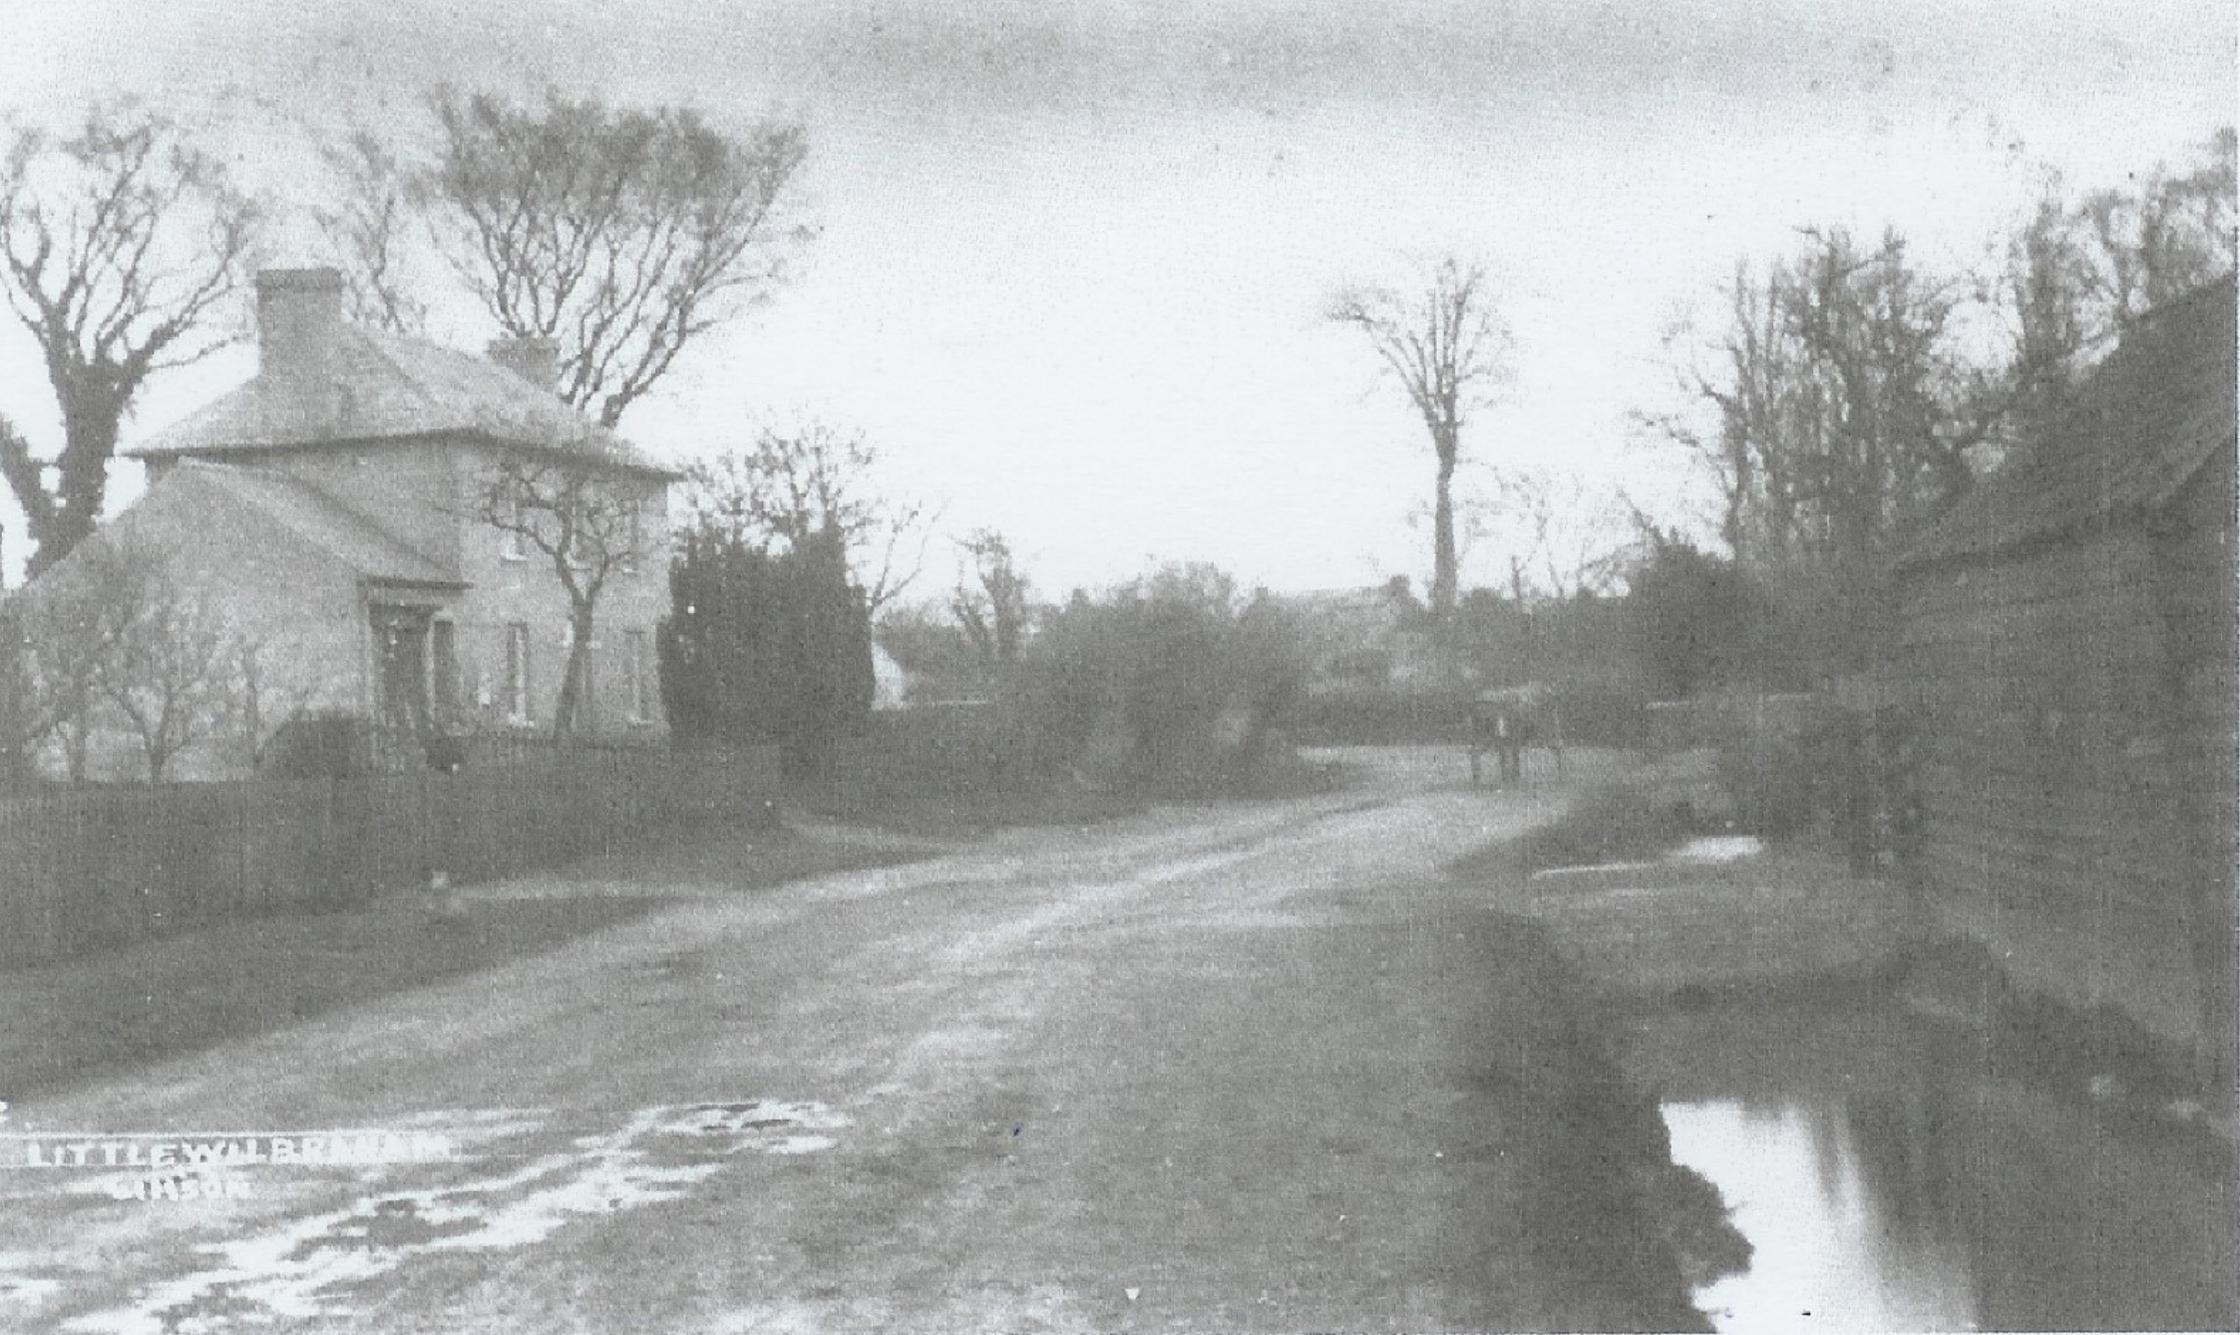
Figure 23. The channel along the southern margin of the High Street in 1906 with culverted access to adjacent properties.

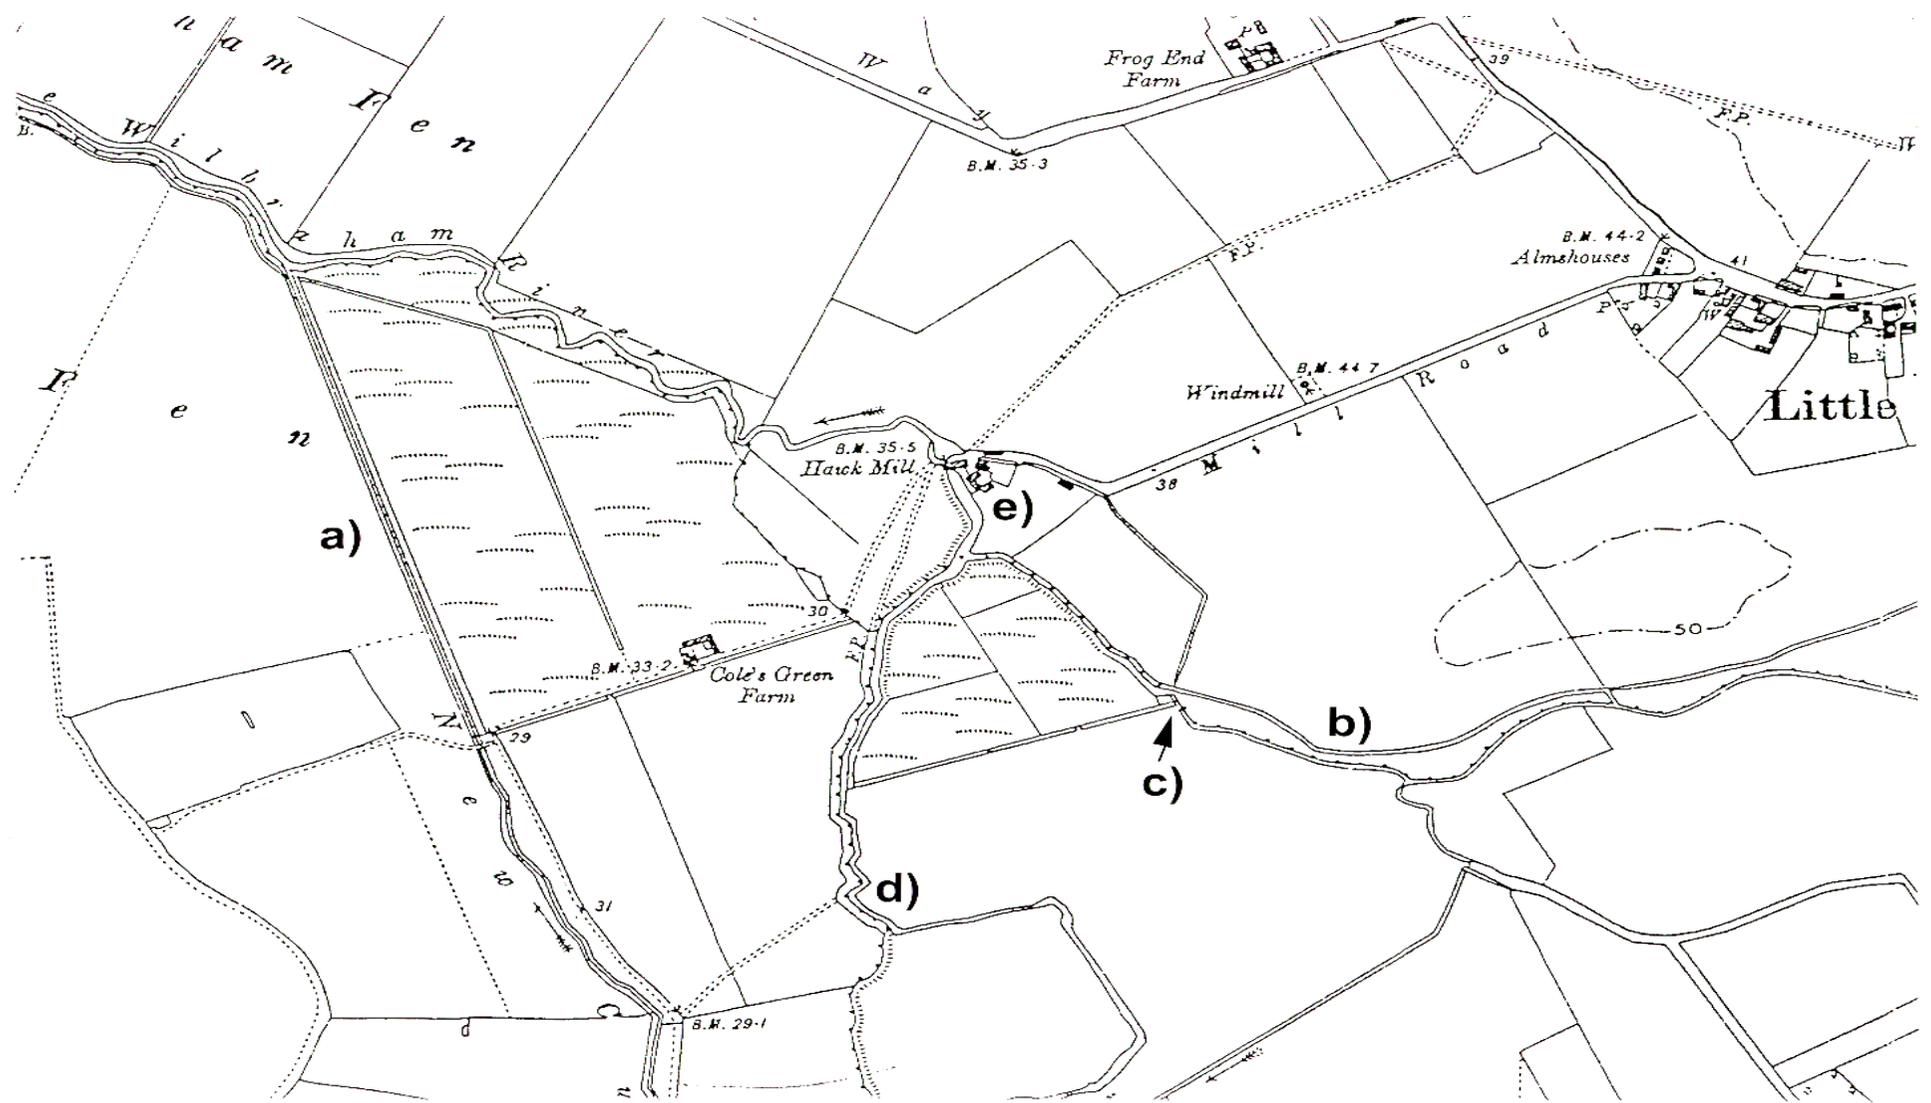
Figure 25. The watercourses and public drains in the region of Hawk Mill Farm. Key: a) Fulbourn New Cut, b) Little Wilbraham New Cut, c) culvert for drain under New Cut, d) Great Wilbraham River, e) mill race.
 (Ordnance Survey map, 1903 edition, reproduced with permission of the Syndics, Cambridge University Library)

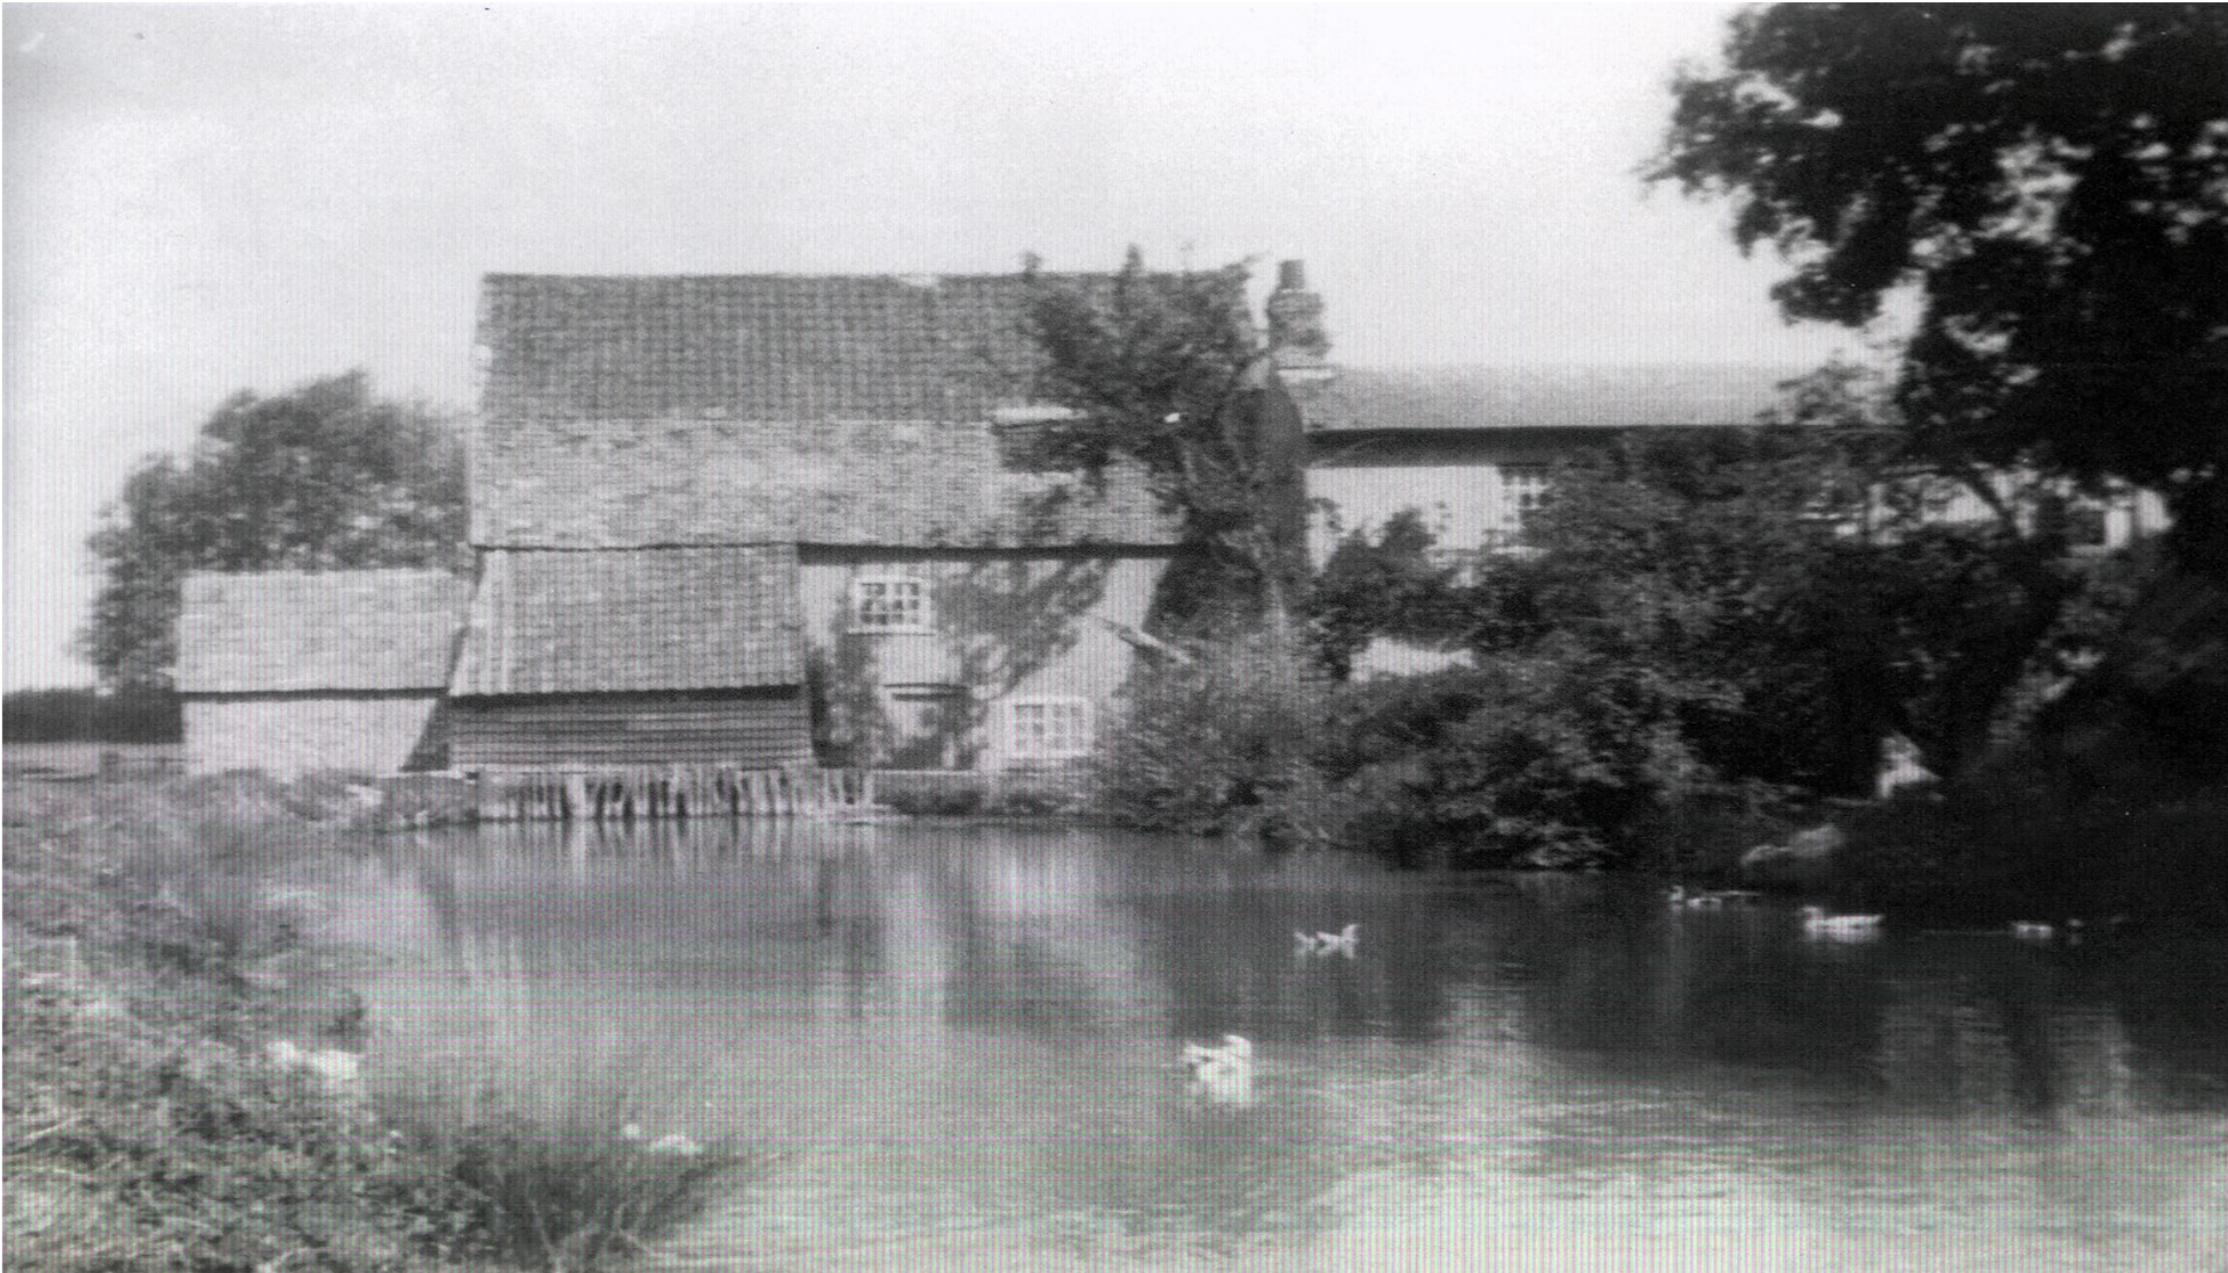
Figure26. Hawk Mill 1929. The mill was still in use but flow was much reduced due to abstraction from the new borehole at Fleam Dyke and the derelict state of the watercourses.
