The drainage
of
Wilbraham
Fulbourn
and
Teversham
Fens

**THE DRAINAGE OF WILBRAHAM
FULBOURN AND TEVERSHAM FENS**

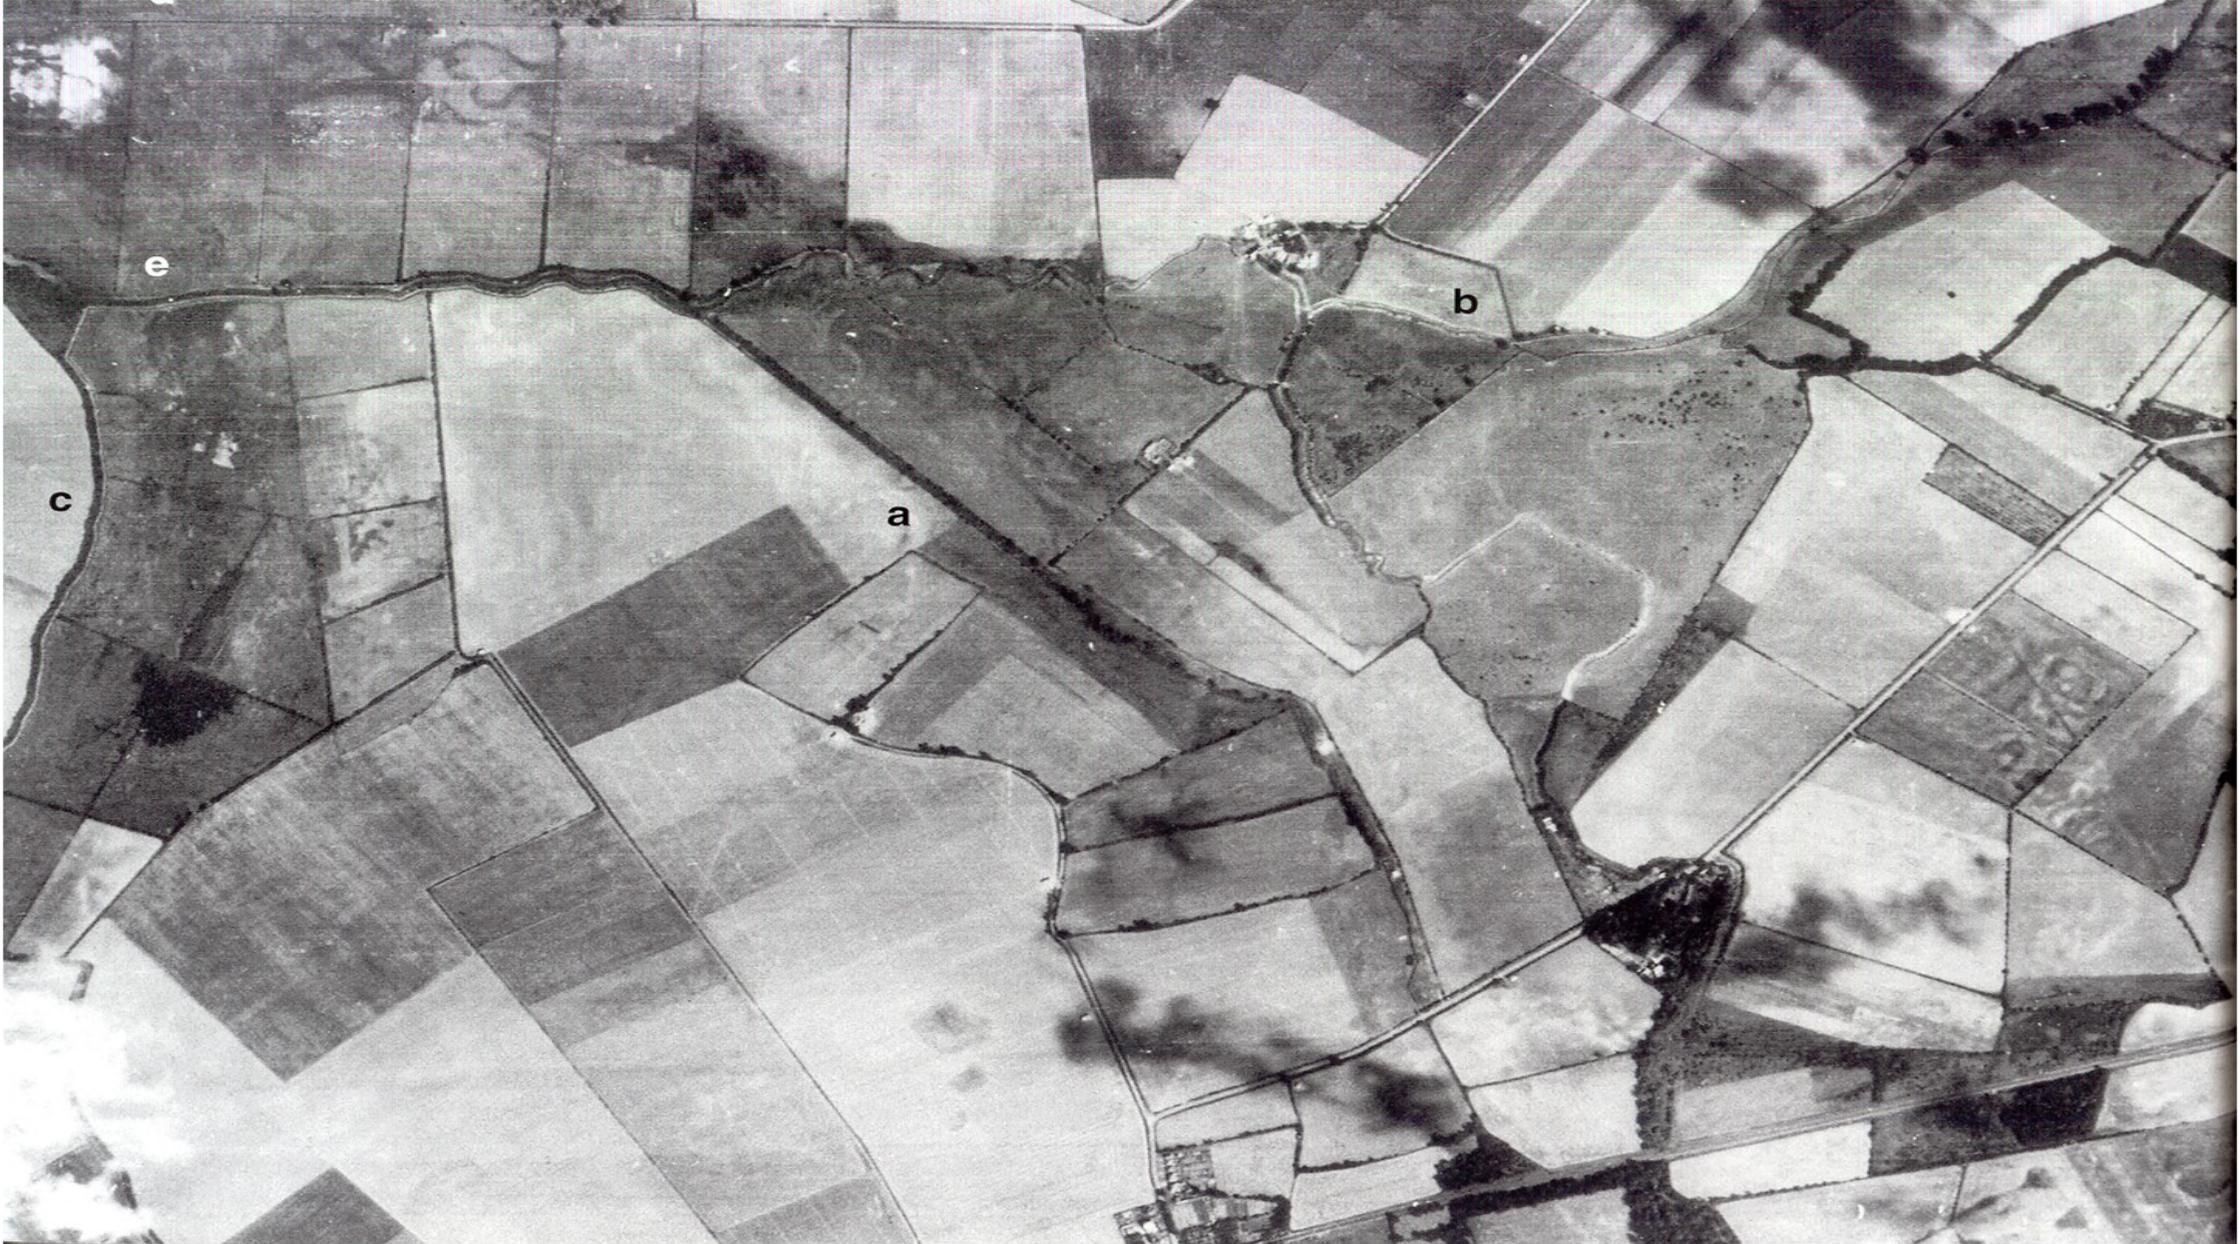
Figure 27. The fields of Hawk Mill Farm. Luftwaffe reconnaissance photograph September, 1940. The dark areas around the farm are waterlogged land due to overspill from Fulbourn New Cut (a) and Wilbraham New Cut (b). The land along side the old Caudle Ditch (c) and between the Long Drove (d) and Little Wilbraham River (e) had long been out of cultivation.

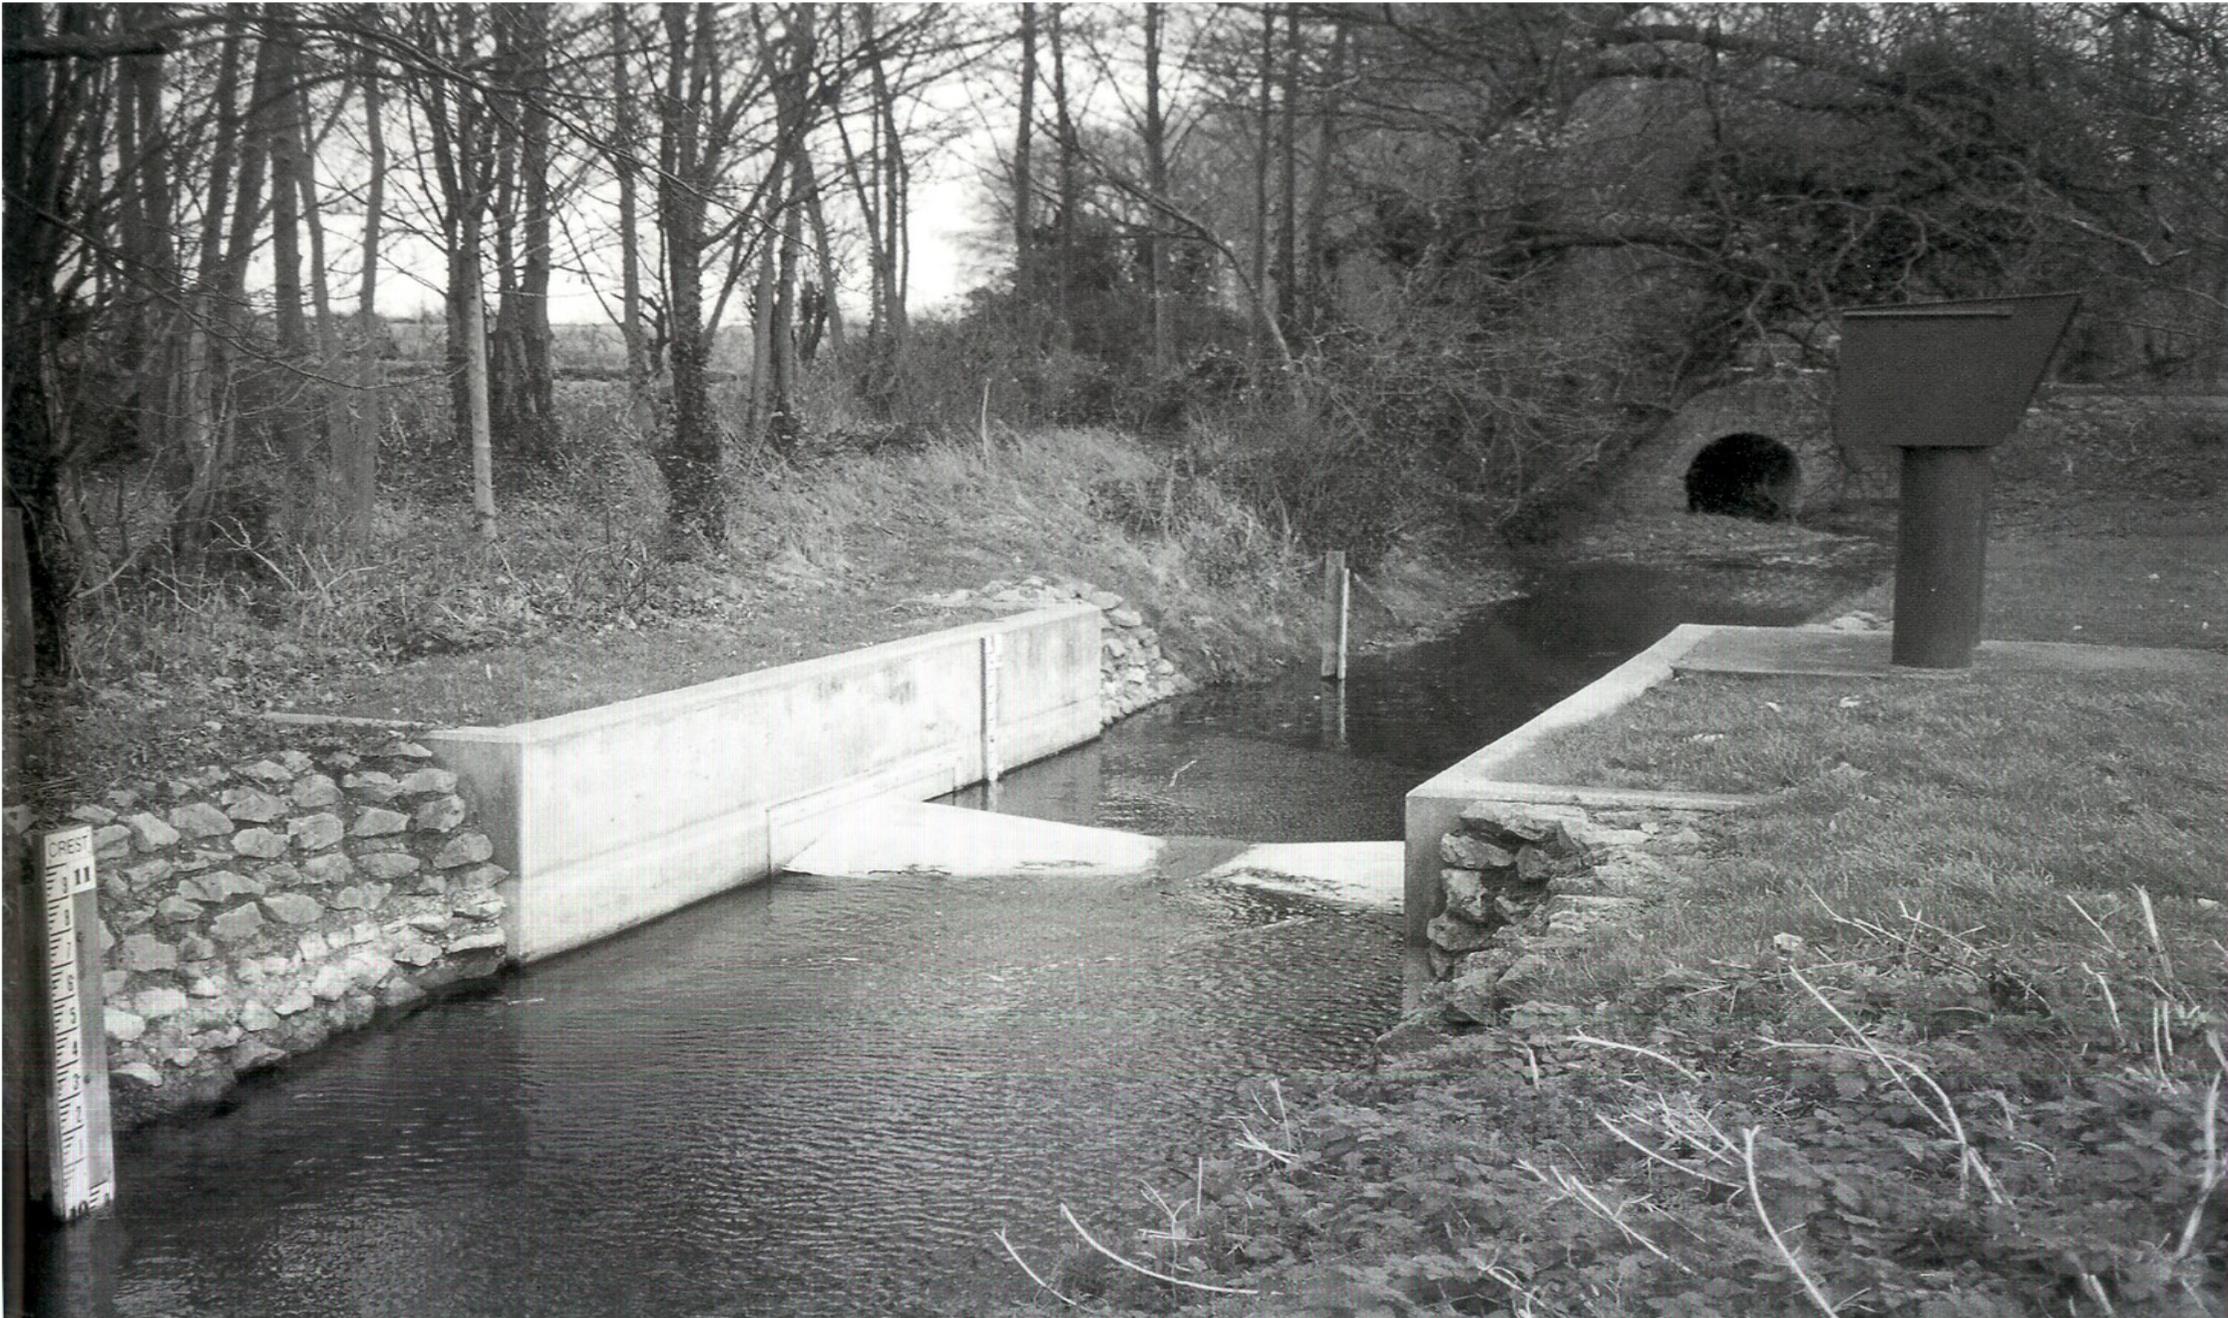
Figure 28. The Lodes-Granta Groundwater Scheme gauging station, Little Wilbraham River, winter 1988. Sited one kilometre downstream from Temple Springs it measures natural and/or augmented river flow

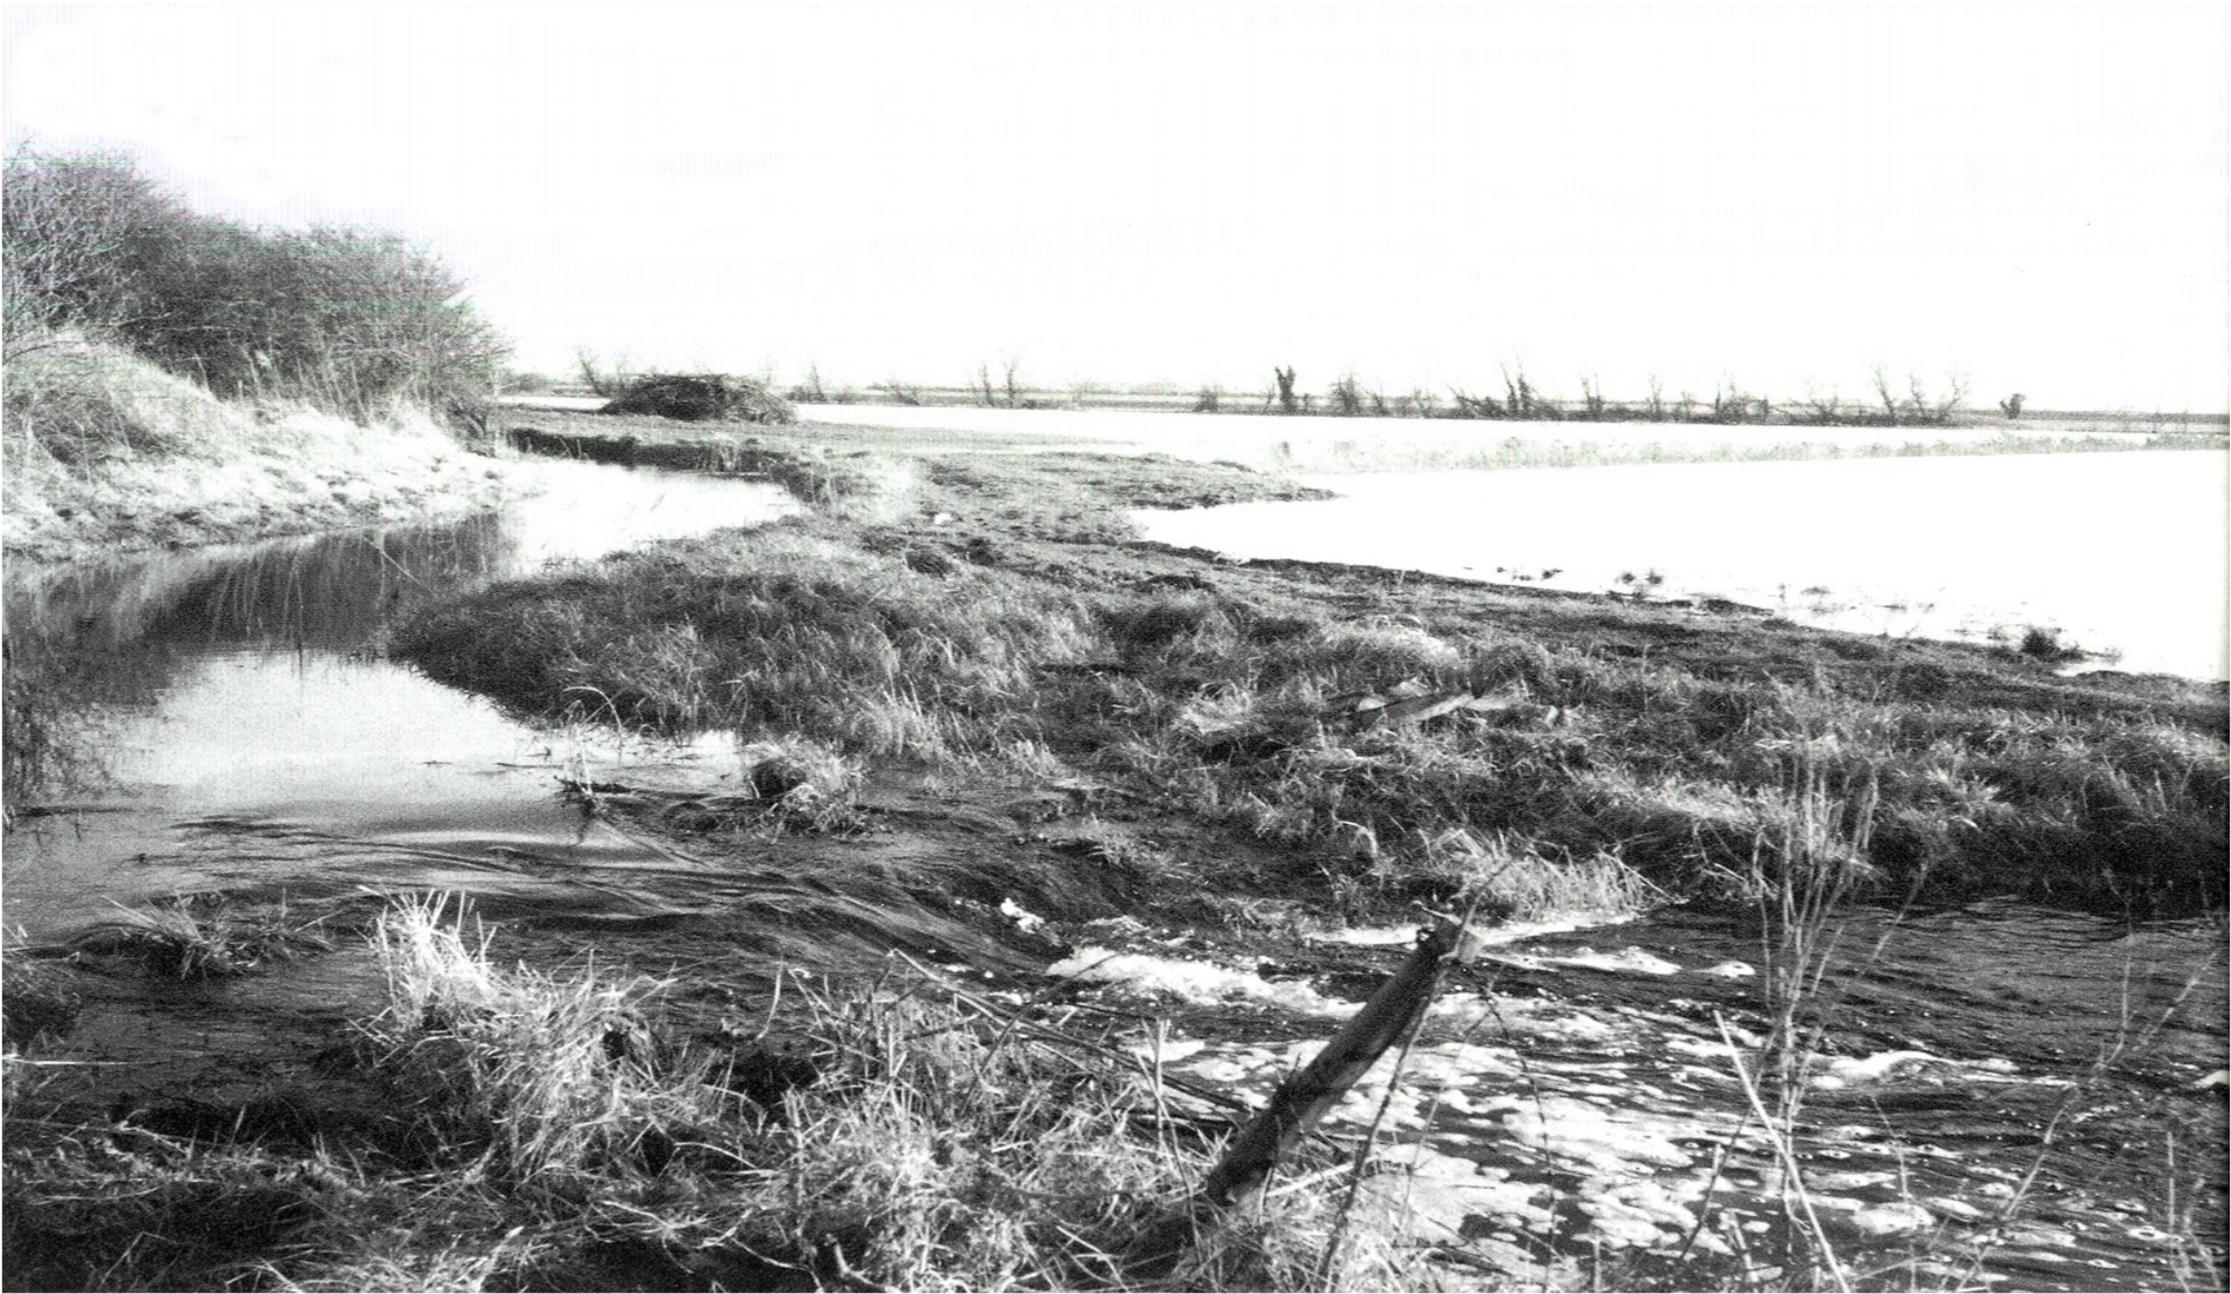
Figure 29. Flooding of Fisher's Fen, Spring 1995. When the flow was restored in Little Wilbraham River much was lost through the bed and banks. The watercourse depicted is the 2nd/3rd public drain (Teversham). The river is above the bank and bushes on the left.

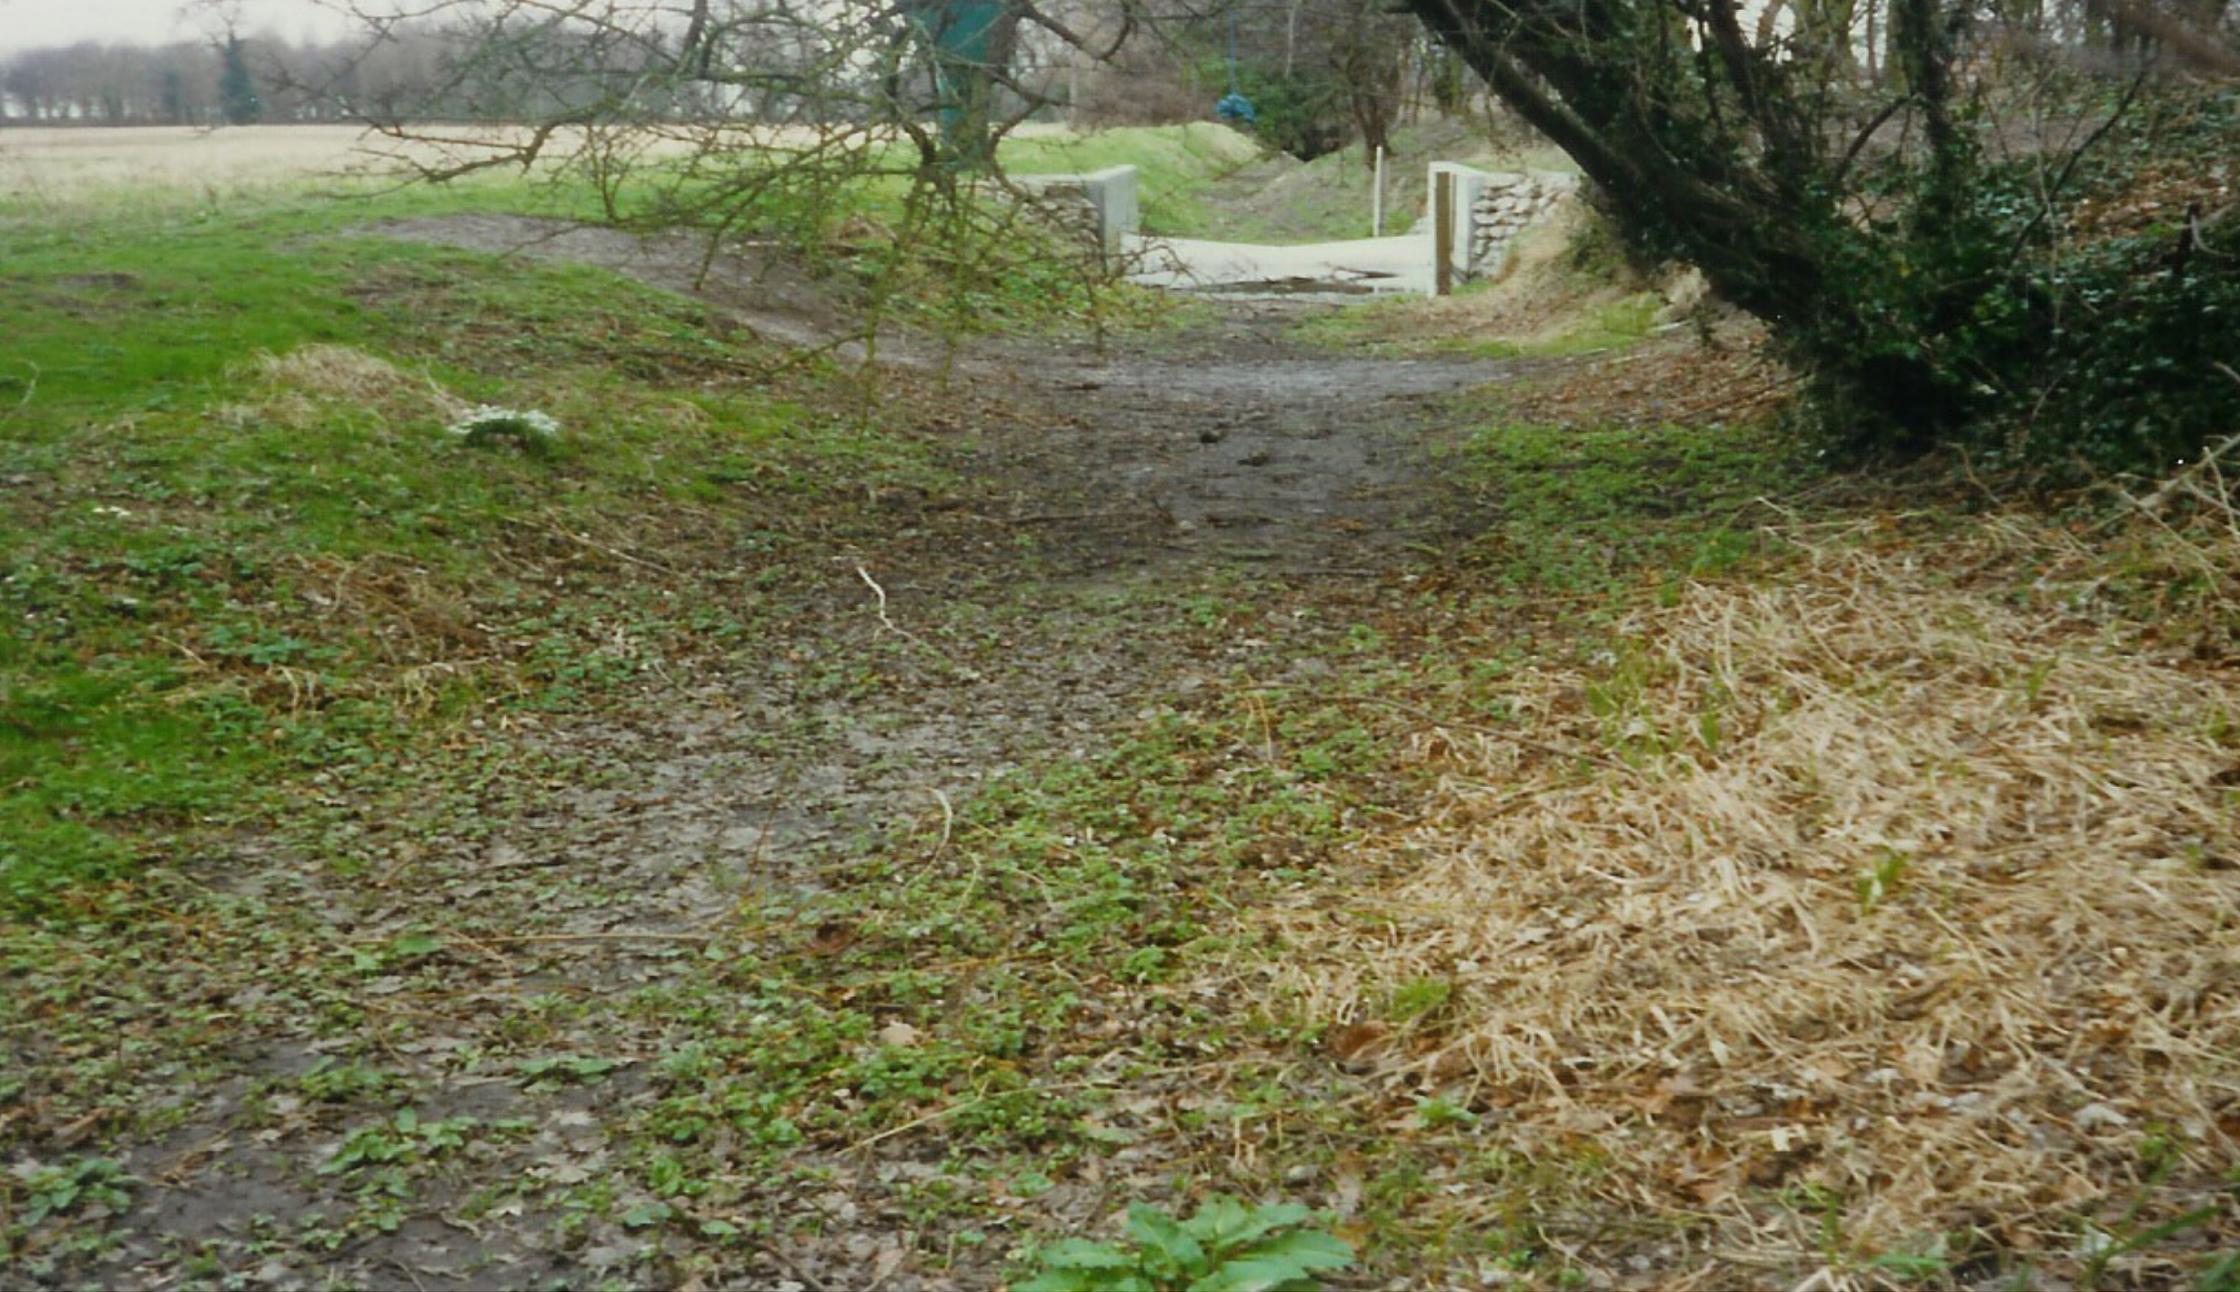
Fig 30 The gauging station looking downstream from the road bridge, 1997. Despite the augmentation scheme to maintain flow long sections of the river were dry.

The failure of the augmentation scheme to maintain flow and the consequent decline in the ecology of the river has been of long-standing concern to the Wilbraham River Protection Society (Figs30&31). The Environment Agency has been monitoring natural flow at the Temple Springs together with groundwater levels, monthly, at a borehole about one kilometre to the east at Cedar Tree Stud.. This revealed wide fluctuation in water levels and in 2010 the abstraction programme was modified so that when natural flow declines it is augmented continuously. This has restored perennial flow and reduced water loss through the river bed. Neither the Society nor the Environment Agency is happy with this abstraction programme and would prefer to see natural flow restored or pumping

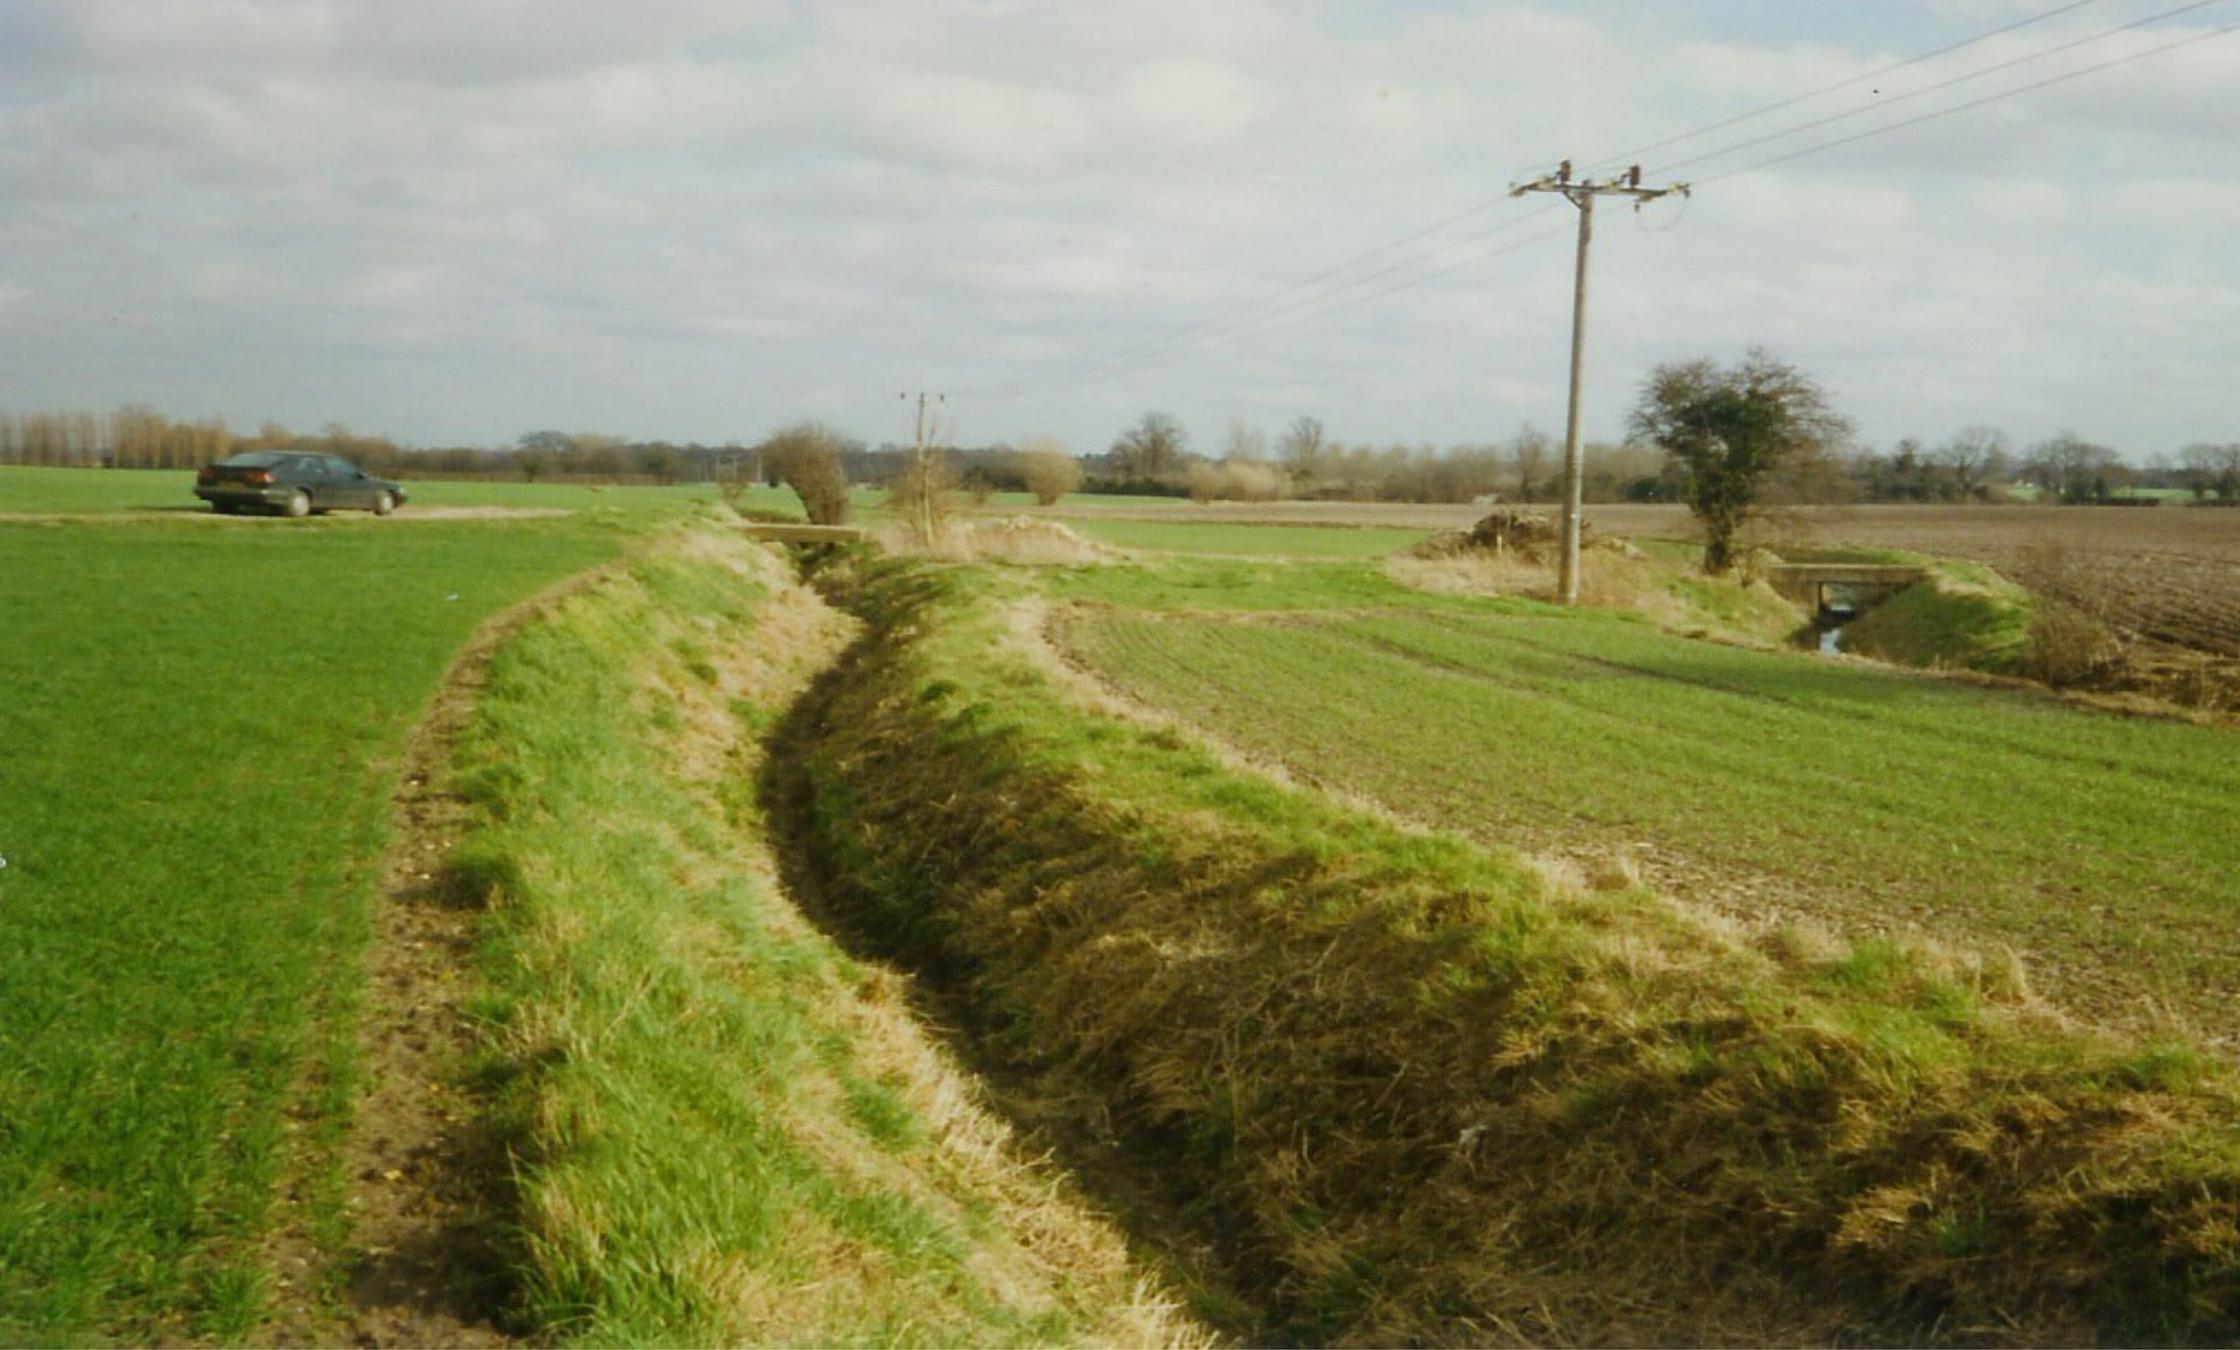
Figure 31. Wilbraham New Cut looking upstream, 1997. The river bed was dry from the gauging station to below Hawk Mill. Water is seen in the drainage ditch to the right of the electricity pylon along the former course of Little Wilbraham River.

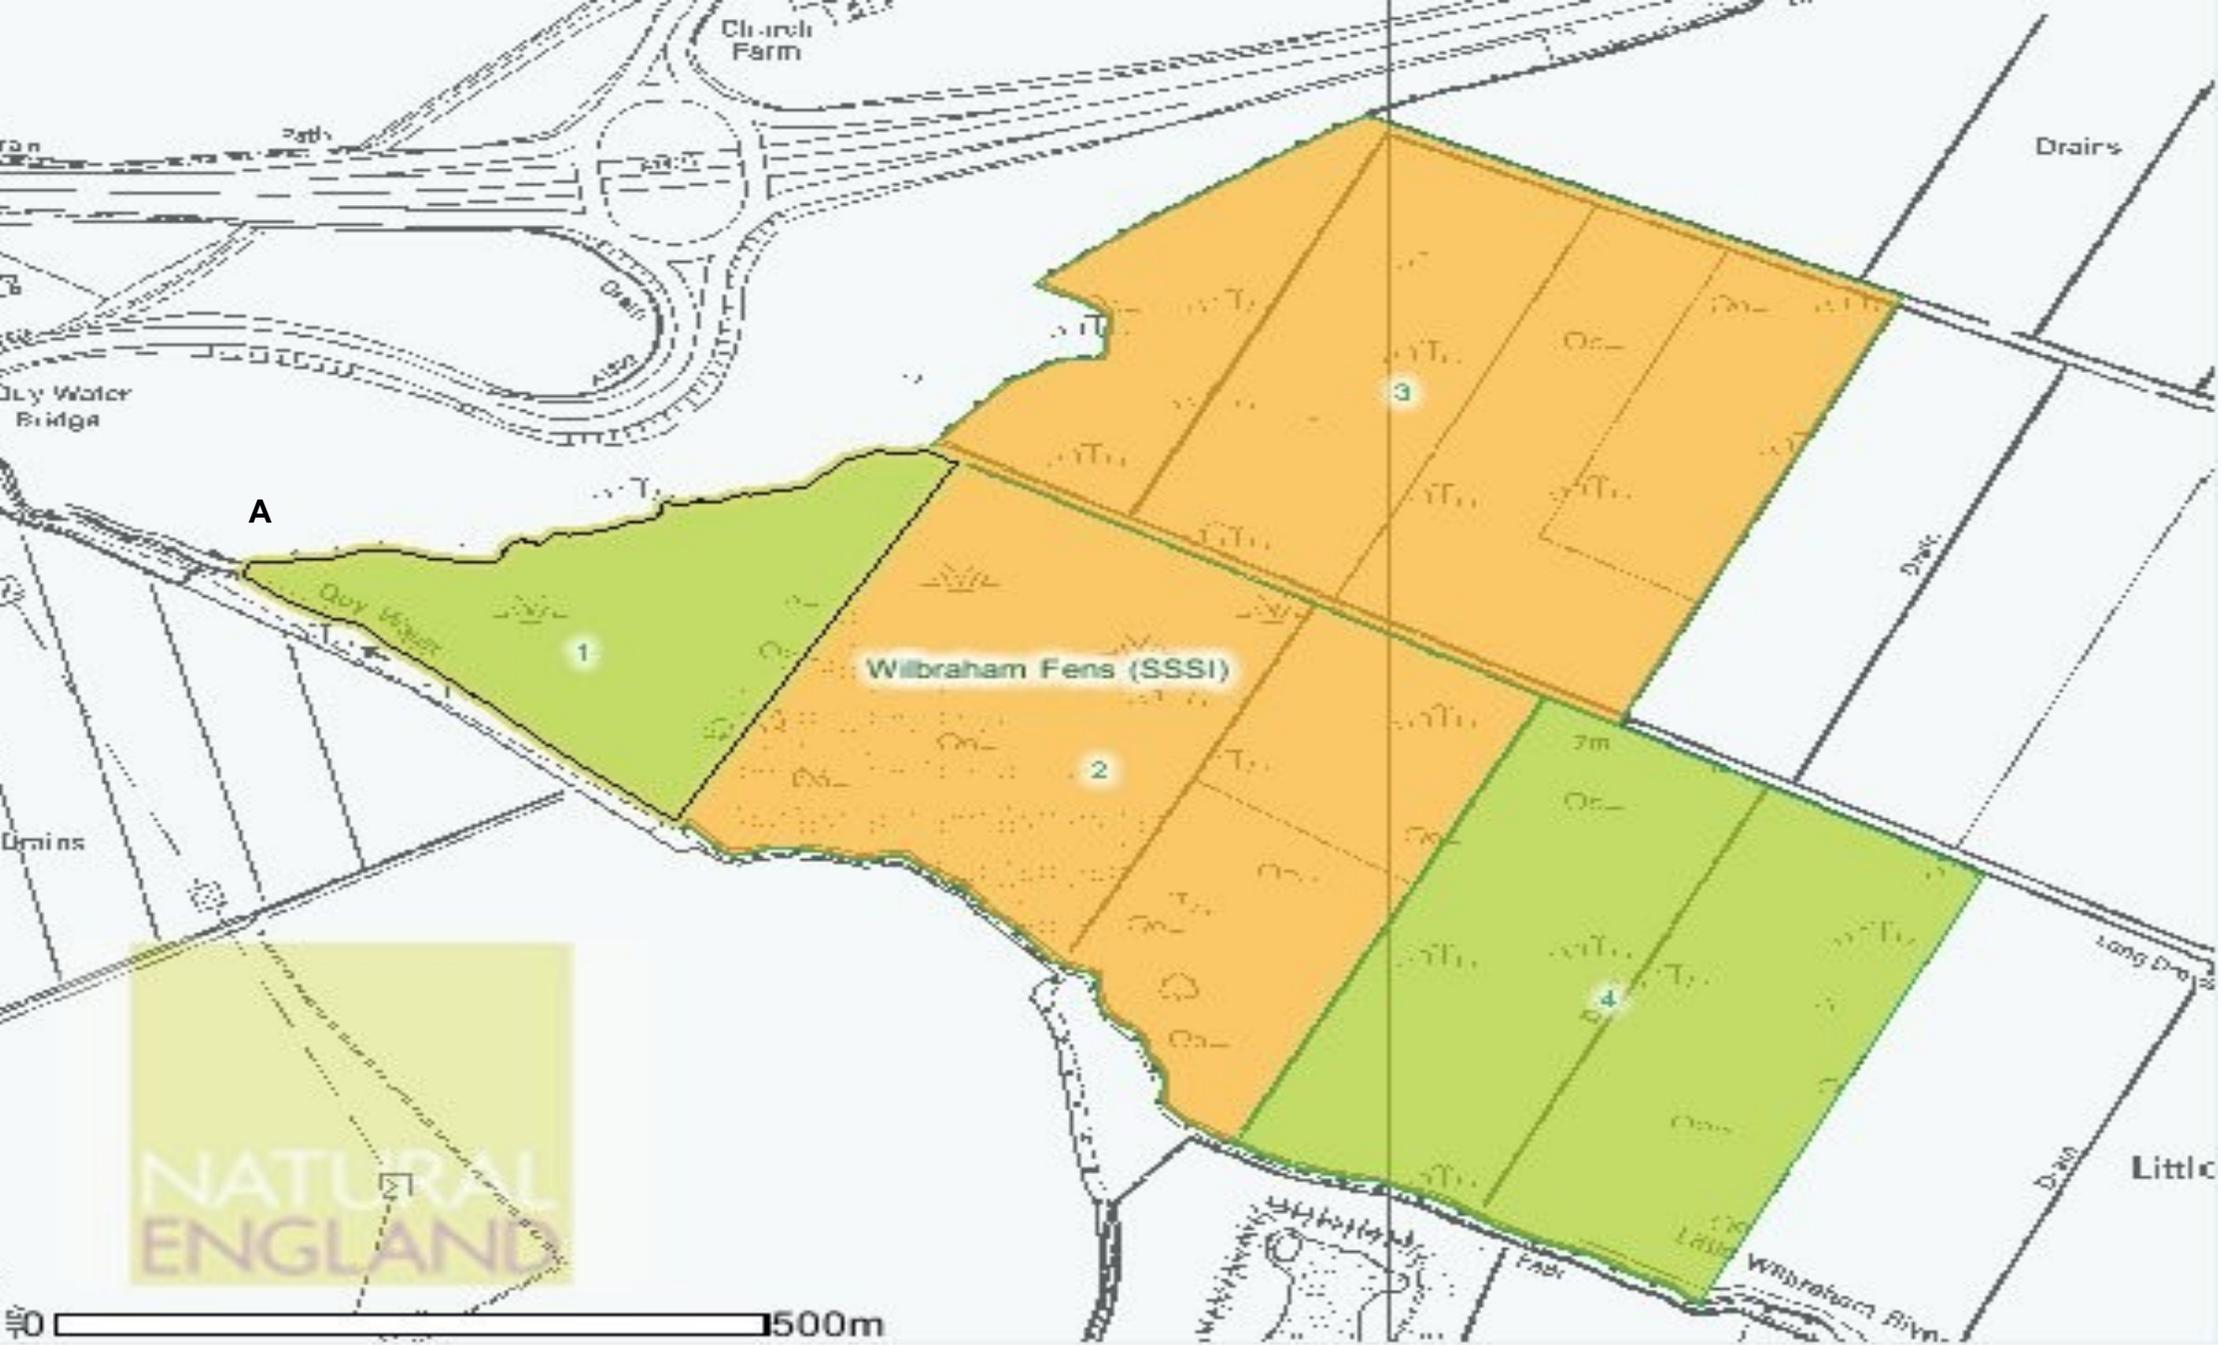
Figure 32. The SSSI Wilbraham Fen. Site of proposed sluice to control water levels (A). The numerals relate to an assessment of the condition of the areas by Natural England.

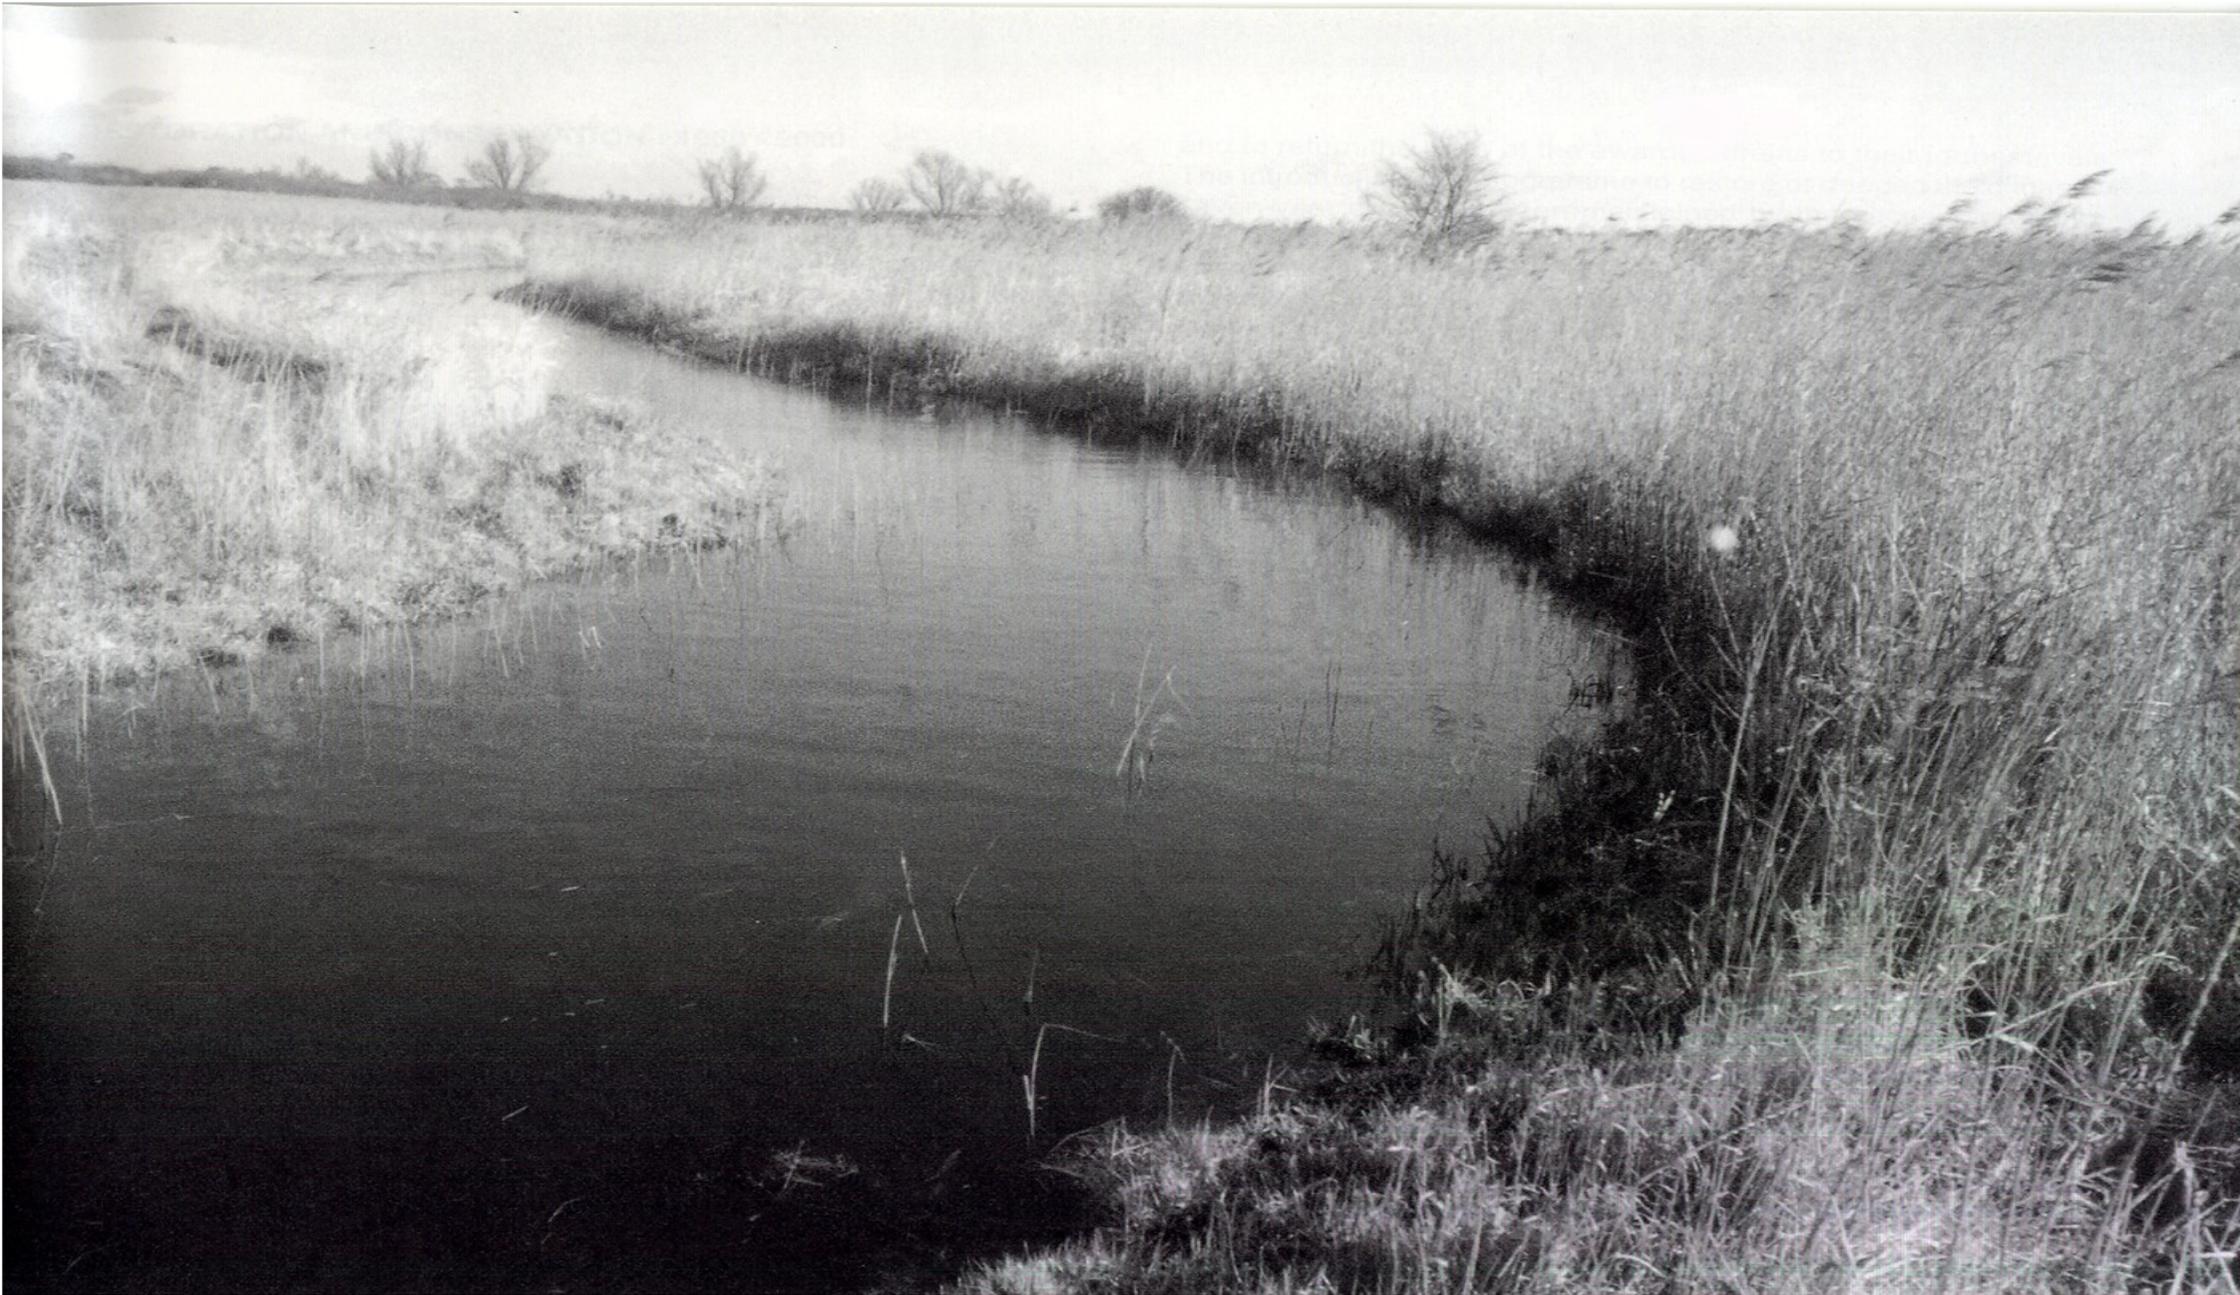
Figure 33. Former fields, now reed beds in the SSSI in Wilbraham Fen. The watercourse is the Parish Ditch between Little Wilbraham and Stow cum Quy

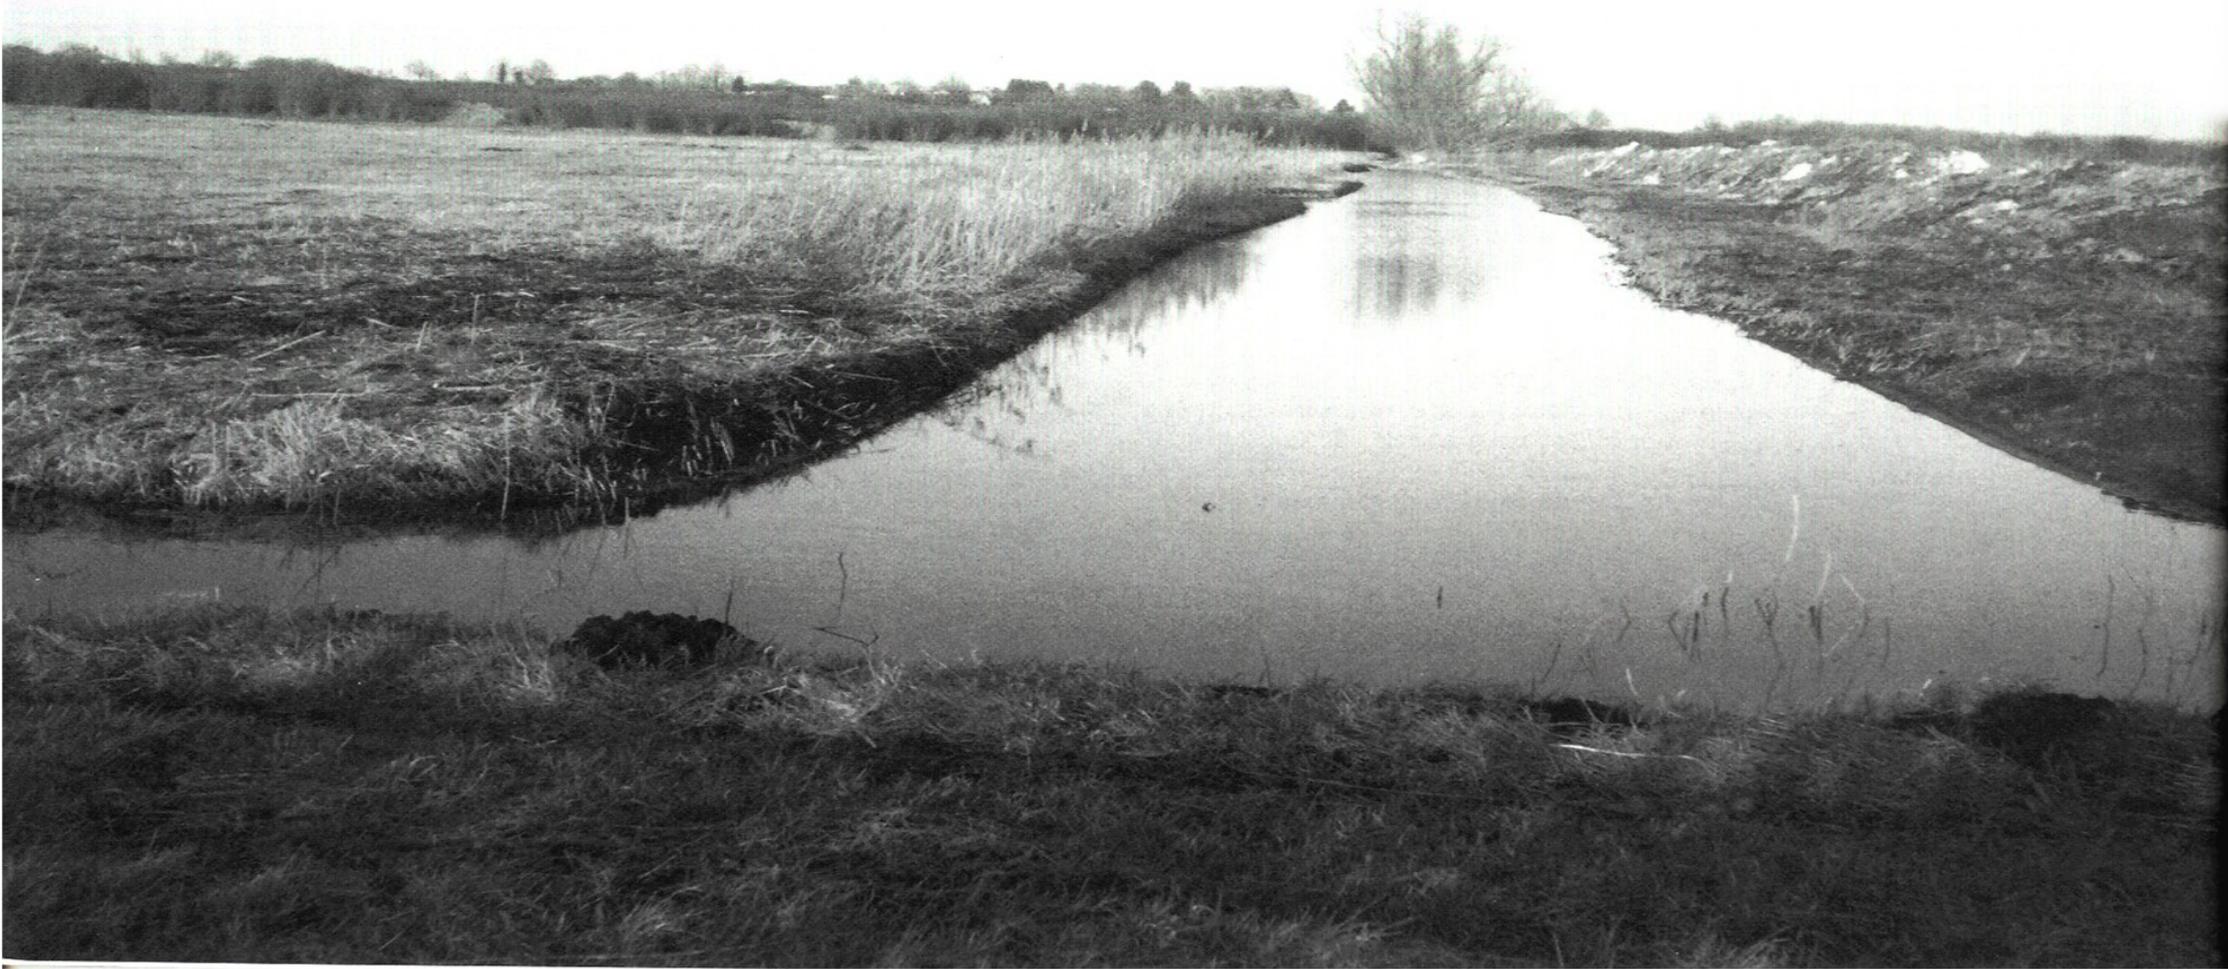
Figure 34. Little Wilbraham Fen., looking north from the Long Drove, winter 1999. The ditches and public drains have been restored and the land to the left cleared of scrub.
